PRELIMINARY INVESTIGATION REPORT

**ACCIDENT OF Mi-17 HELICOPTER
REG. NO AP-BIL OPERATED BY DGA KP CRASHED NEAR
TEHSIL PINDALI, MOHMAND AGENCY, KPK PAKISTAN ON 15-08-2025**

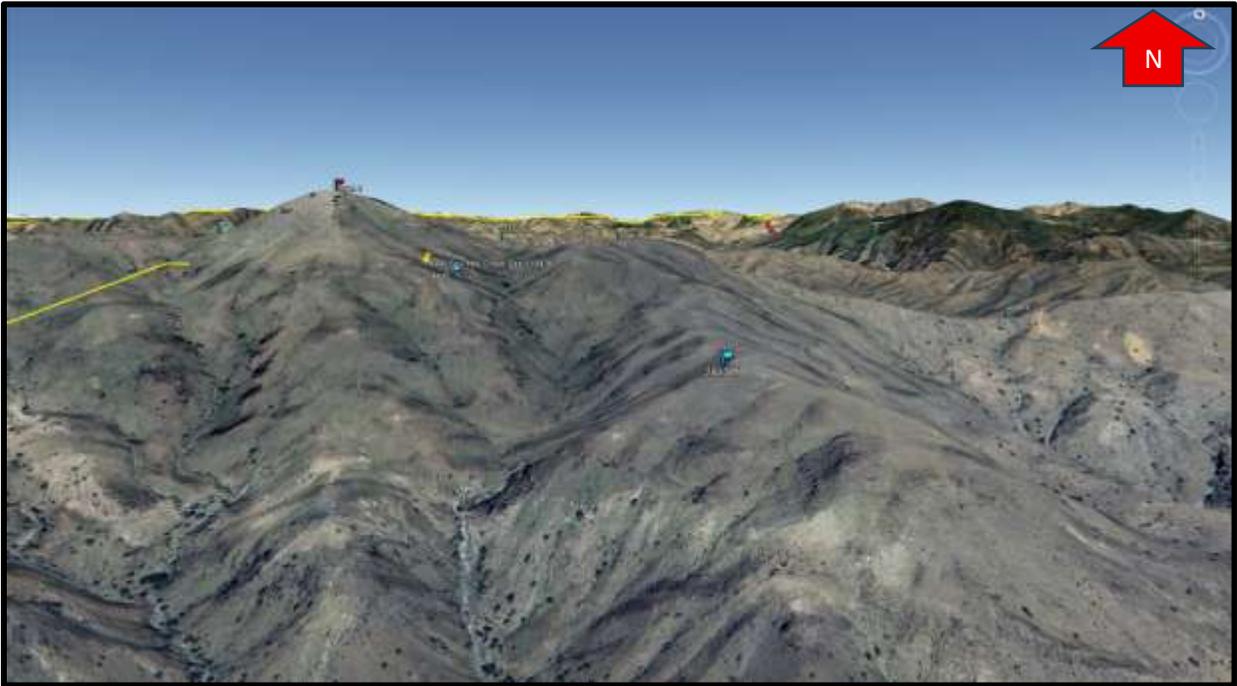
Figure 1 View of Heli Route and Altitude of the Area

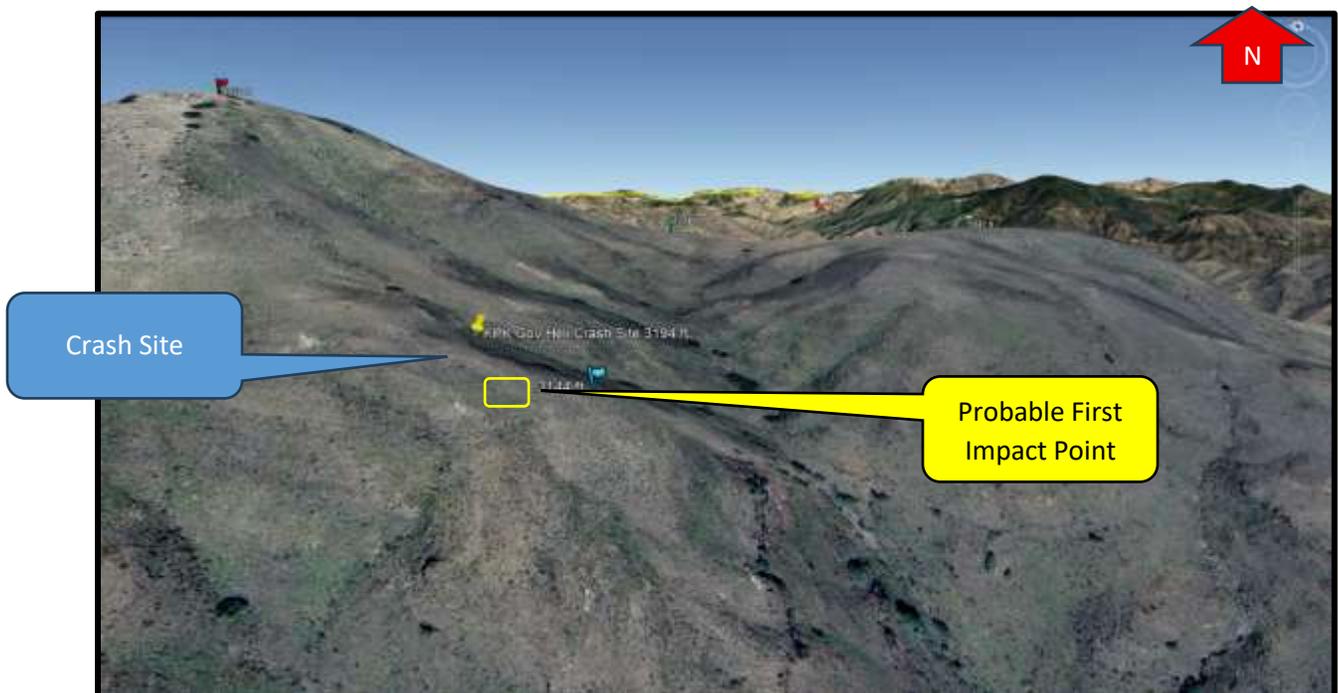
Figure 2 View of Crash Site Altitude at 3,144 ft with the Surrounding

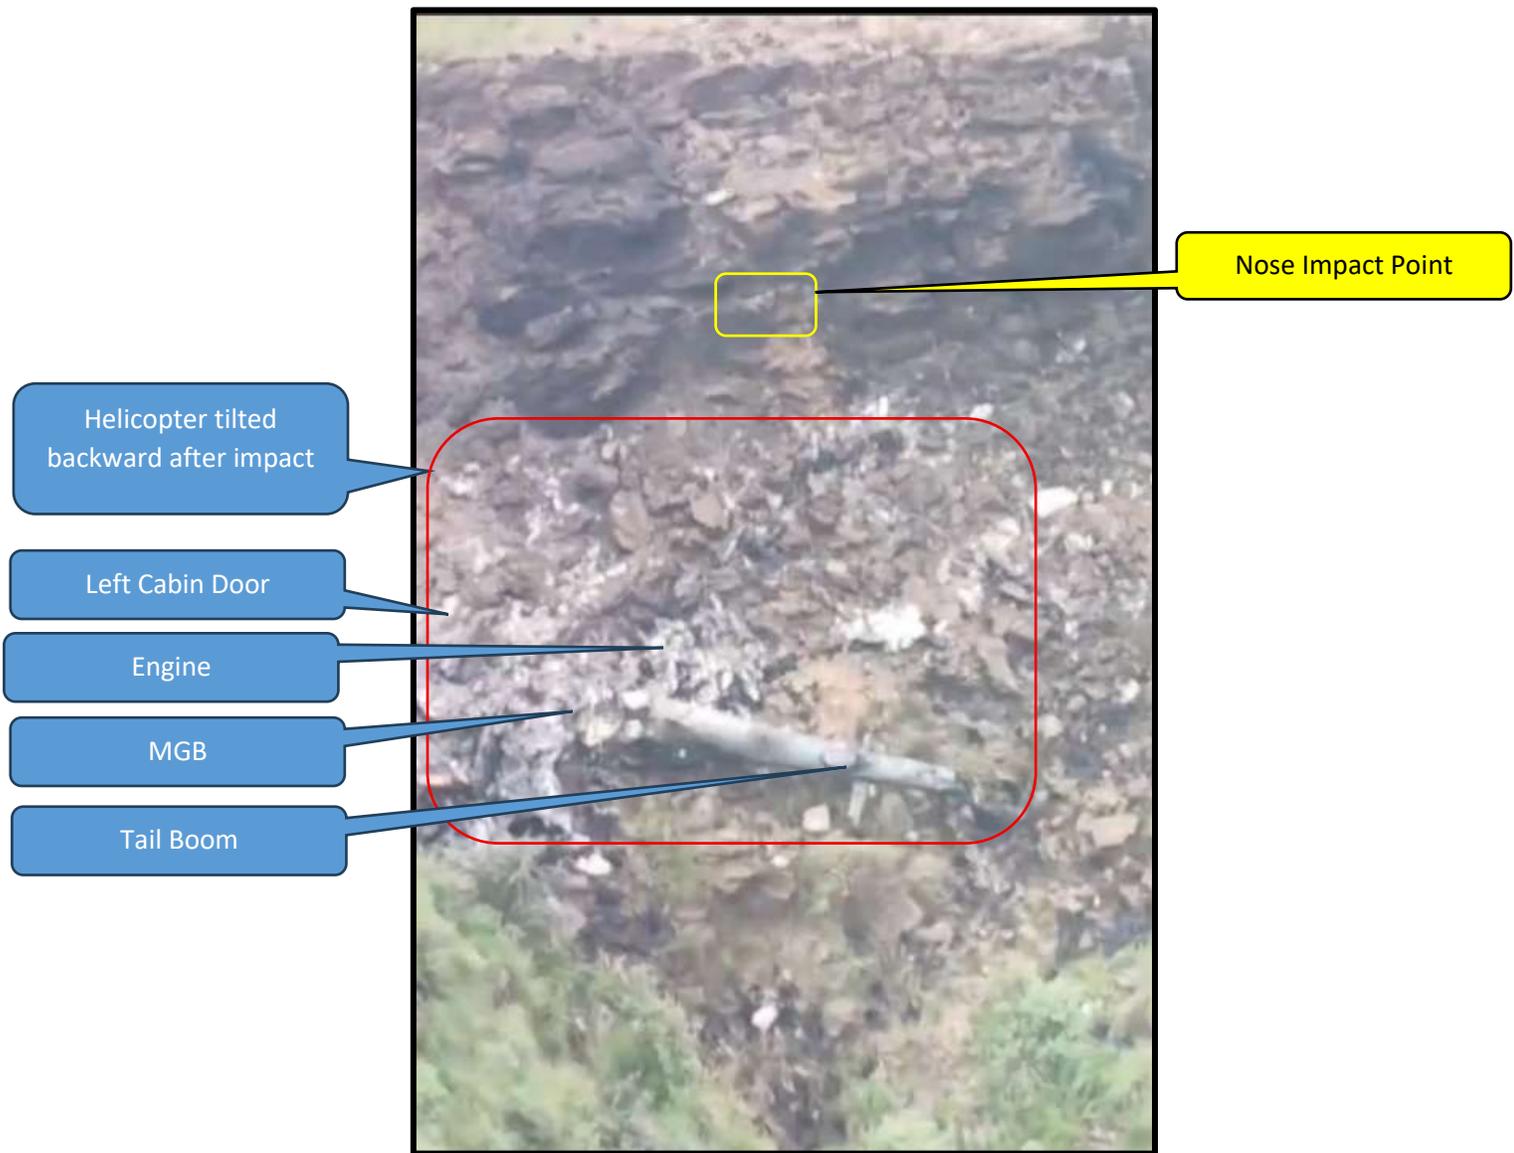
Figure 5 Aerial View of AP-BIL wreckage – Day 1

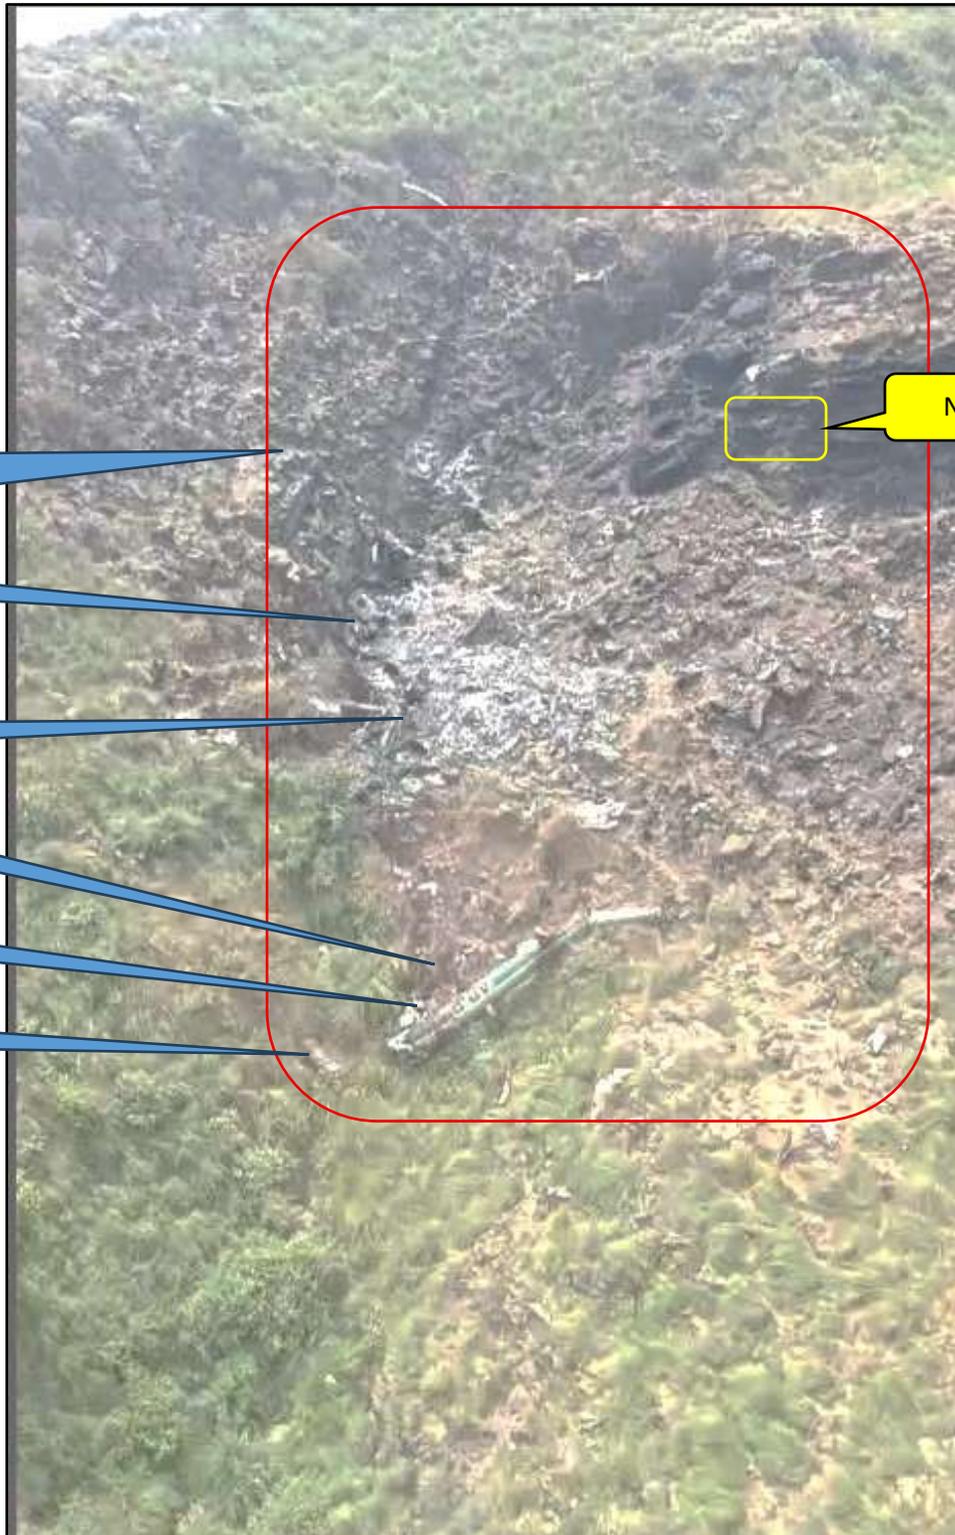
Figure 6 Aerial View of AP-BIL wreckage – Day 2

Helicopter tilted backward after impact

Nose Impact Point

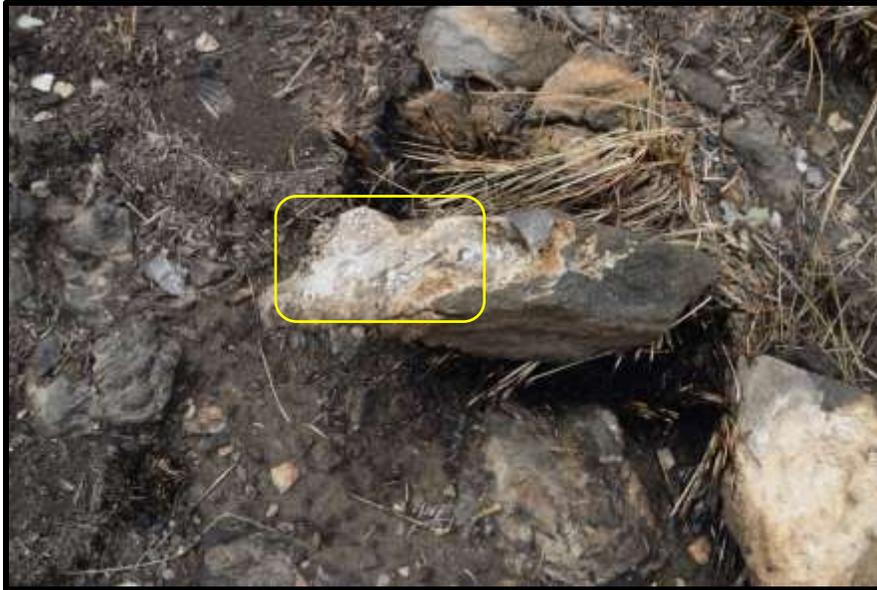
Figure 8 Cut marks of the Main Rotor Blades – Impact point

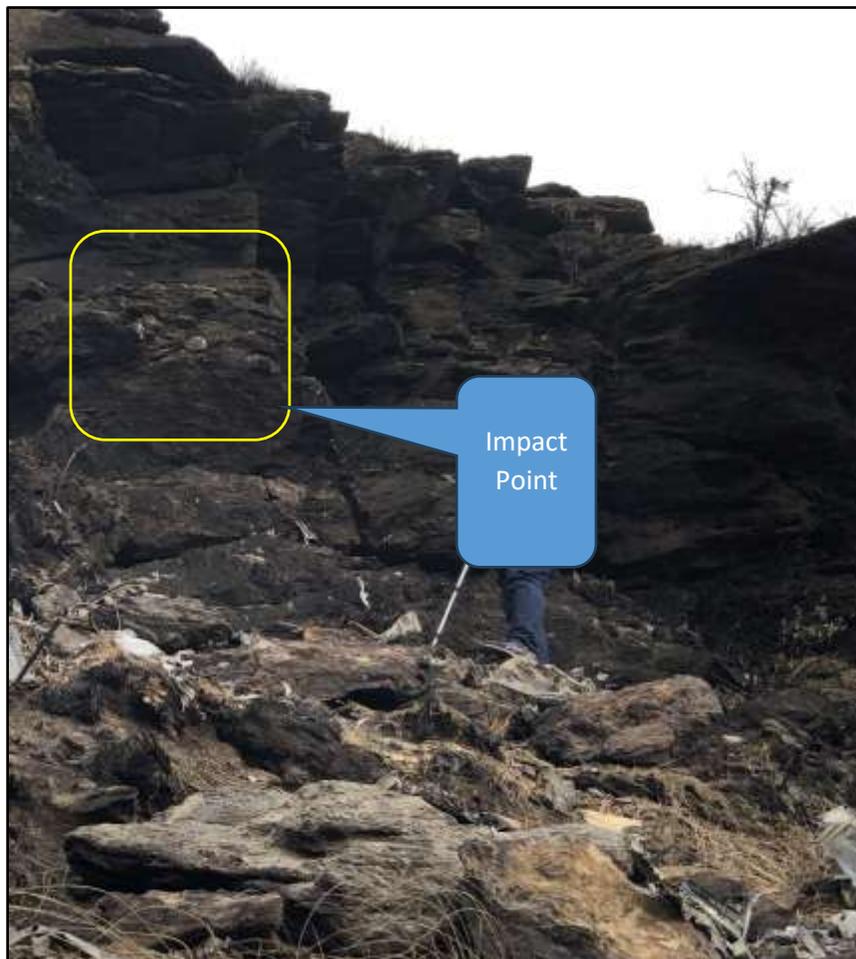
Figure 9 AP-BIL Nose Impact Point

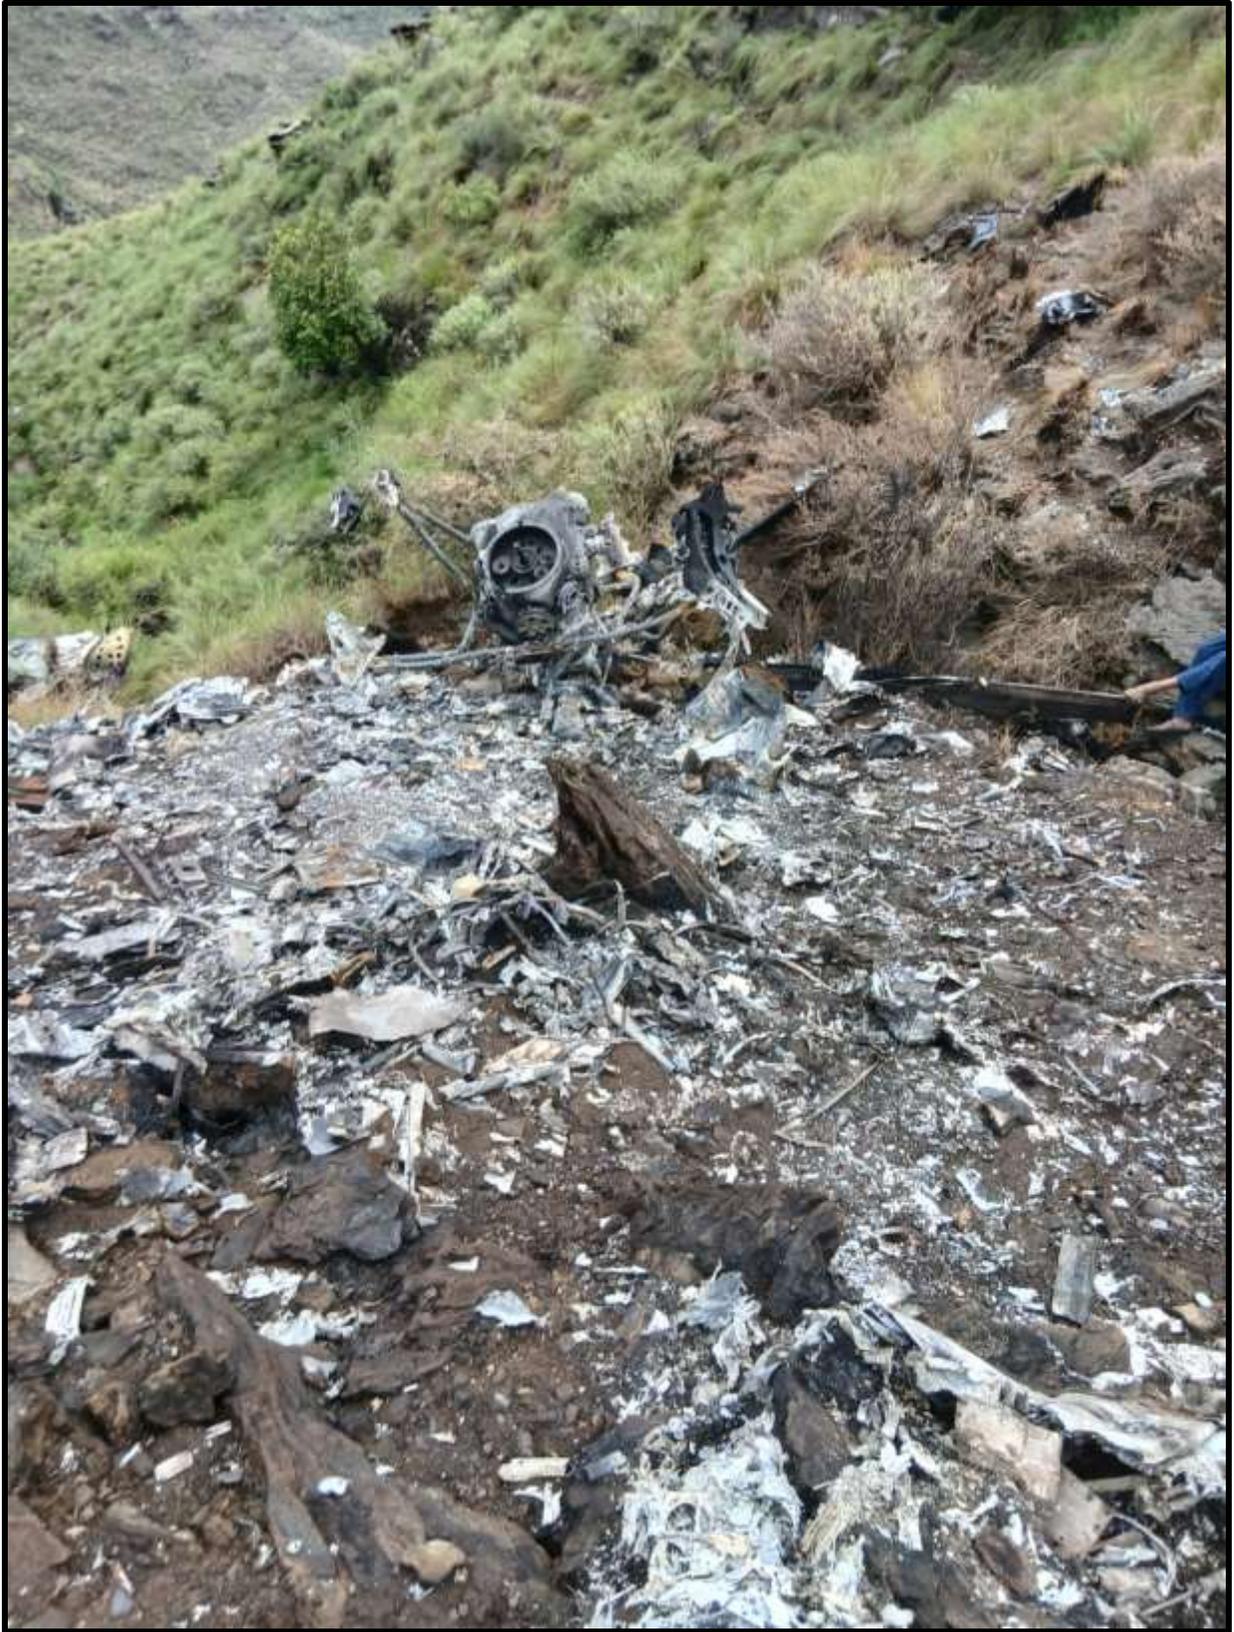
Figure 16 Main Gear Box and melted / disintegrated wreckage of AP-BIL

46. Almost the entire helicopter was burnt out, except for both engines, tail boom, part of MGB, Air conditioner, left door, nose wheel and few pieces of main rotor blades. Some of the wreckage parts had been stolen and few were subsequently recovered by the local police. Due to steep slope, and narrow pathway, the heavy parts are impossible to lift by humans and animals. In this regard, heli airlift was requested from Pakistan Army and Pakistan Air Force for recovery of larger wreckage parts. However, as the helicopters were committed to flood relief operations, the request could not be materialized. Moreover, through Jirga (Tribal Area Administration), a vendor has been hired for recovery of the 05 wreckage parts by building a vehicular track of approx 3000 feet and installation of zip line 500 feet. The work is presently in progress.

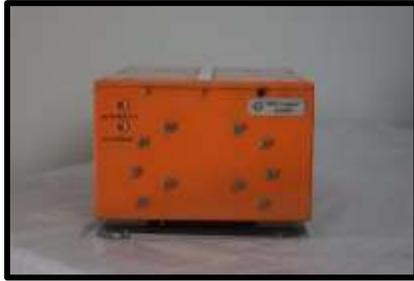
47. FDR and CVR were recovered from the accident site in slightly damaged state with burn marks. All other instruments and navigation equipment had been completely destroyed by fire.

Figure 7 FDR

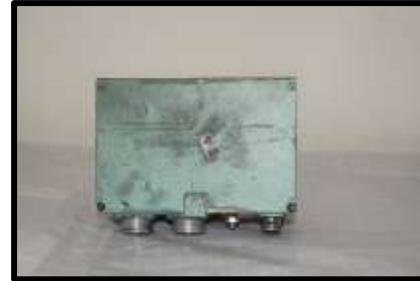
Figure 8 CVR
