FINAL INVESTIGATION REPORT

**SERIOUS INCIDENT (FLAME OBSERVED IN RIGHT ENGINE)
AIRBLUE FLIGHT ABQ-410, AIRBUS 321-211 AIRCRAFT,
REG. NO. AP-BMP, AT AIIAP, LAHORE ON 02-08-2022**

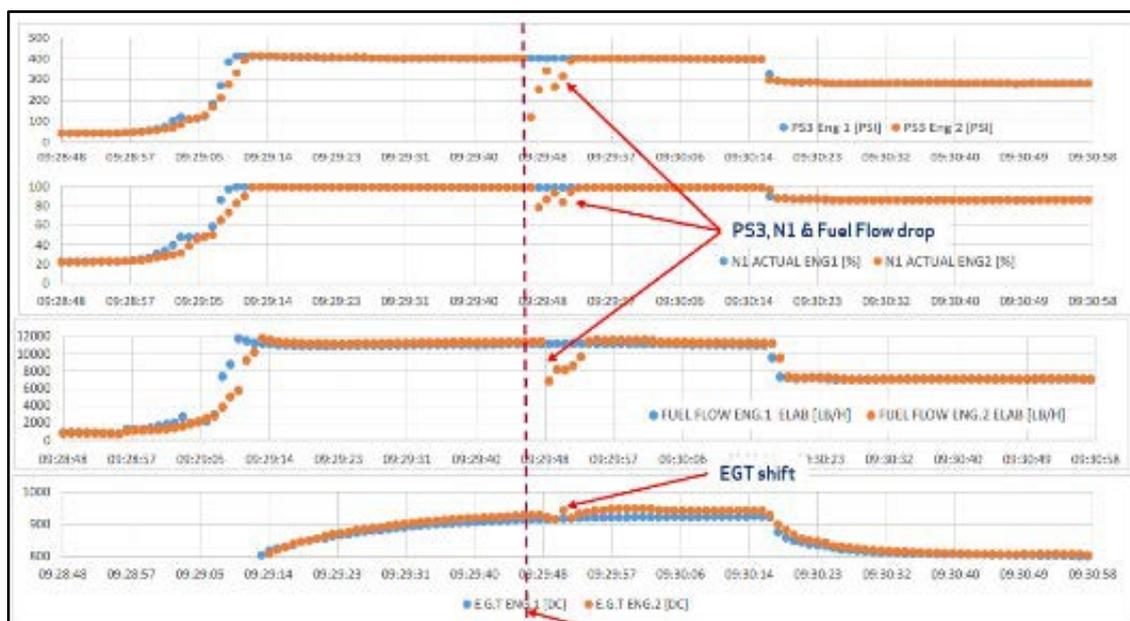
Figure 1 PSI of Engine No 1 2

1.11.1. DFDR analysis revealed, approximately after 30 s full throttle, the PS3 dropped from 400 PSI to 120 PSI, the N1 & N2 and Fuel flow decreased in line with the PS3, and EGT shifted. This is a signature of an engine stall.

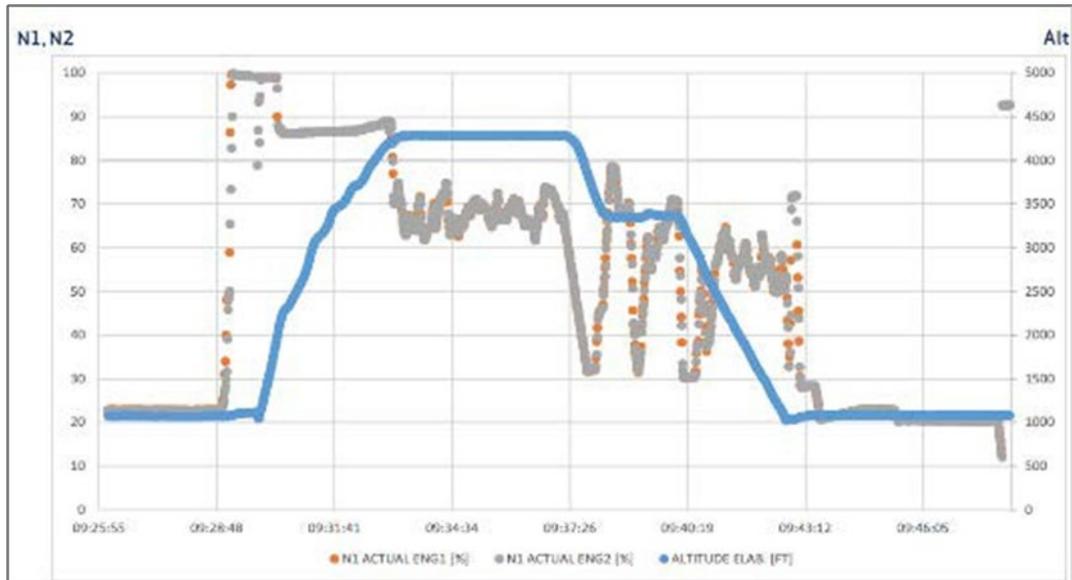
Figure 2 Engine Parameters

1.11.1.1. After 6 s, all engine parameters return to the normal range, in line with the sister engine.

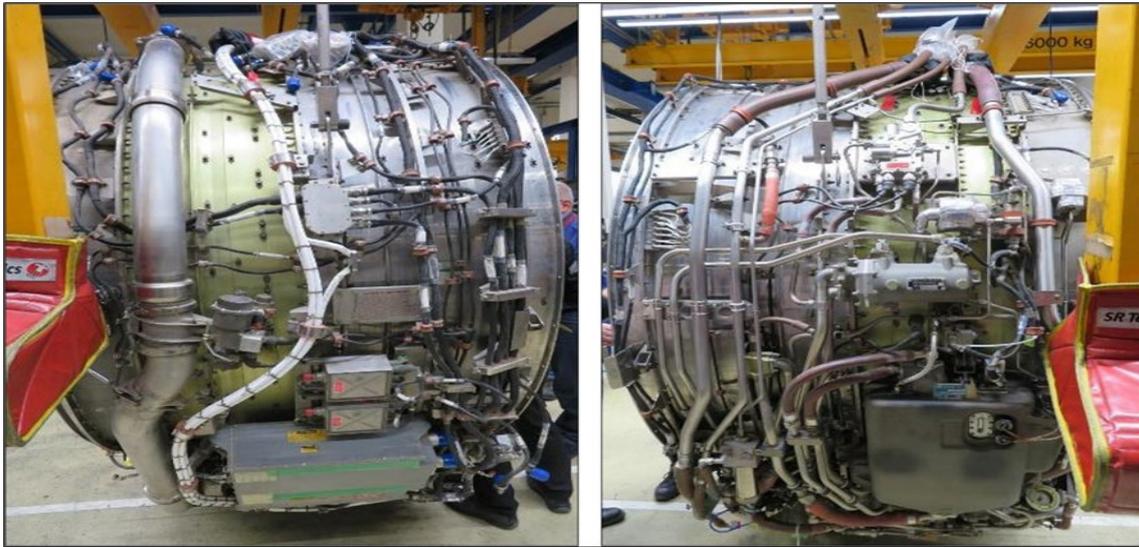
Figure 4 Fan Module Sides Overview

2.3.5. **Fan Module Sides Overview** – No abnormality was found / seen in Engine Fan Modules during analysis.

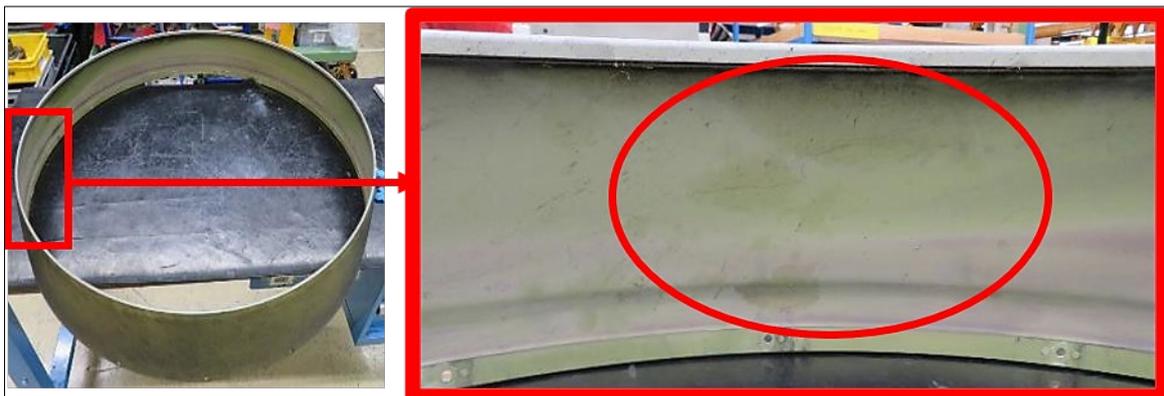
Figure 6 Flow path Separator

2.3.5.1. **Flow path separator:** No evidence of bird remains; this part may have been cleaned by the operator after the bird strike.

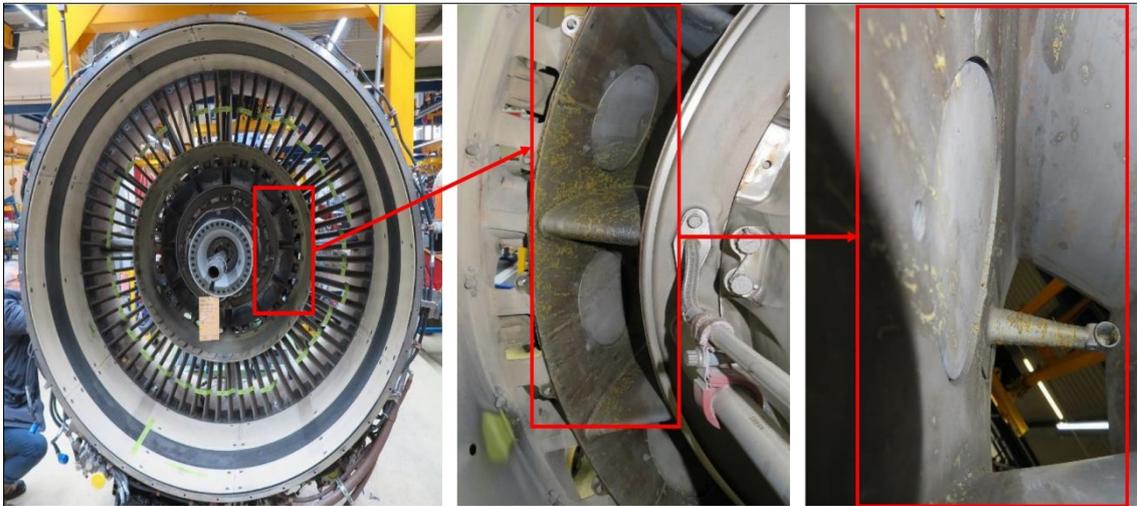
Figure 7 FAN Case Module FWD Primary Flow Path

2.3.5.2. **FAN Case module FWD:** FAN Case module FWD primary flow path exhibited large quantity of bird remains from 2:30 to 6 o'clock.

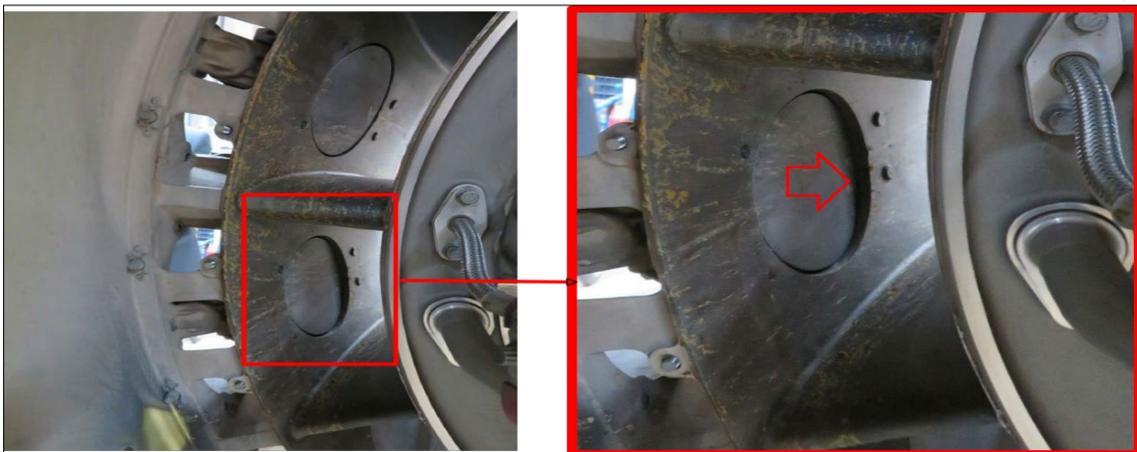
Figure 8 VBV Doors Misalignment due to Bird Impact

2.3.5.3. **Variable Bleed Valve (VBV) doors:** VBV doors misaligned due to bird impact.

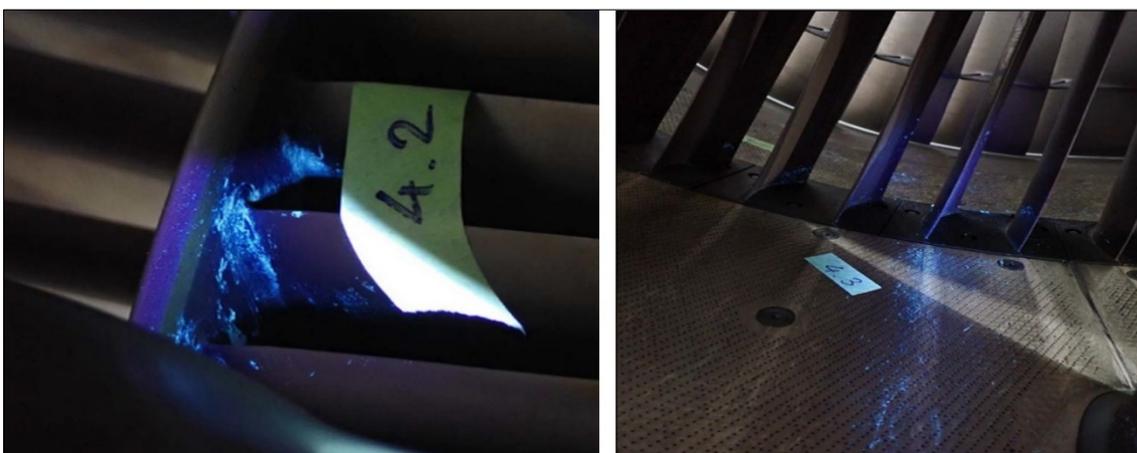
Figure 9 FAN Case Module, Black Light Inspection

2.3.5.4. **FAN Case module:** Black light inspection was carried out for inspection of organic traces on OGVs.

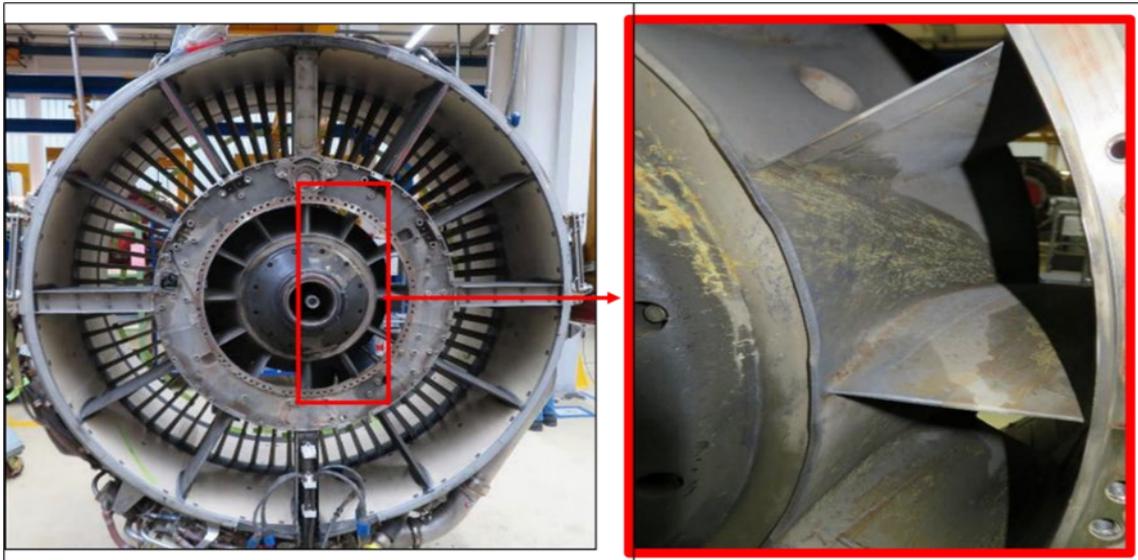
Figure 10 FAN Case Module AFT (2h30 to 6h)

- (a) Fan Case module AFT large quantity of bird remains from primary flow path from 2h30 to 6h can be seen.

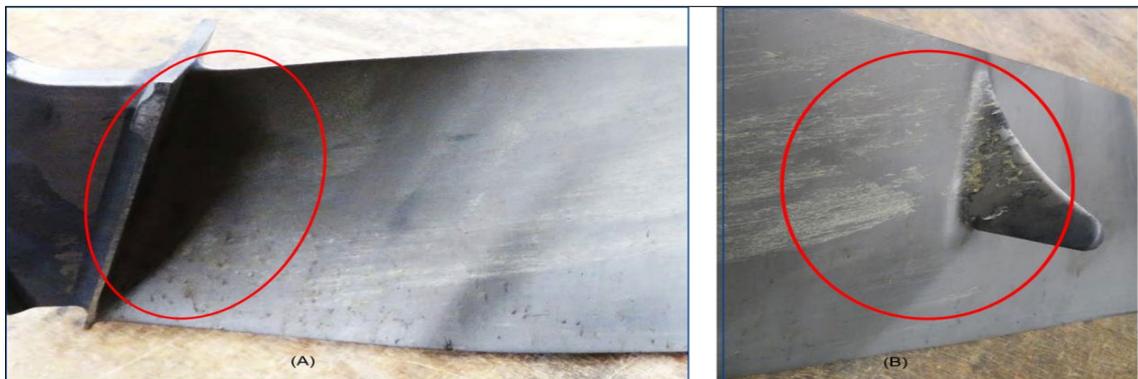
Figure 11 Fan Blade No.36, Bird Remains Traces

- 2.3.5.5. **Fan Blade:** Fan blade No. 36 Area (A) of Impact is shown in highlighted portion, Bird remains can be seen.

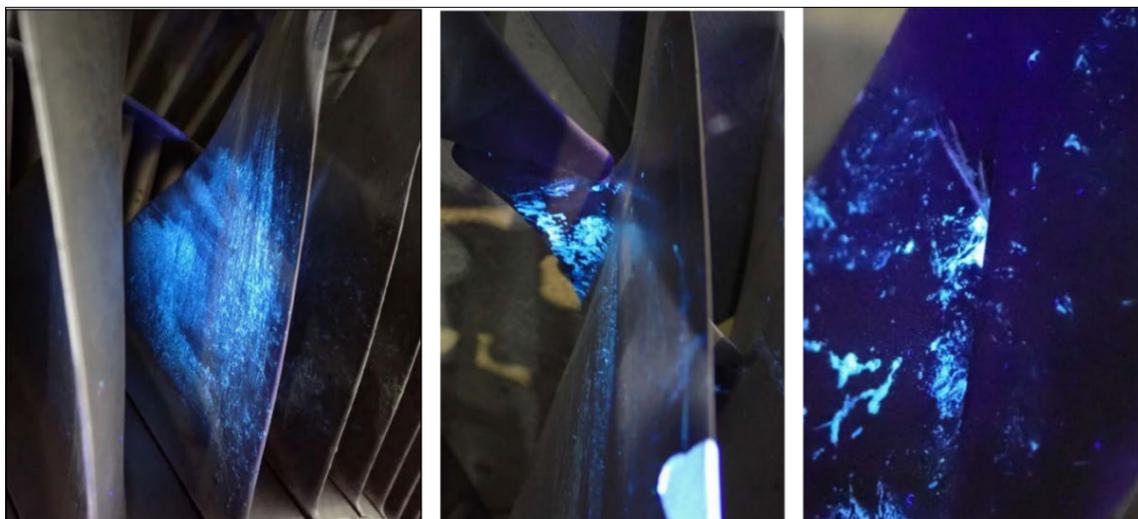
Figure 12 Fan Blades Black Light Inspection

- (a) Black light inspection showed bird remain traces from the root of the blade.

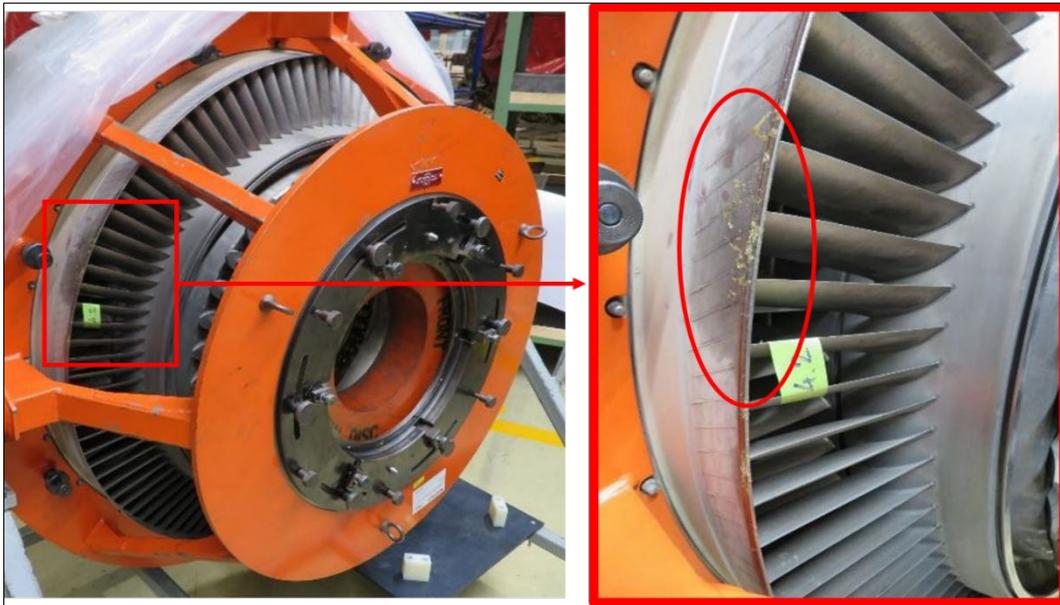
Figure 13 LPC FWD Side (below 3h)

2.3.5.7. **Low Pressure Compressor (LPC) FWD side** evidence of local (below 3h) bird remains. No blade / vane distortion seen.

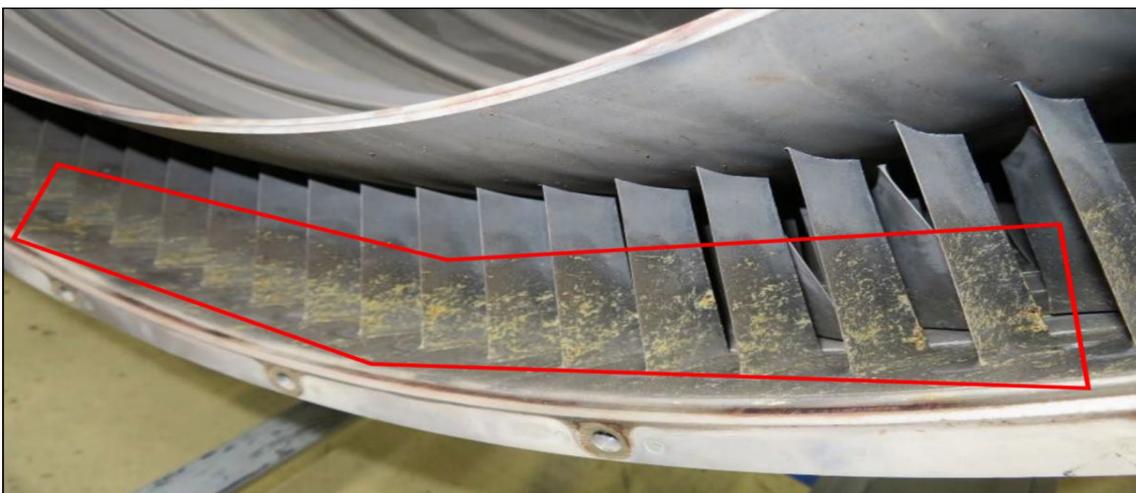
Figure 14 LPC AFT Side (3h-6h)

(a) LPC AFT side evidence of large quantity of bird remains (3h-6h). No blade/vane distortion seen.

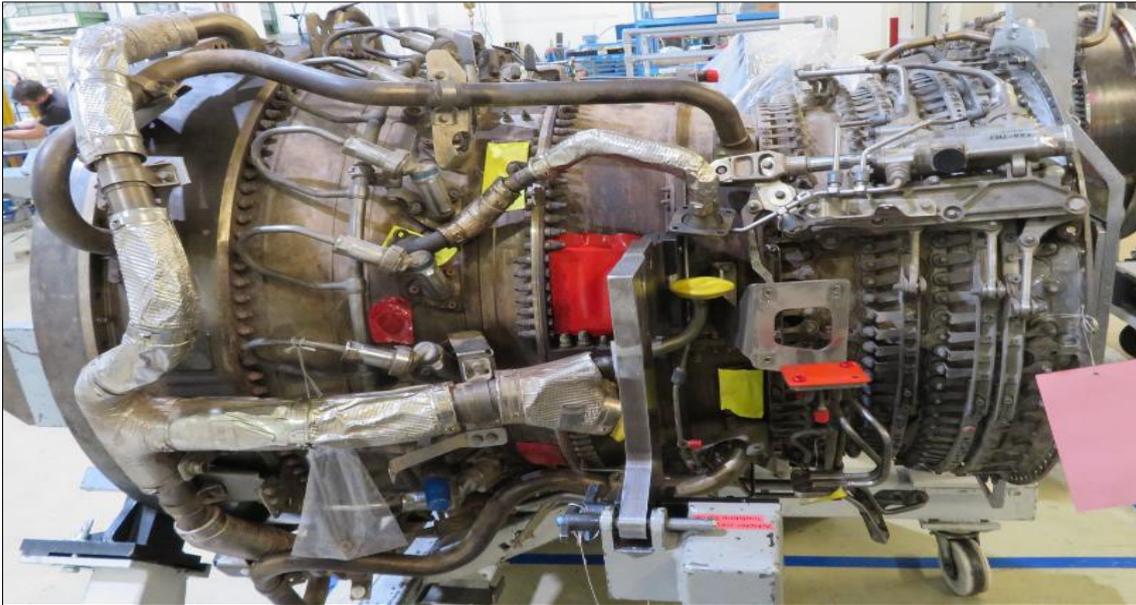
Figure 15 HPC 3h side View

2.3.5.8. HPC 3h side: No evidence of torn / disengaged lever arm (TBC).

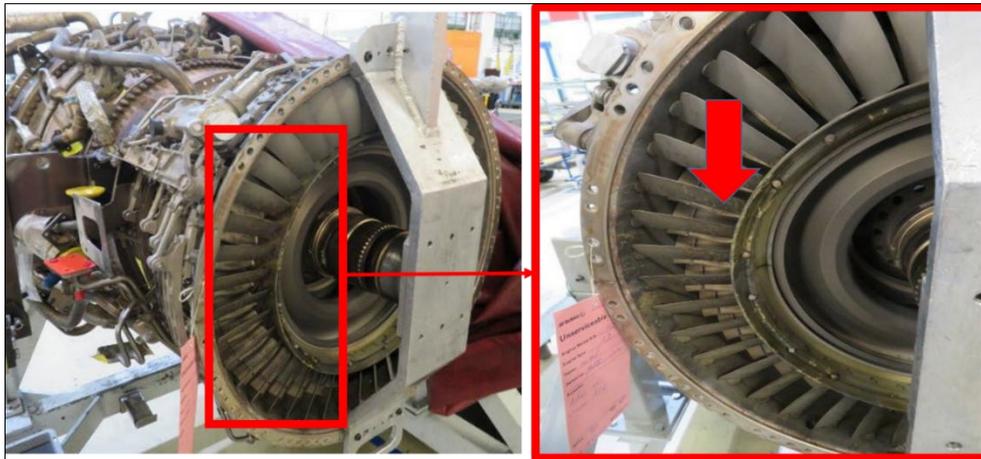
Figure 16 HPC FWD Detail

2.3.5.9. High Pressure Compressor (HPC) FWD Side: Bird remains on primary flow path.

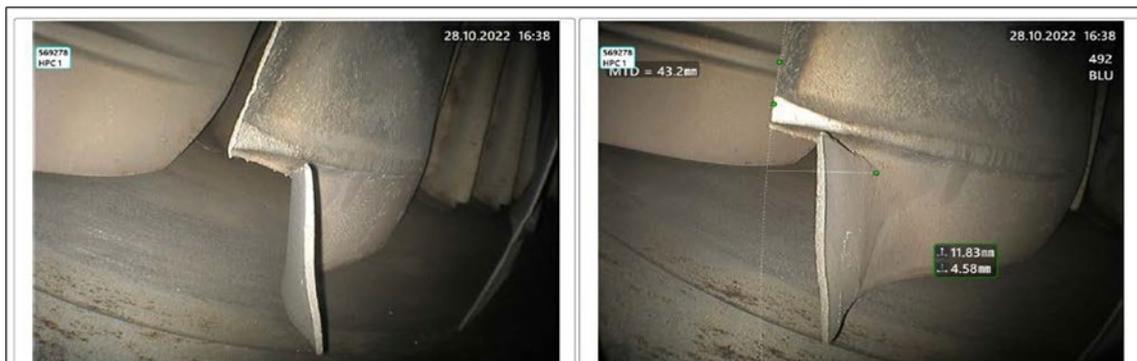
Figure 17 Main Boroscopic Inspection

(a) Main boroscopic inspection finding is 1ea CHP1 blade with LE badly damaged.

3.1.11. The bird-strike during the previous flight caused the HPC stage 1 damage, which then reduced the stall line. At T/O thrust the stall margin was reduced. The thermal effect, possibly combined with another transient element (i.e. a distortion peak) consumed the already reduced margin and resulted in the stall.

4.1.1.2. The operator should implement enhanced post-bird-strike inspection checklists, including engine boroscopic examination where applicable, to detect potential internal damage.

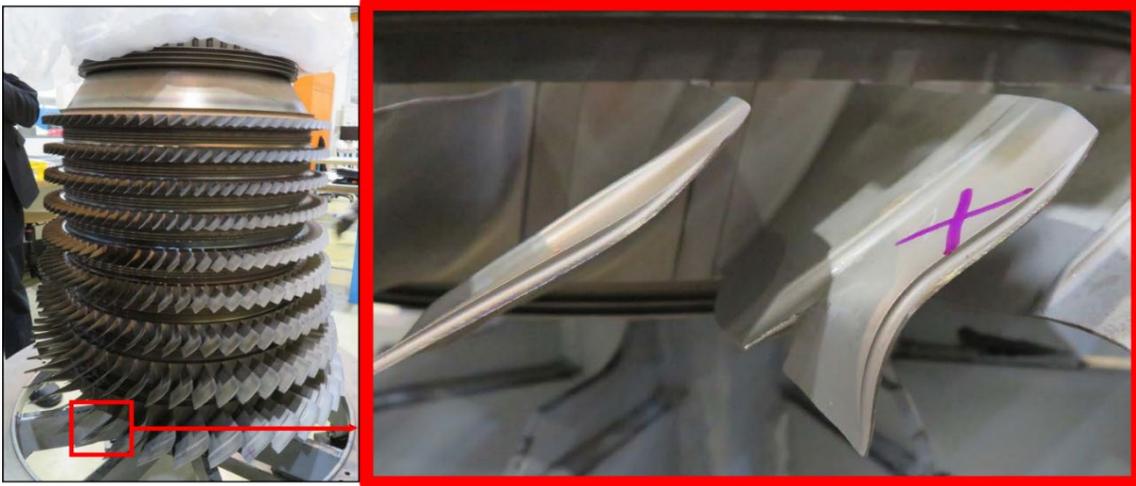
Figure 18 HPC Rotor Inspection

(b) HPC rotor inspection, one (1) HPC1 blade bent and torn from LE on mid span area.

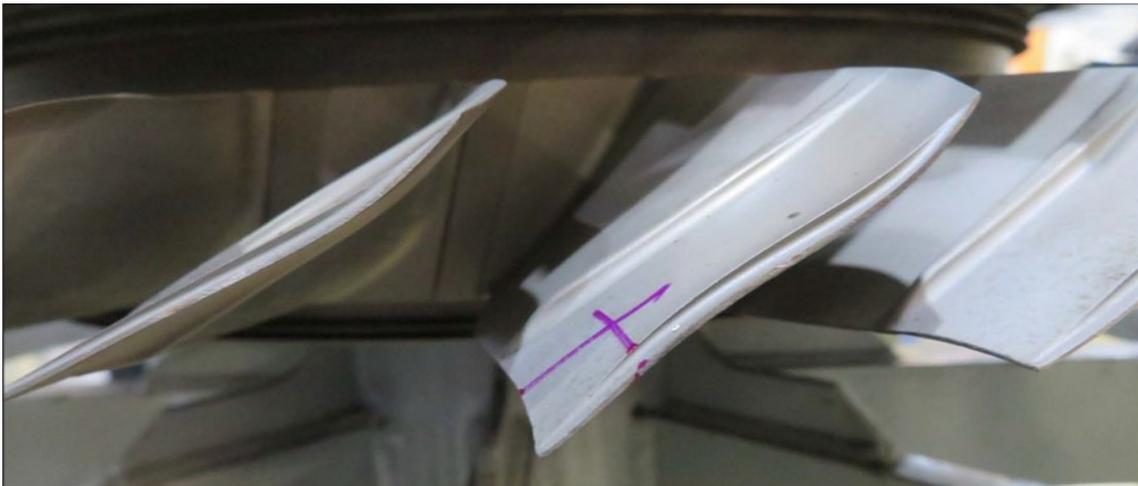
Figure 19 HPC1 blade bent but not torn

(c) HPC rotor inspection two (2) other HPC1 blade bent but not torn. Moderate rub at the top of all the blades.

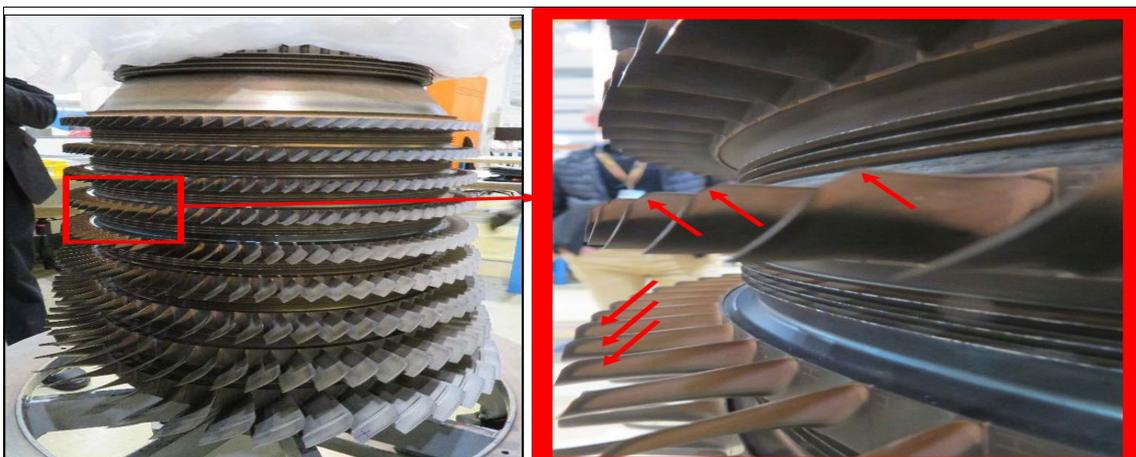
Figure 20 HPC Rotor Inspection

(d) HPC rotor inspection all blades (all stages) exhibit tip TE erosion evidence and moderate rub at the top.

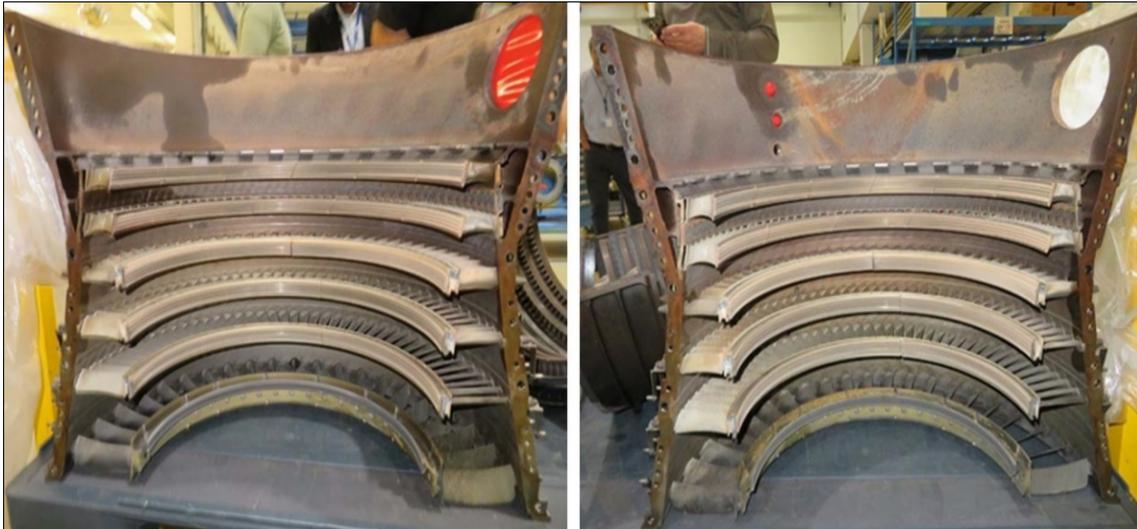
Figure 21 FWD HPC stator inspection

- (e) **FWD HPC stator inspection, no major damage seen.**
- (f) **FWD HPC upper stator inspection HPT1 blade contact (between 9h & 10h) HPT2 contact evidence.**

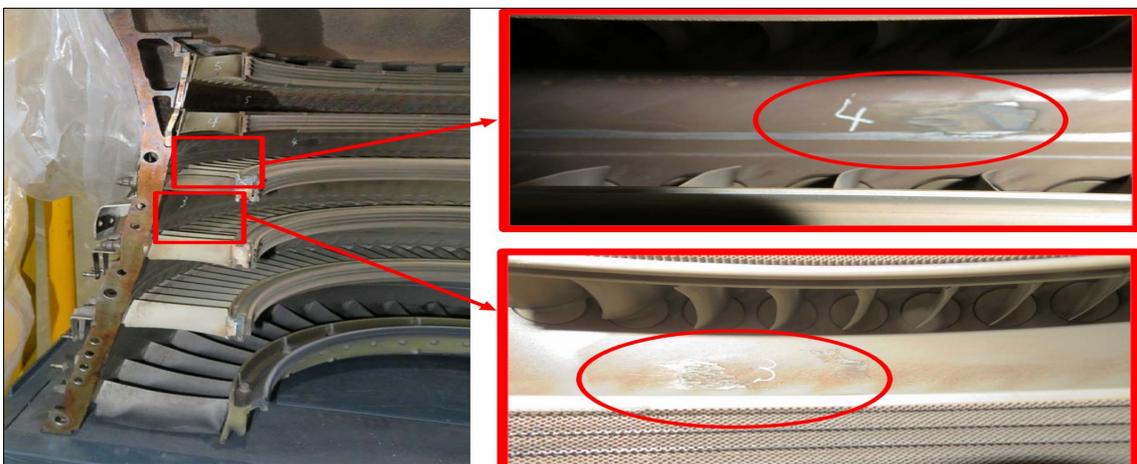
Figure 23 FWD HPC Upper Stator Inspection HPT3 & HPT4

- (g) **FWD HPC upper stator inspection HPT3 and HPT4 local hard contact (between 9h & 10h) + rub.**

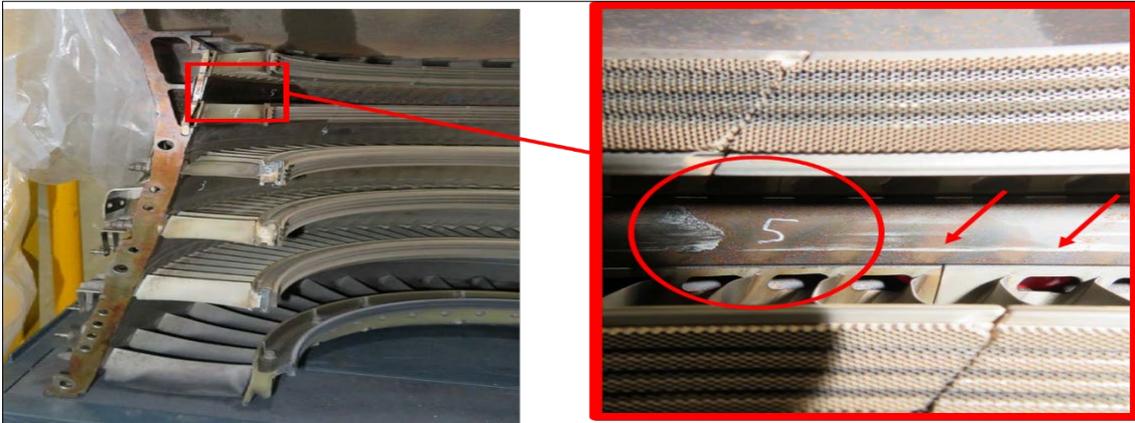
Figure 24 FWD HPC Upper Stator Inspection (HPT 5)

- (h) FWD HPC upper stator inspection HPT 5 local hard contact (between 9h & 10h) + rub.

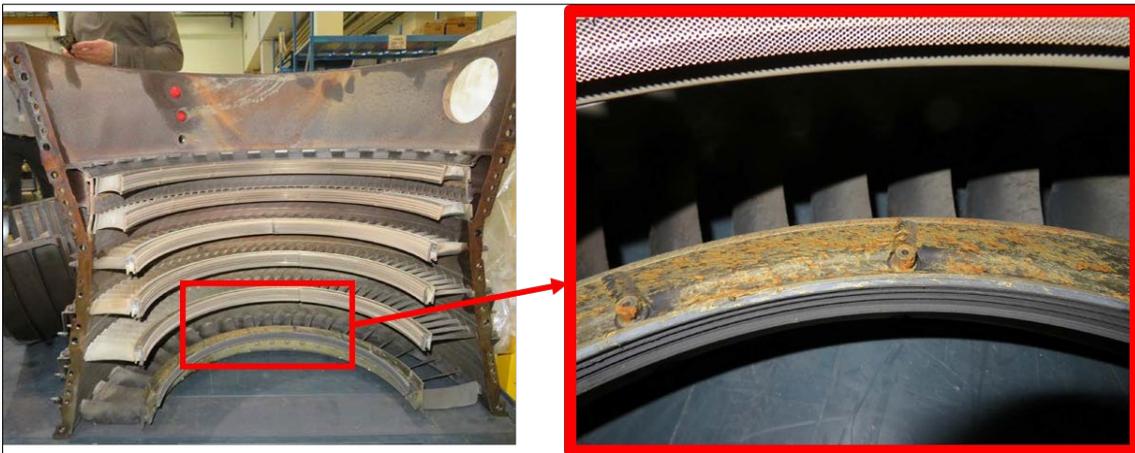
Figure 25 FWD HPC Lower Stator Inspection

- (i) In FWD HPC lower stator inspection revealed Organic remains.

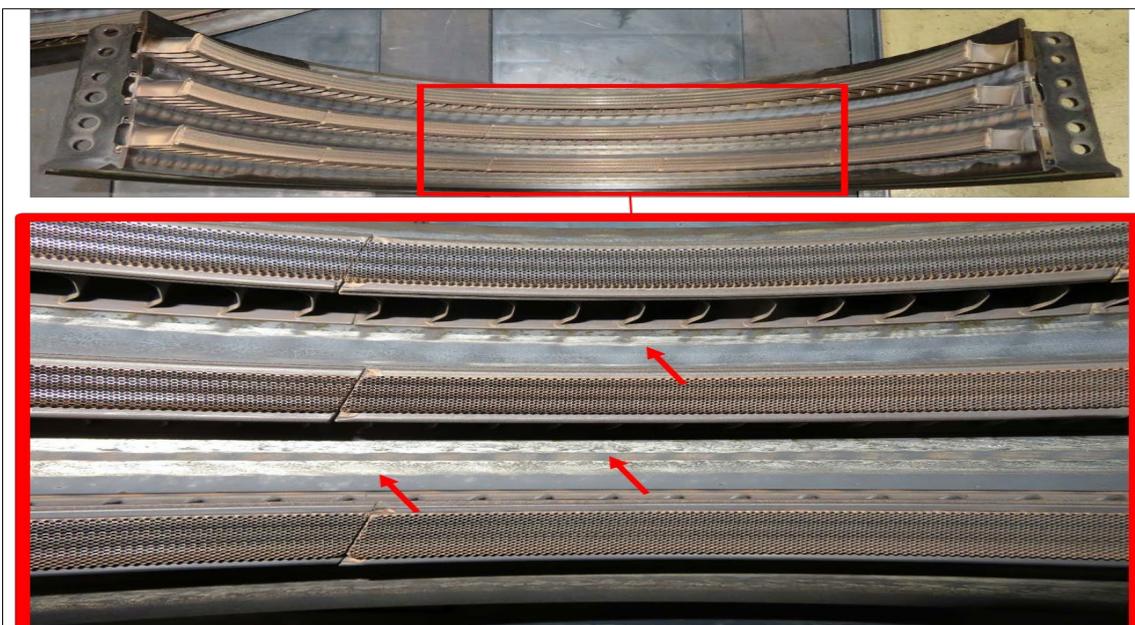
Figure 26 AFT HPC Stator Inspection

- (j) In AFT HPC stator inspection Rub evidence can be seen.

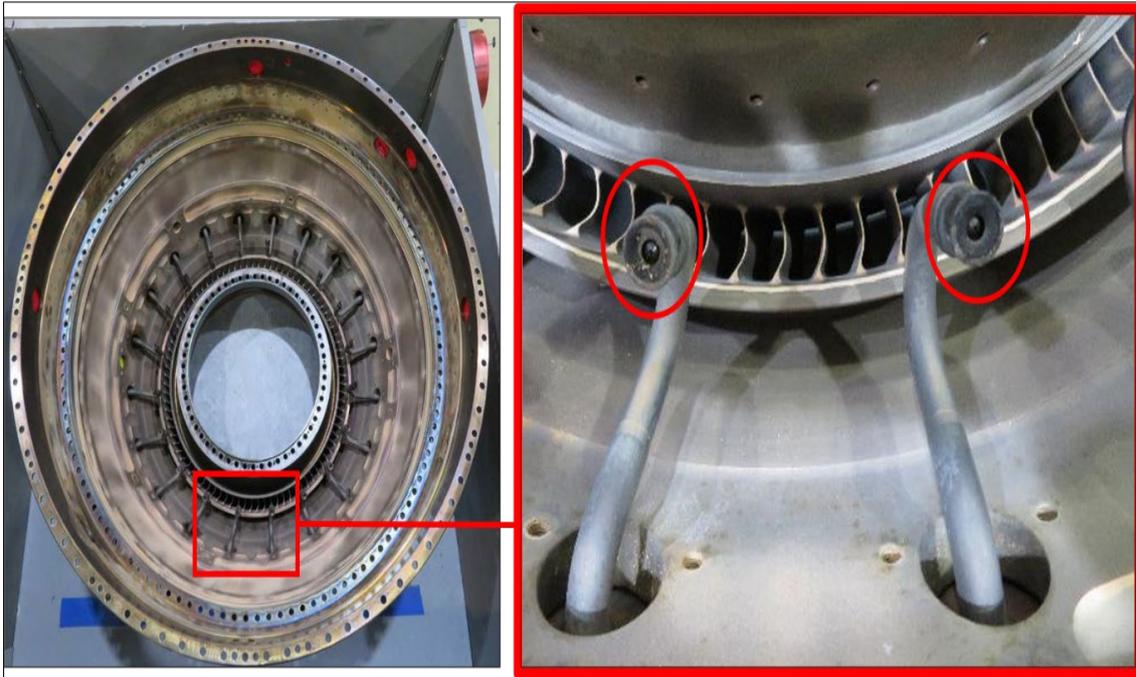
Figure 27 Combustion case inspection

- (k) **Combustion case inspection:** Usual condition, soot evidence on nozzles.

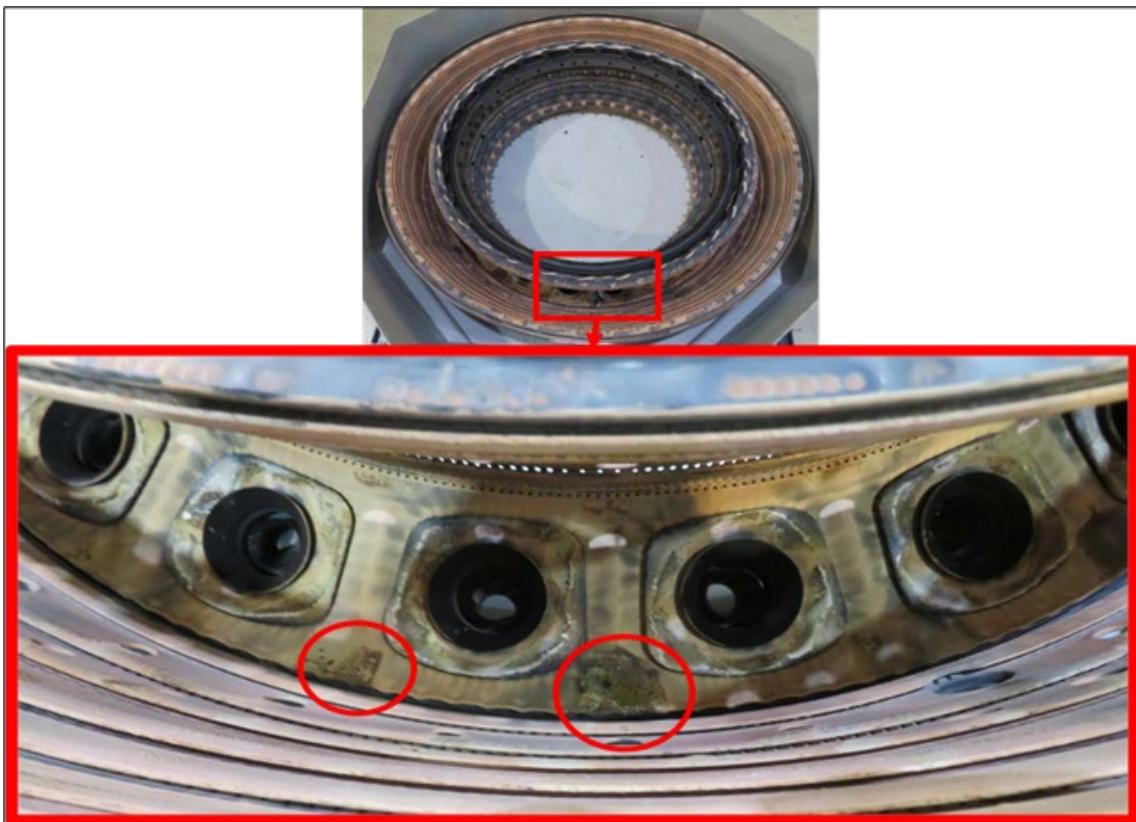
Figure 28 Combustion chamber inspection

- (l) **Combustion chamber inspection:** Usual condition except local deposits.

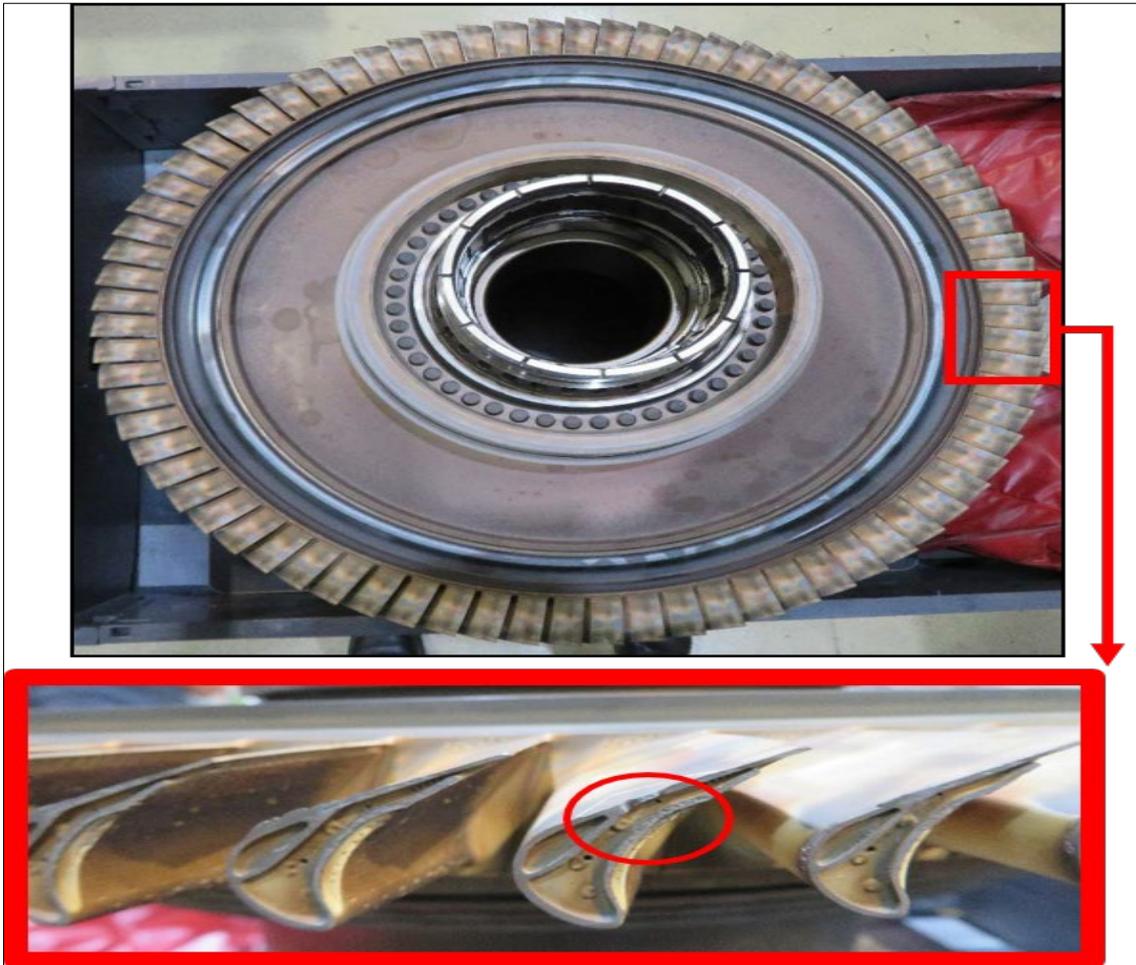
Figure 29 HPT Rotor Inspection AFT side

(n) **High Pressure Turbine (HPT) Rotor:** HPT rotor inspection AFT side showed nothing unusual. Top of blades one notch can be seen.

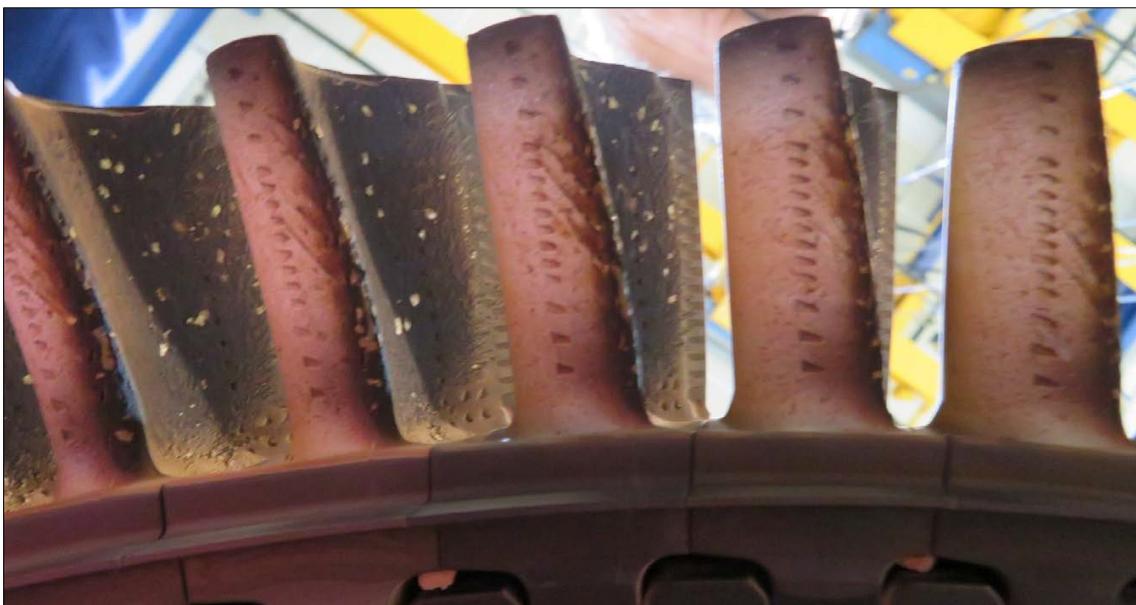
Figure 30 HPT rotor inspection

(o) **HPT rotor inspection:** Carbonised remains deposit on blades LE and concave side.

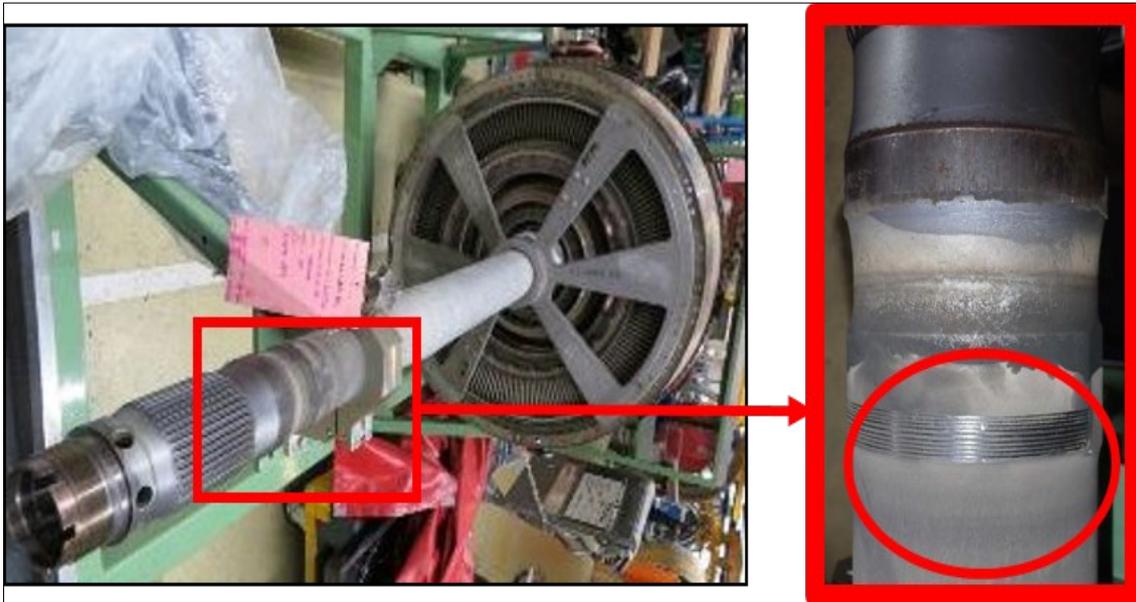
Figure 31 LPT Inspection

2.3.5.10. **Low Pressure Turbine (LPT) module** – LPT was in good condition. Unusual traces were founded on LPT shaft balancing area.

- (a) **LPT 1 nozzles:** Nothing to report.
- (b) **LPT:** LPT inspection unusual rotated contact evidence can be seen on LPT shaft balancing area.
