FINAL INVESTIGATION REPORT

SERIOUS INCIDENT LANDING ON WRONG RUNWAY

**SAUDI AIRLINES FLIGHT SVA-724 BOEING 777-368 (ER)
REG NO HZ-AK21 AT IIAP, ISLAMABAD ON 14-10-2024**

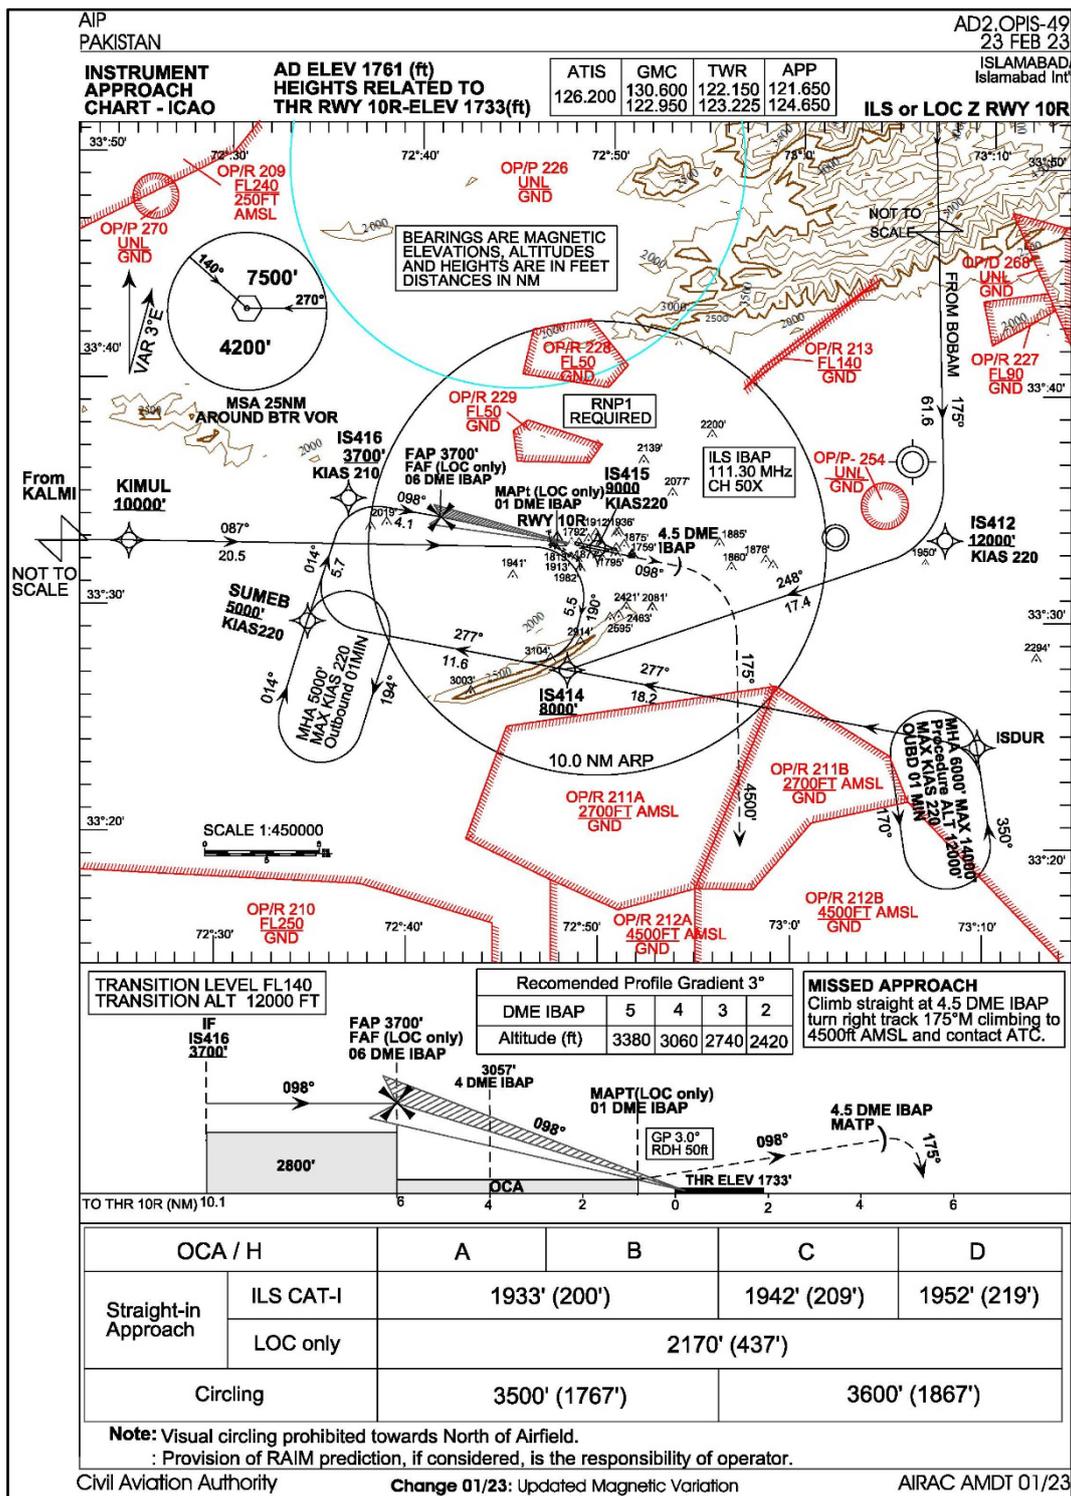
Figure 2 ILS-Z RW 10R OPIS, Islamabad

1.1.10. **021828.** SVA-724 contacted Islamabad Approach at position KALMI and was reissued ATC Clearance for ILS Z Approach RW 10R, with descent to 5,000 ft.

- 1.1.11. **021838.** SVA-724 again read back the ATC clearance for SUMEB followed by IS416, but **did not mention the type of Approach or Runway.**
- 1.1.12. **022424.** SVA-724 started descent to 3,700 ft as published in the Aeronautical Information Publication (AIP) and was advised by the Approach Controller to report established.
- 1.1.13. **022607.** Approach Controller passed latest QNH 1015 to SVA-724 but the read-back by the Saudi pilot was not clear.

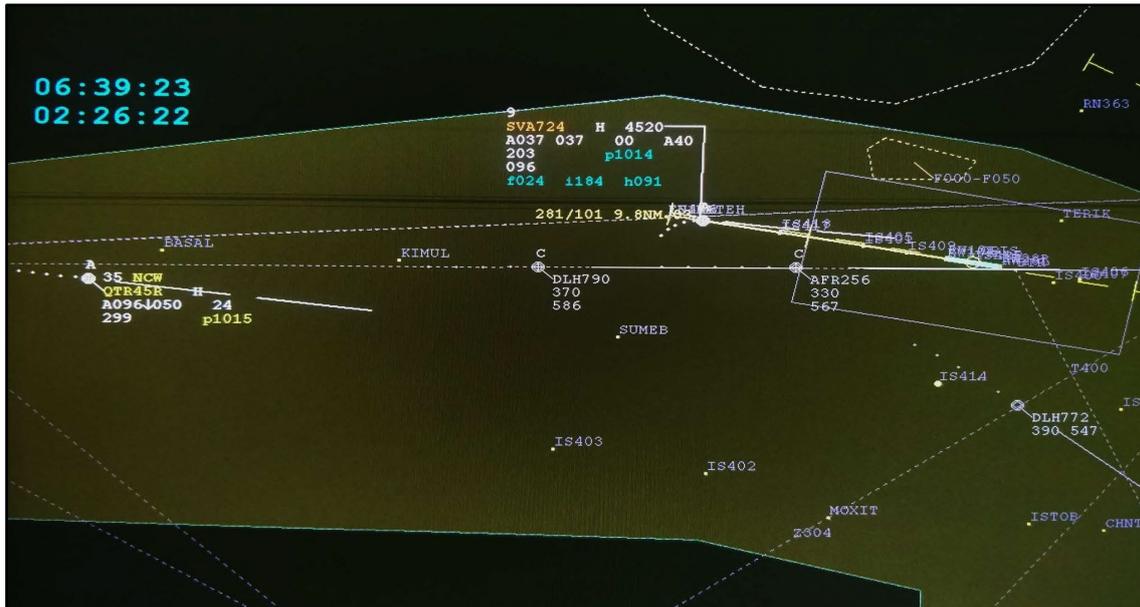
Figure 3 Change over to Islamabad Tower frequency

1.1.14. **022622.** Approximately 08 Nautical Miles (NM) from RW 10R, SVA-724 was changed over to Islamabad Tower on frequency 122.150 MHz.

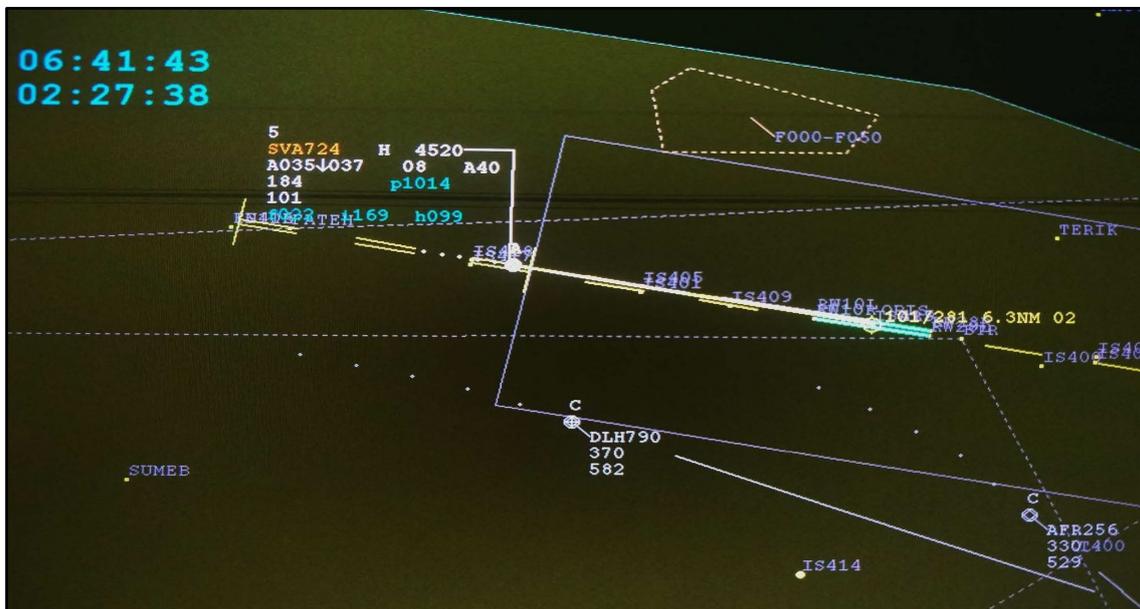
Figure 4 Landing clearing by ATC

1.1.15. **022641.** SVA-724 contacted Islamabad Tower and reported “established”. Tower Controller issued a landing clearance explicitly stating: “Clear to land RW 10R”, along with caution for birds, wind and gear check. **but the read back by SVA-724 only stated RW 10 without mentioning Left (L) or Right (R).**

1.1.16. **023014.** SVA-724 landed on RW 10L instead of the cleared RW 10R.

2.4.3.1. **Ambiguous Read-Back Accepted** – At 022641, Tower Controller issued landing clearance stating **“Clear to land Runway 10R”**, yet **accepted the pilot’s truncated read-back “Runway 10”** without querying **“Left or Right”**, hence failing to challenge an ambiguous read-back directly; enabling the aircraft to continue aligning with RW 10L.

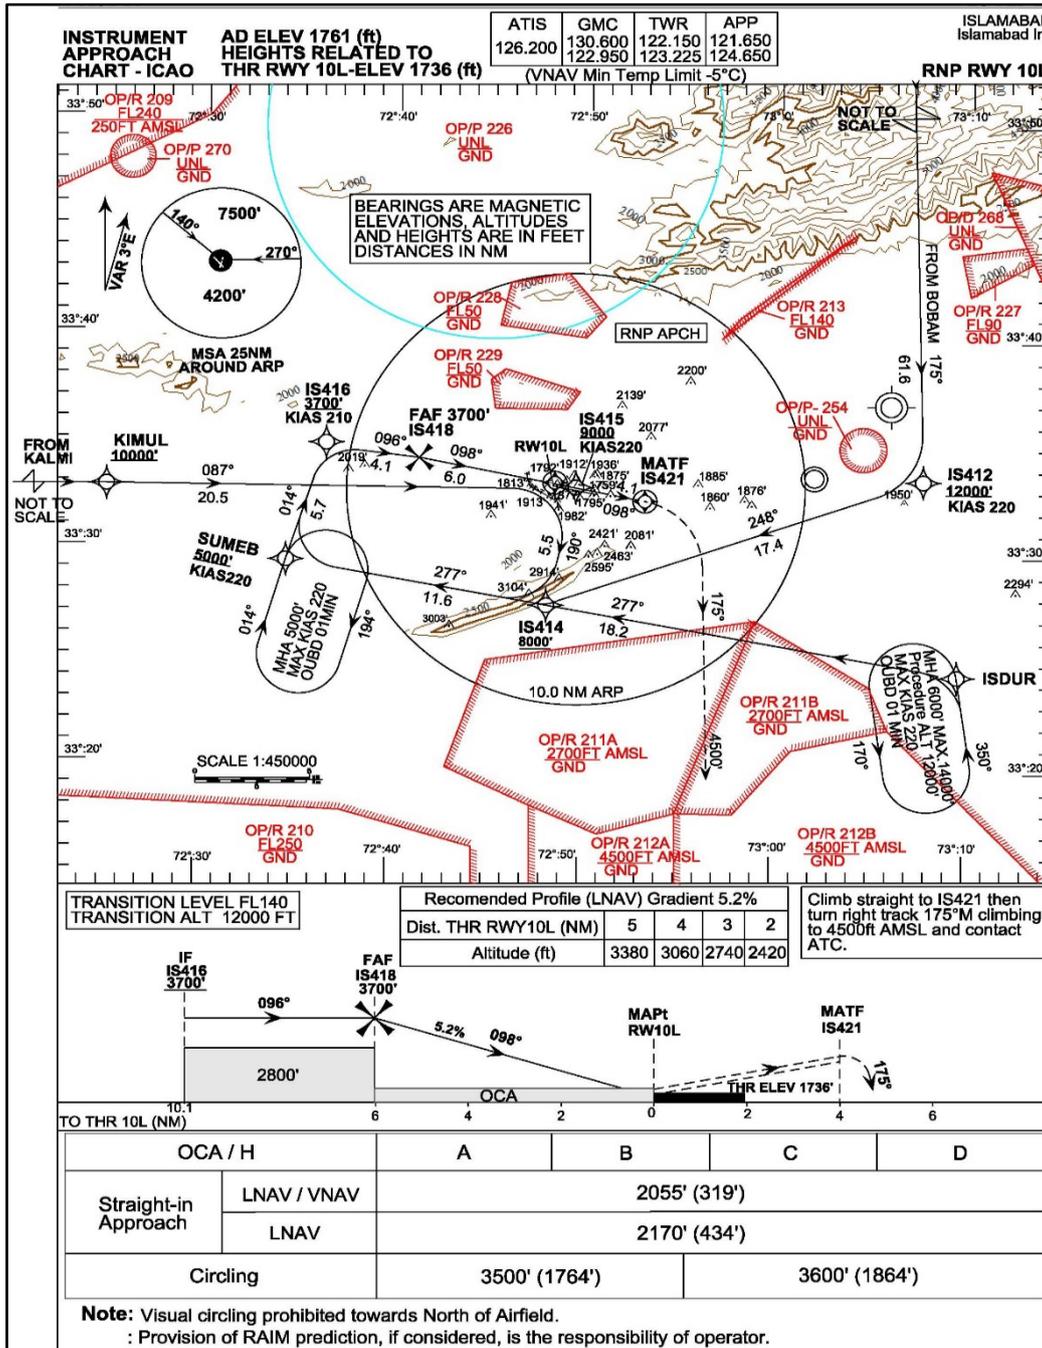
Figure 5 RNP Approach RW 10L OPIS, Islamabad

1.1.17. **040653.** SVA-724 contacted Islamabad Tower stating that the aircraft was cleared for RNP Approach RW 10L instead of ILS Approach RW 10R.

- 3.1.11. **The crew reported receiving clearance for an RNP Approach RW 10L**, which is not supported by ATC recordings.
- 3.1.12. **Captain's post landing statement suggests confusion** regarding clearance type (ILS vs RNP).
