## **FINAL INVESTIGATION REPORT**

**SERIOUS INCIDENT (SMOKE IN COCKPIT)  
PAKISTAN AVIATORS & AVIATION FLIGHT NST1  
GULFSTREAM G-200 AIRCRAFT REG NO. AP-NST  
AT AIIAP, LAHORE ON 31 MAY, 2022**

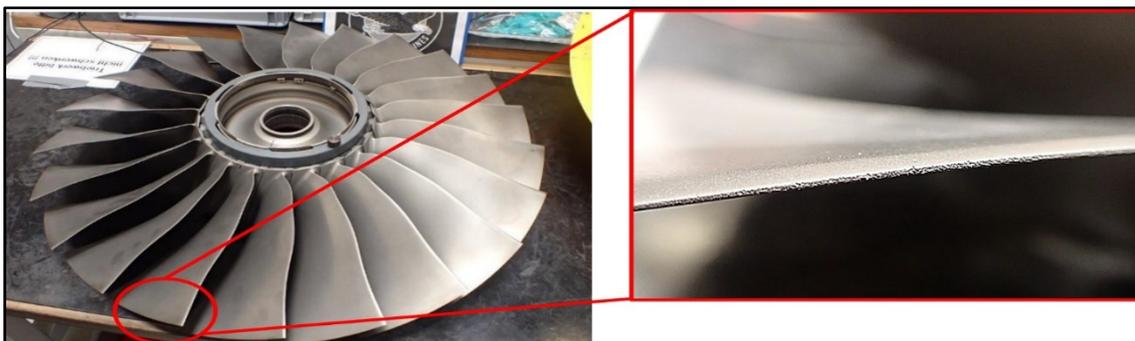
Figure 1 LP Rotor Balancing Assembly (Fan) and Erosion on Fan Edges

1.6.6.1. **Fan of Low Pressure (LP) Rotor Balancing Assembly** - Minor erosion and nicks were found at blade leading edges.

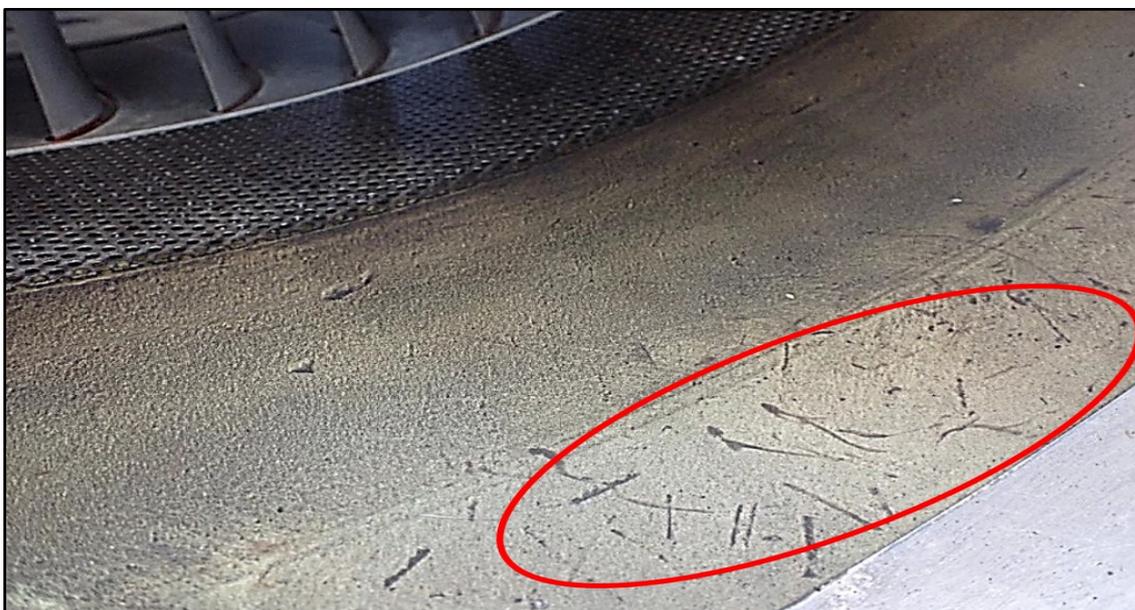
Figure 3 Scratch marks on Fan Case Assembly

1.6.6.2. **Fan Case Assembly**- Deterioration of abradable coating was found.

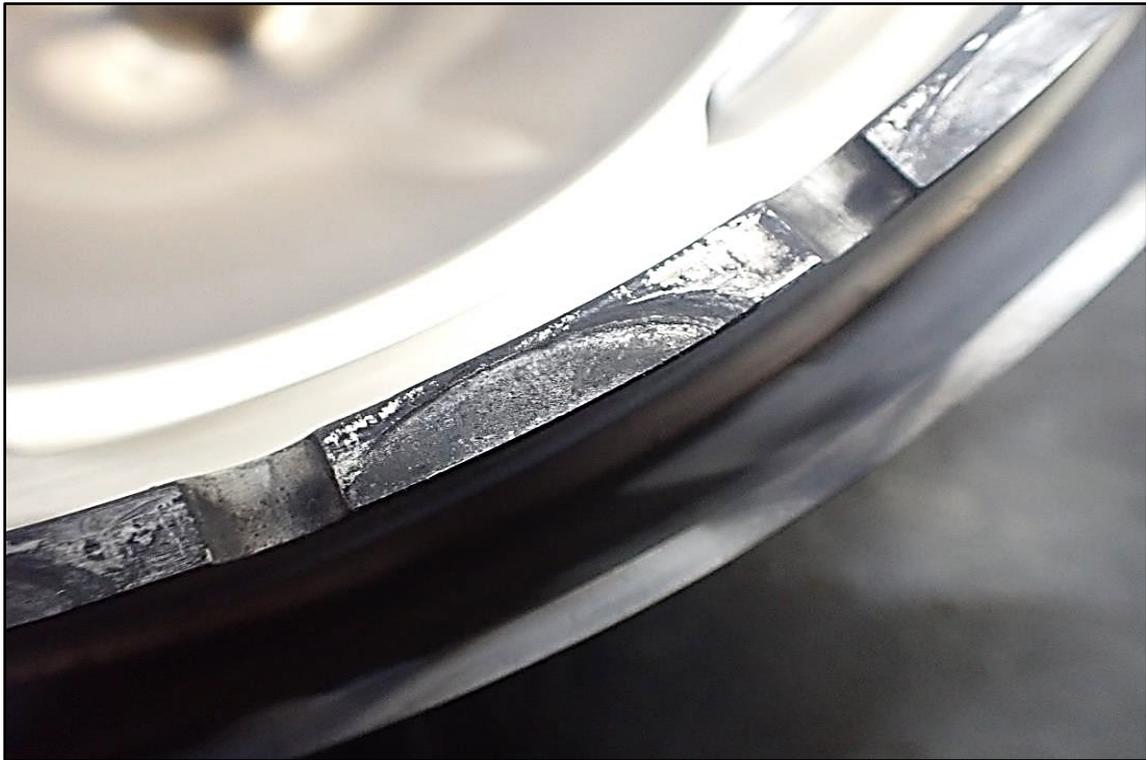
Figure 4 Compressor Inlet Cone

1.6.6.3. **Compressor Inlet Cone** - Fretting wear at fan blade contact faces was found.

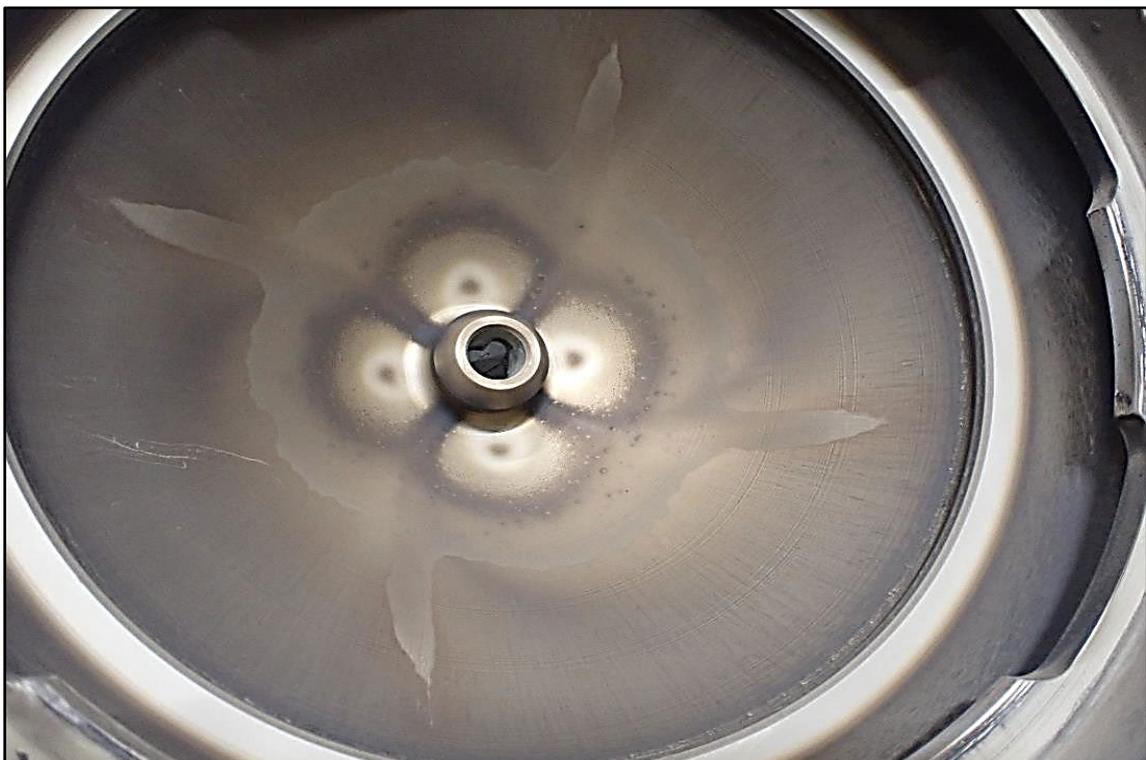
1.6.6.4. **Compressor Inlet Cone** – During investigation traces of oil were found.

Figure 5 Traces of Oil in Compressor Inlet Cone

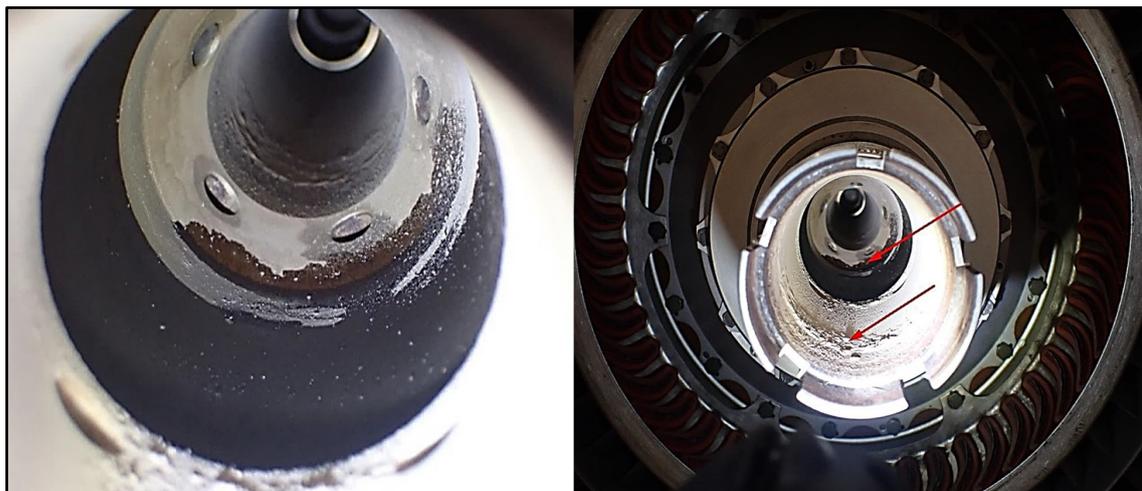
Figure 6 LC Shaft Assembly Rear and Front

1.6.6.5. **Low Compressor (LC) Shaft Assembly** – It was revealed during investigation inner cavity was oil wetted with sandy deposits.

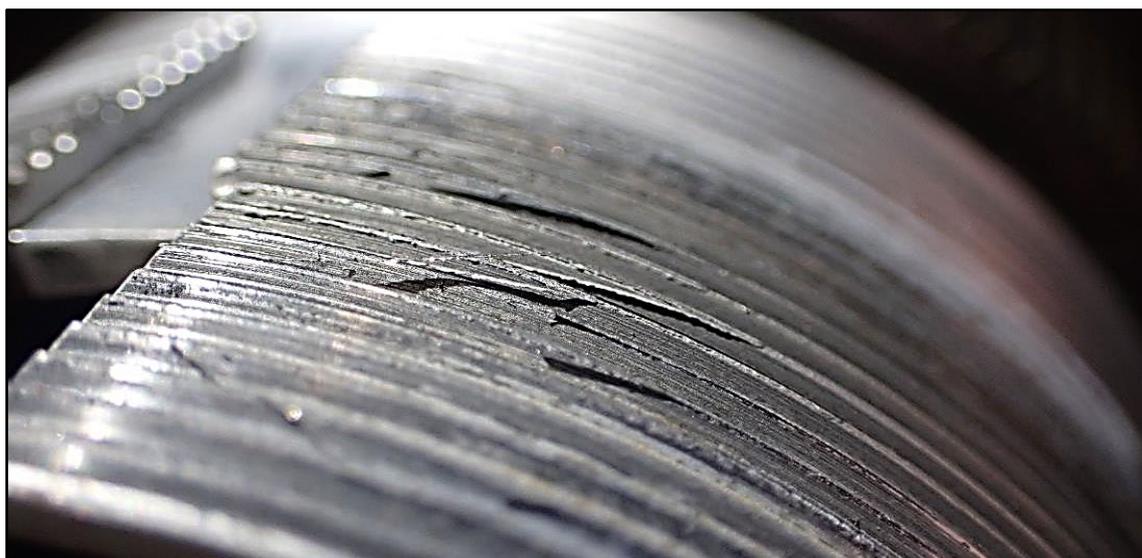
Figure 7 LC Shaft Assembly (close-up)

1.6.6.6. **LC Shaft Assembly** - Damaged threads were found.

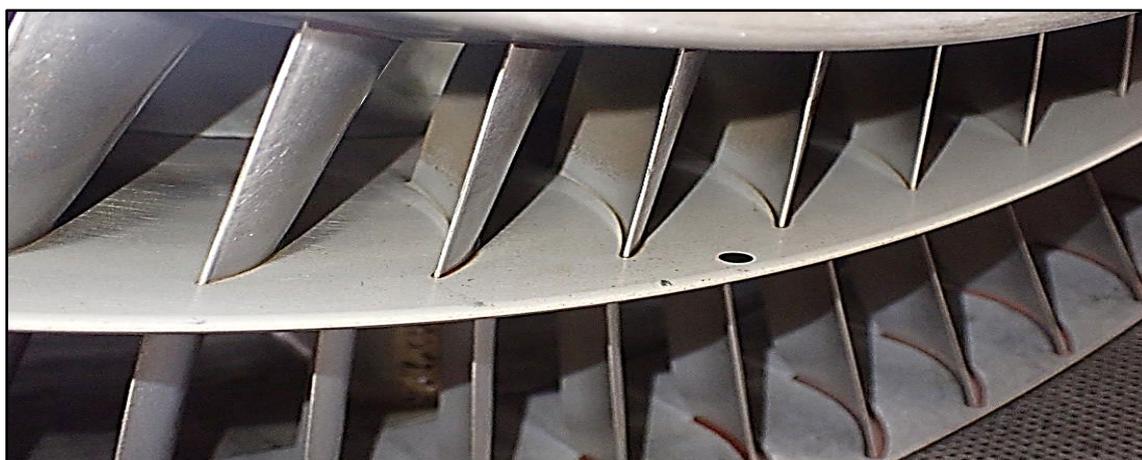
Figure 8 Compressor Inlet Vane Assembly

1.6.6.7. **Compressor Inlet Vane Assembly** - Oil wetted vanes were present.

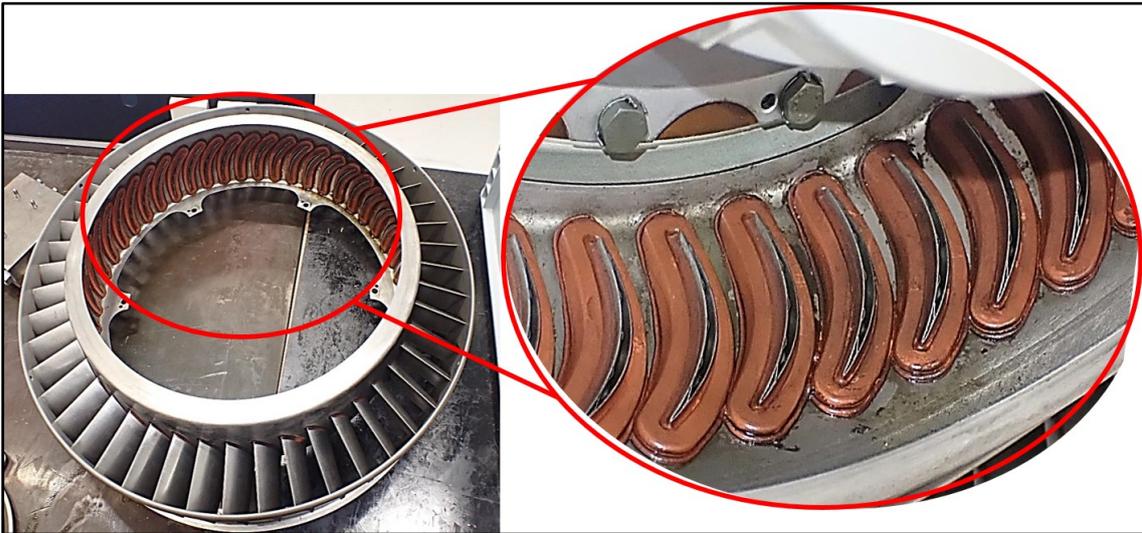
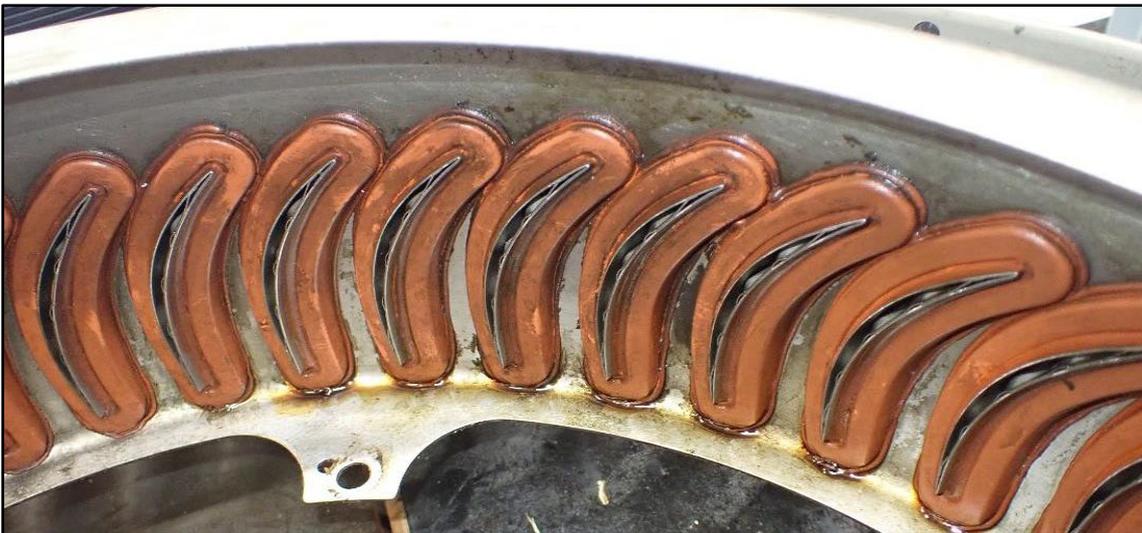
Figure 9 Compressor Inlet Vane Assembly

1.6.6.8. **Compressor Inlet Vane Assembly** - Inner shroud was found oil wetted.

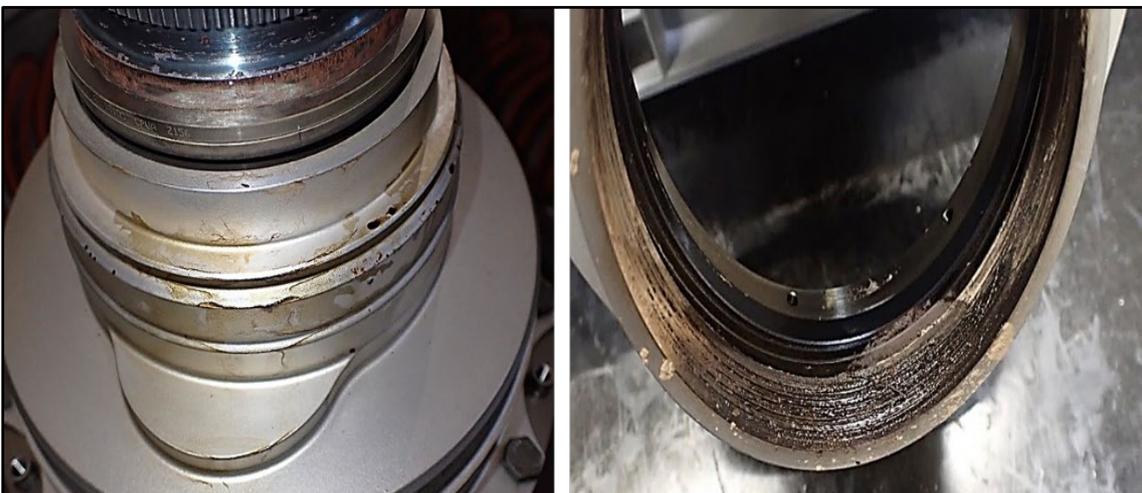
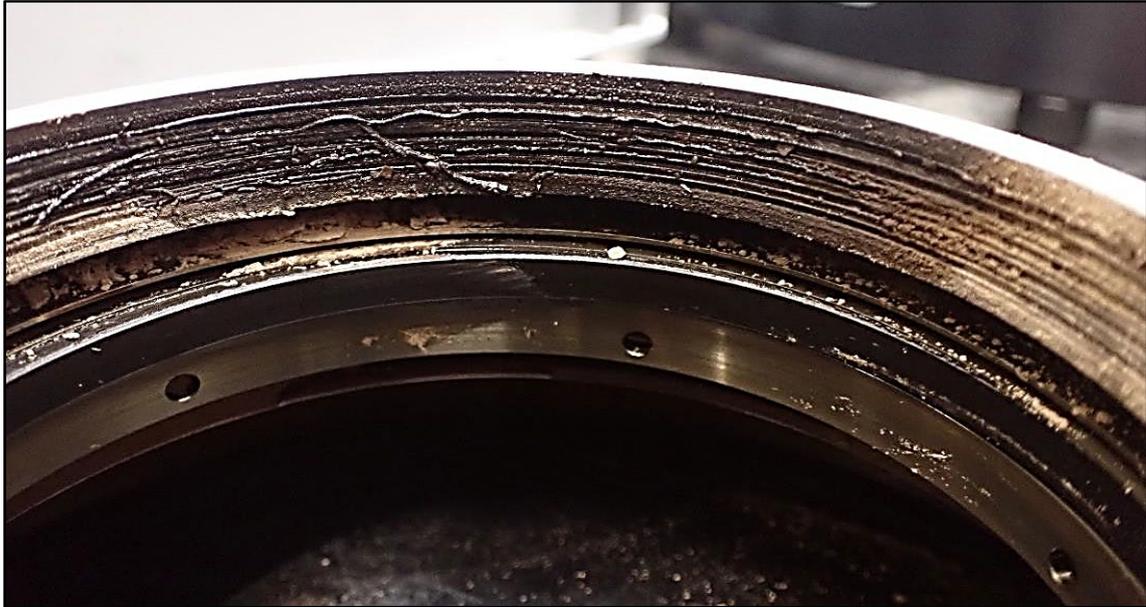
Figure 11 Bearing No.1 Cover

1.6.6.9. **Bearing No.1 Cover** - Signs of oil leakage was found.

3.1.1.5. Disassembly inspection revealed the main source of oil leakage from the No.1 bearing polymer seal. Additional oil staining was noted on various other mainline seals; however, the staining was not located at the sealing surfaces and is not believed to be a contributing factor in the event.

3.1.1.7. The smoke ingress into the cabin was a result of a worn / degraded No.1 bearing air / oil seal, which resulted from an ingress of abrasive particulate.

3.2.1.1. The premature wear of the No.1 bearing cover air / oil seal due to exposure to a severe dusty and polluted environment permitted ingress of oil into the gas path.

4.1.1.1. Review and revise the compressor wash interval policy to account for actual environmental operating conditions, including increased wash frequency or condition-based washing for aircraft operating in dusty or polluted routes.

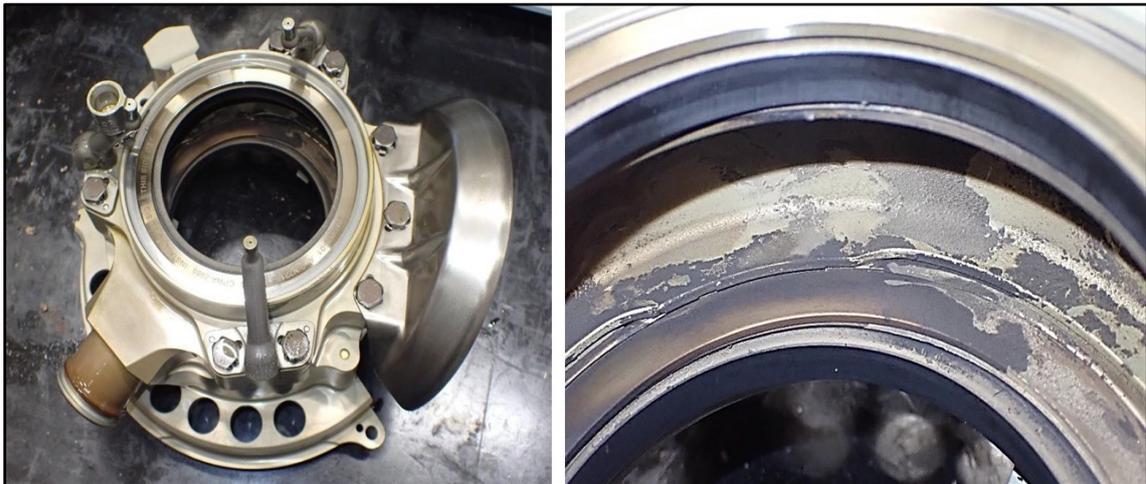
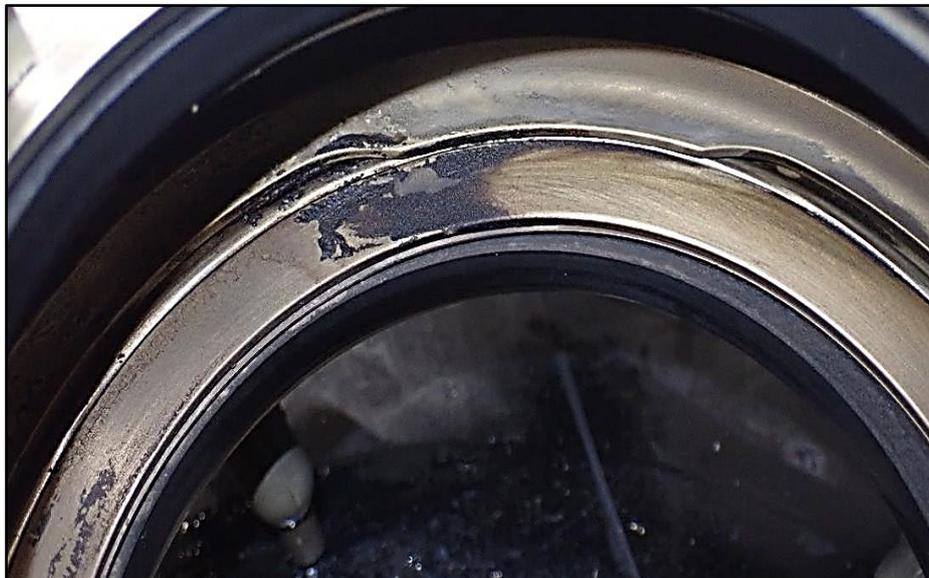
Figure 13 Inter-shaft Seal Housing Assembly

1.6.6.10. **Inter-shaft Seal Housing Assembly** - Sandy deposits, signs of oil staining were found.

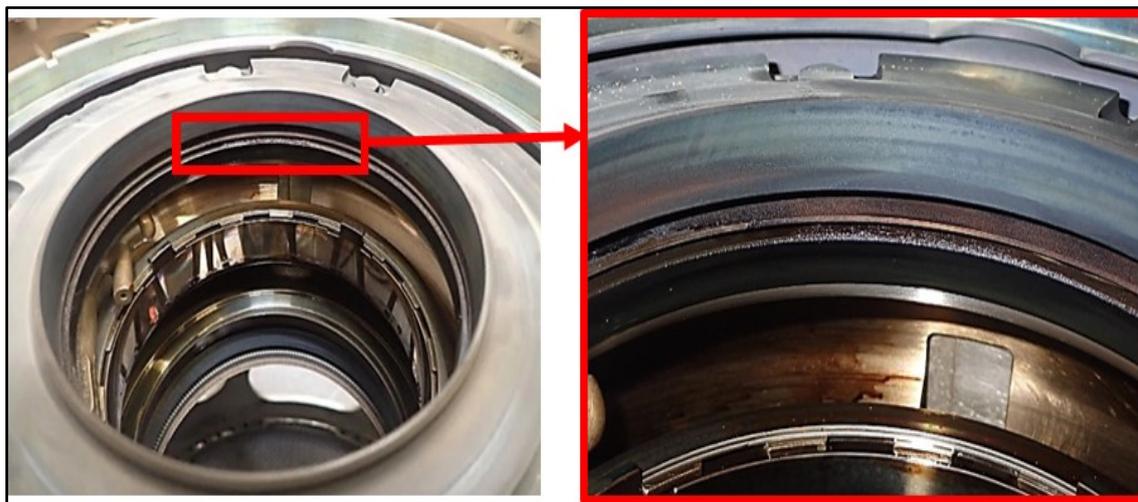
Figure 15 Bearing No.3 Rear Cover Installation

1.6.6.11. **No.3 Bearing Rear Cover Installation** - Oil carbon deposits, signs of oil staining were found.

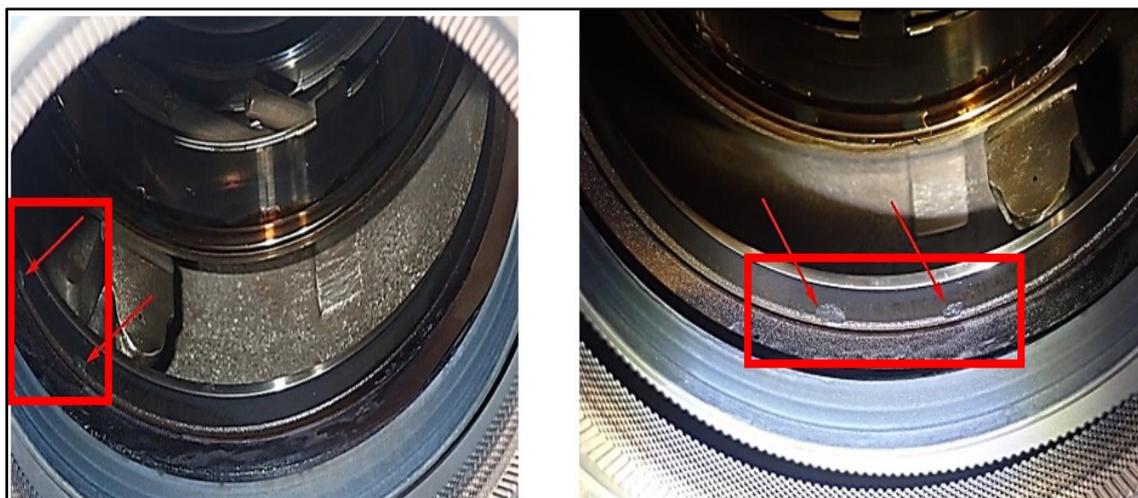
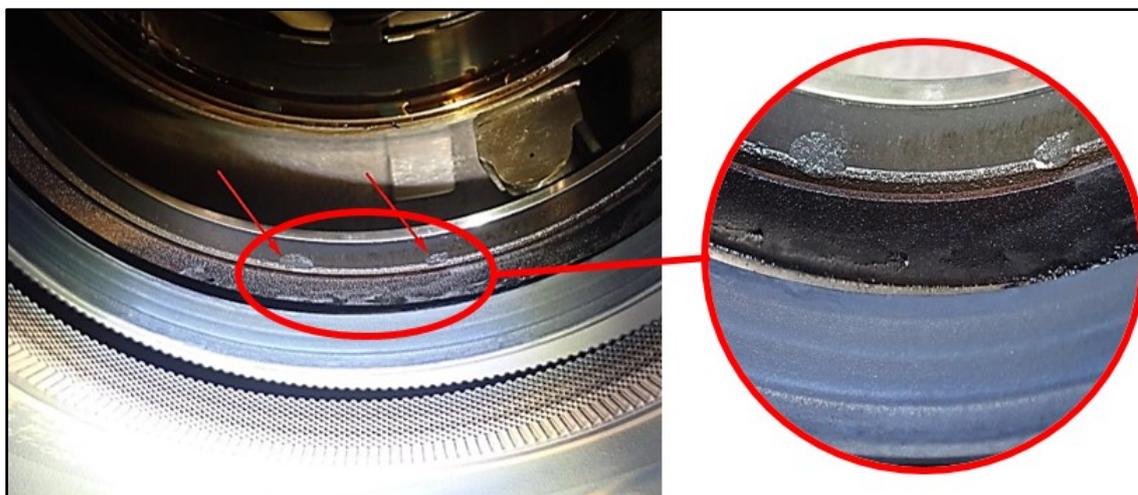
Figure 16 Bearing No.3 Front Cover Installation

1.6.6.12. **Bearing No.3 Front Cover Installation** – Oil staining and chips on the edge of the front carbon seal element were found.

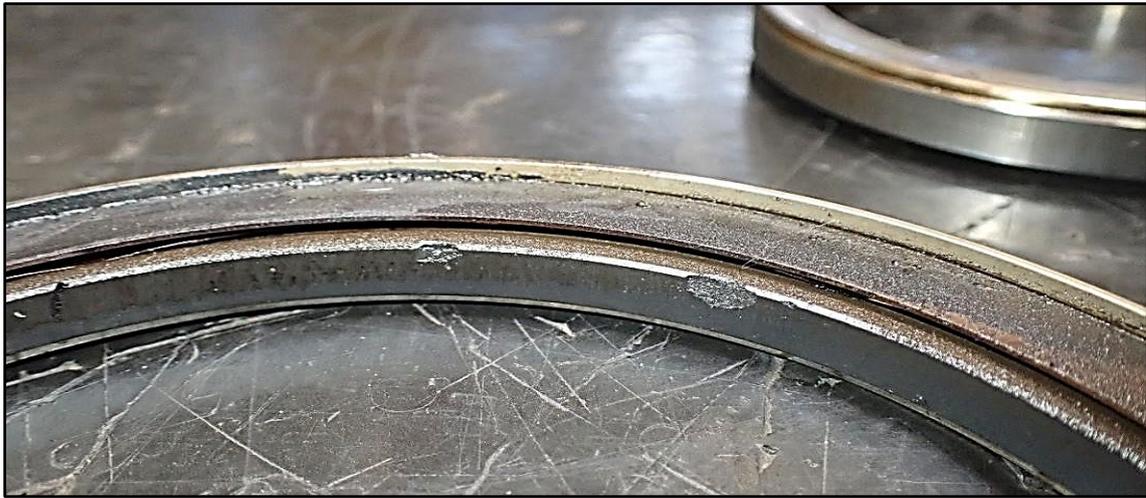
Figure 18 Bearing No.3 Front Carbon Seal

1.6.6.13. **Bearing No.3 Front Carbon Seal** - Staining and chips on the edge of the front carbon seal No.3 bearing carbon seal element were found.

approximately 40 % of the sealing surface, thus the chips of the No. 3 front carbon seal and the staining observed on the known sealing surfaces of the carbon seals is not considered a contributor.

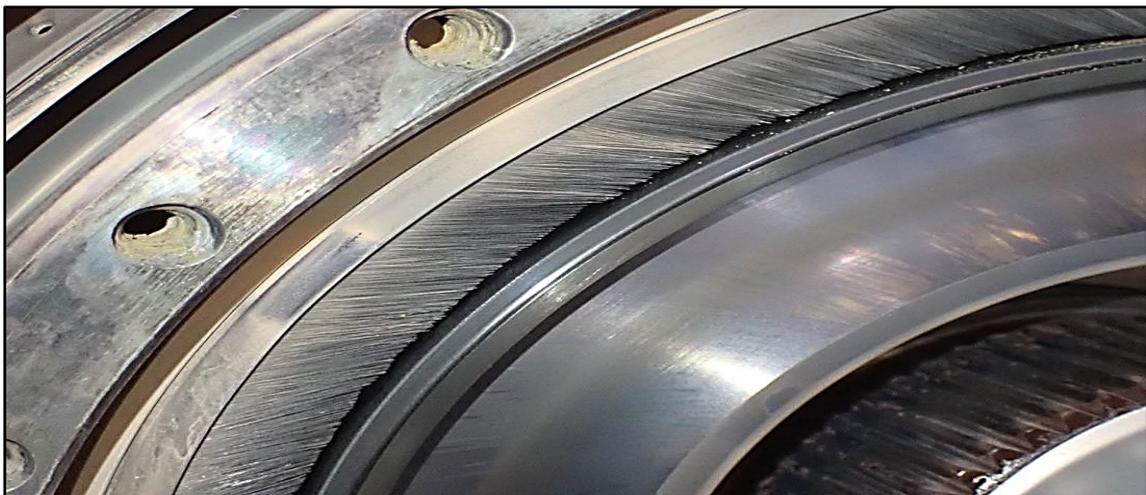
Figure 19 HP Turbine Air Seal (Large Brush Seal)

1.6.6.14. **High Pressure (HP) Turbine Air Seal (Large Brush Seal)** - Worn bristles was found.

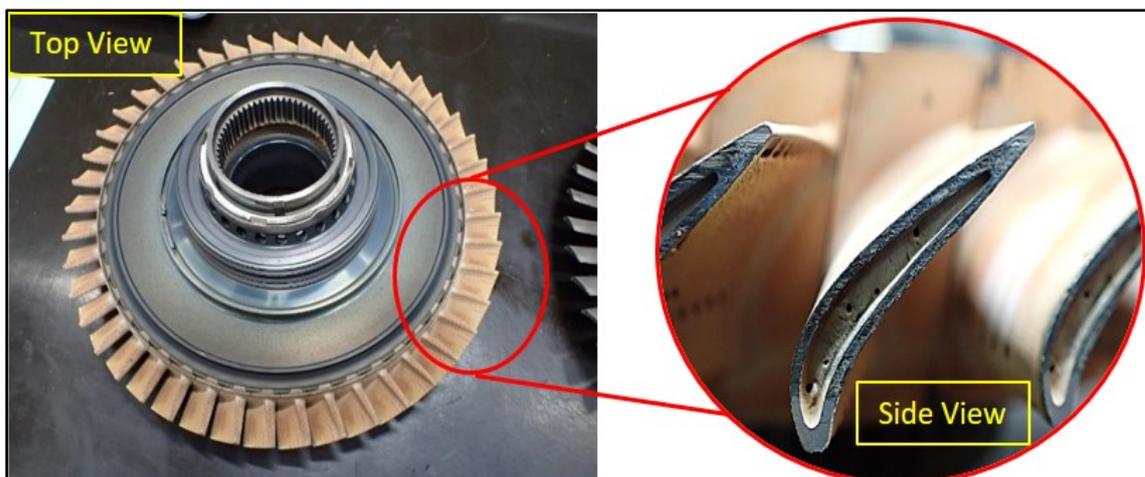
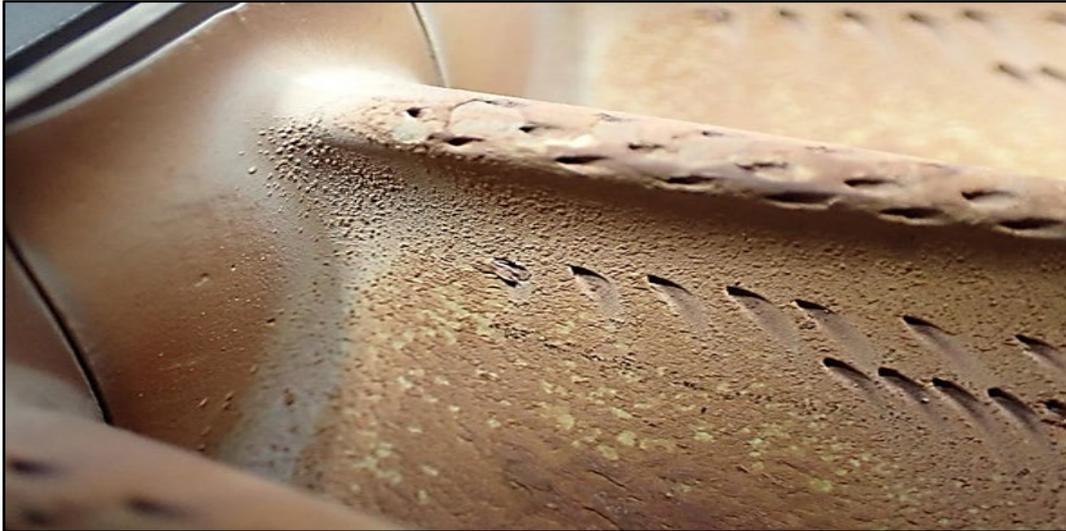
Figure 20 1st Stage HP Turbine Disk Assembly

1.6.6.15. **1<sup>st</sup> Stage HP Turbine Disk Assembly** - Blade tip rubbing, sandy deposits and coating deterioration were found.

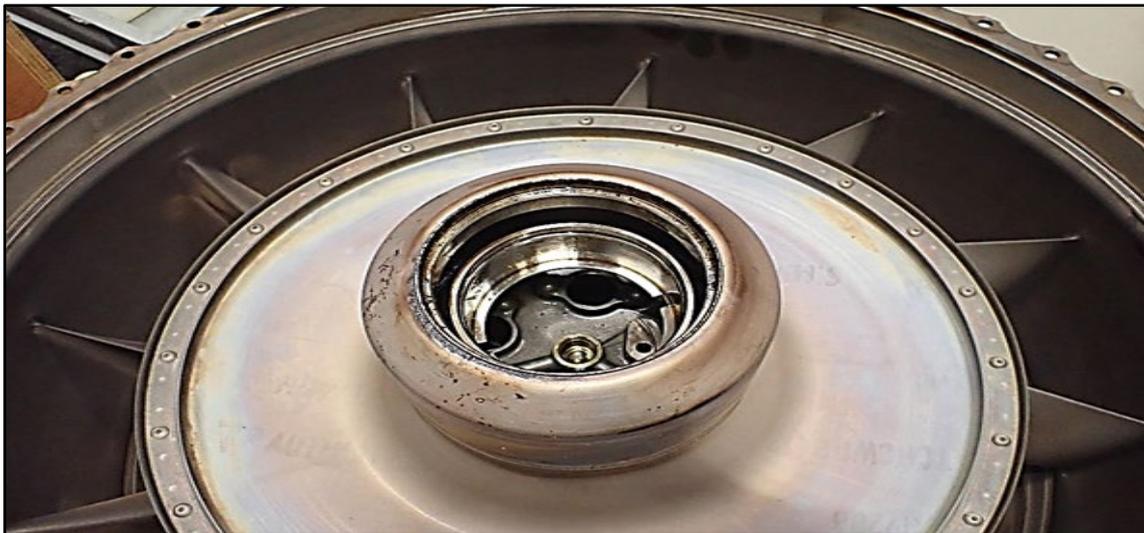
Figure 22 Turbine Exhaust Case Assembly

1.6.6.16. **Turbine Exhaust Case Assembly** - Signs of oil staining was found.

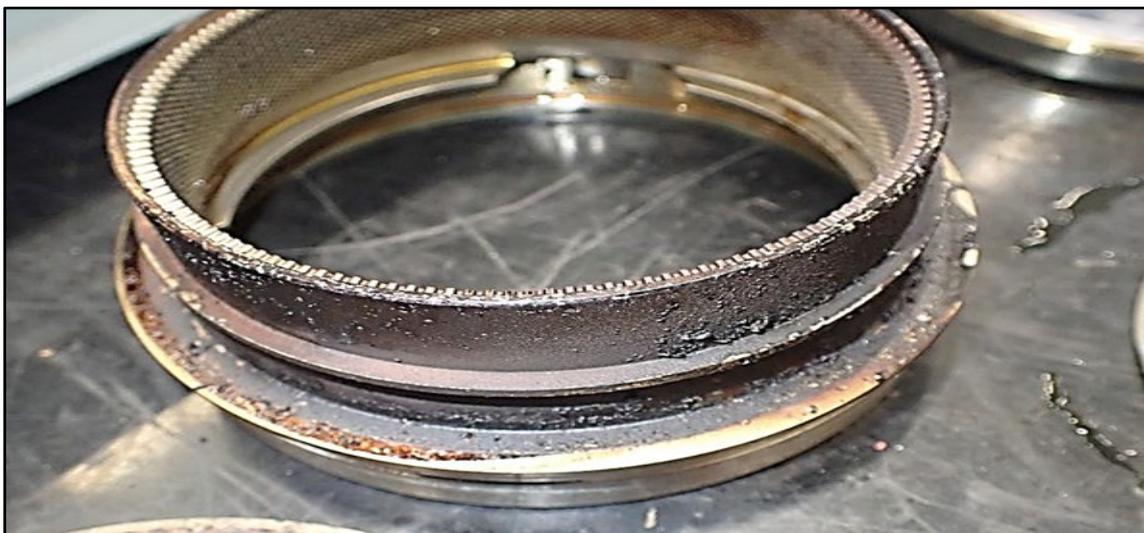
Figure 23 Bearing No.4 Carrier

1.6.6.17. **BearinNo.4 Carrier** - Cooked oil - oil staining was found

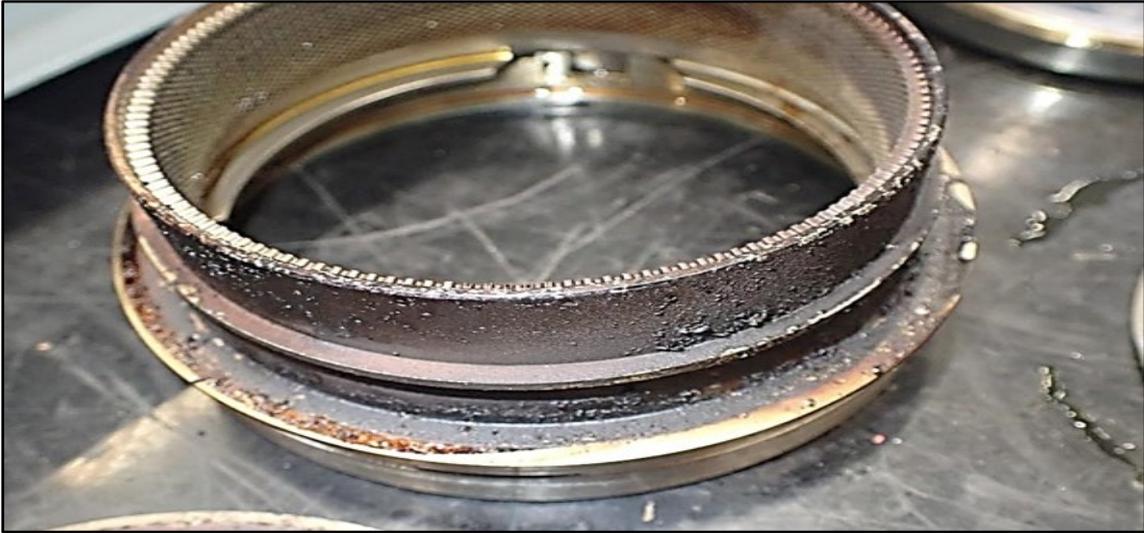
Figure 24 Bearing No.4 Carbon Seal

1.6.6.18. **Bearing No.4 Carbon Seal** - Cooked oil - signs of oil staining was found.

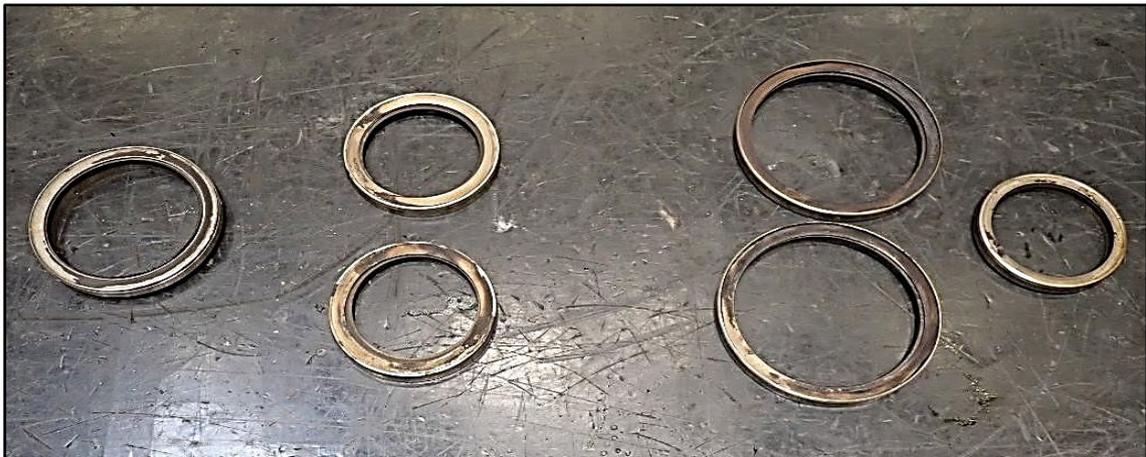
Figure 25 Main Bearing Carbon Seals

1.6.6.19. **Main Bearing Carbon Seals** – varying degrees of oil staining at (from left to right) Bearing No. 1 Carbon Seal and two (2) Inter-shaft carbon seals, two Bearing No. 3 Carbon Seal, Bearing No. 4 Carbon Seal.

1.6.7. Oil staining of varying severity was present on the inter-shaft and the No. 3 and No. 4 carbon seals. In addition, localized chipping was observed on the No. 3 bearing front carbon seal element. Inspection identified significant wear and deterioration of the No. 1 bearing cover polymer seal. This condition provided a plausible leakage path for oil migration into the gas path, leading to the smoke in cockpit scenario. The premature degradation of the No. 1 bearing cover polymer seal is assessed to be consistent with prolonged exposure to abrasive particulates, such as sand and pollution, which may have accelerated seal wear.

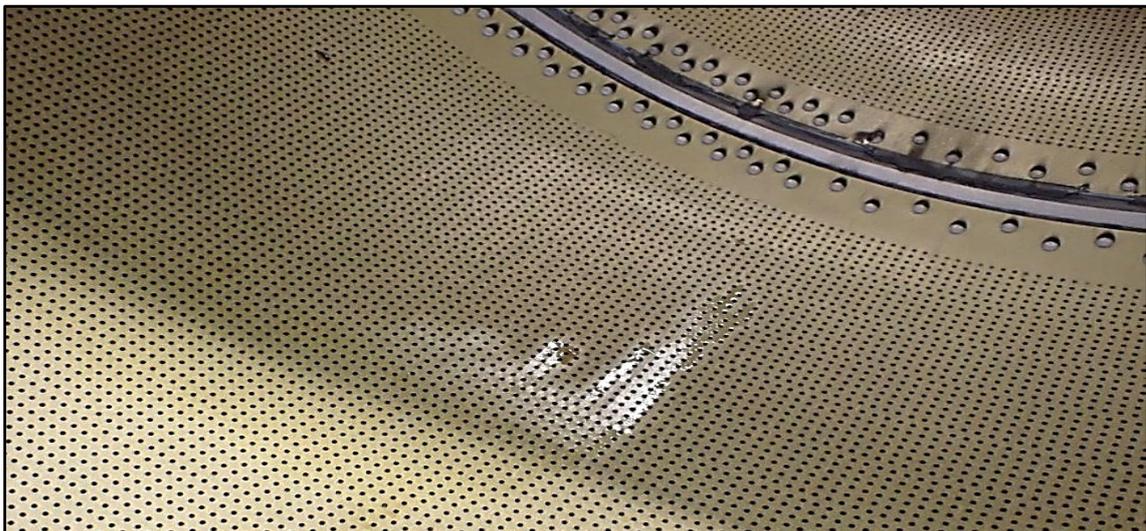
Figure 26 Rear Outer B/P Duct

1.6.6.20. **Rear Outer B/P Duct** - Rear Outer B/P Duct was found oil wetted.
