FINAL INVESTIGATION REPORT

SERIOUS INCIDENT LANDING ON WRONG RUNWAY

**PAKISTAN INTERNATIONAL AIRLINES FLIGHT PK-150
AIRBUS 320-214 AIRCRAFT REG NO. AP-BON AT AIIAP,
LAHORE ON 17-01-2025**

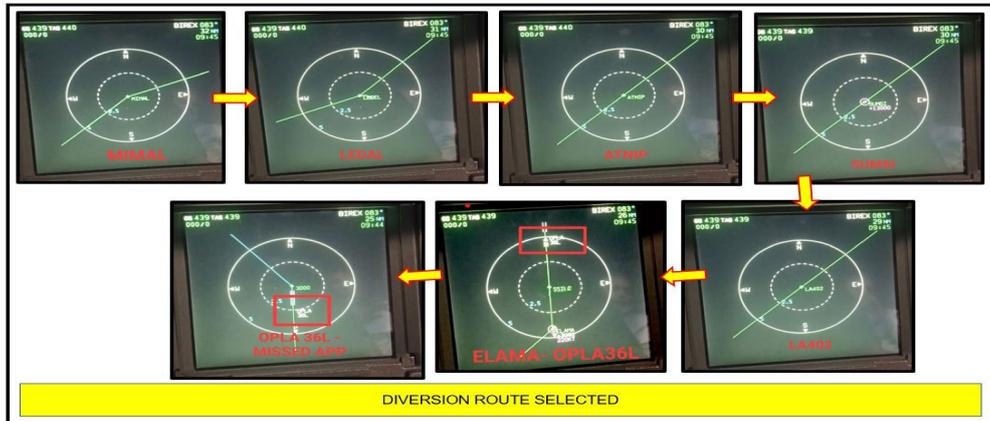
Figure 4 Diversion route selected display on ND

2.2.2. After deciding to divert and LVP enforced at Lahore, data in FMS was fed by PM instead of PF. A clear violation of procedure by PF as it is mandatory to feed in data in FMS by PF and cross check by PM. Moreover, both pilots individually carried out FMS cross checked data but failed to recognize and could not identify the mistake (36L instead of 36R) while cues available on Navigational Display (ND). The pictorial display of diversion flight plan from simulator is depicted below: -

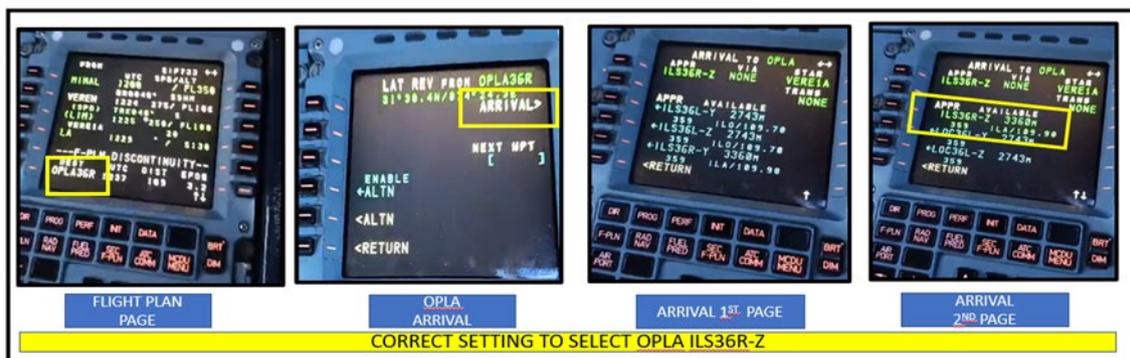
Figure 5 Correct Settings to select OPLA ILS-36R-Z (pg1 of FMS)

2.2.5. **Wrong selection of runway by PM during FMS data feeding** – It is pertinent to highlight that while carrying out HAT checks in A320 aircraft on Flight Plan Page once destination is selected OPLA and on its arrival page the 1st page indicates ILS36L-Y (109.7), ILS36L-Z (109.7) & ILS36R-Y (109.9) and on 2nd page ILS36R-Z (109.9), LOC36L-Y & LOC36L-Z as shown in figure below: -

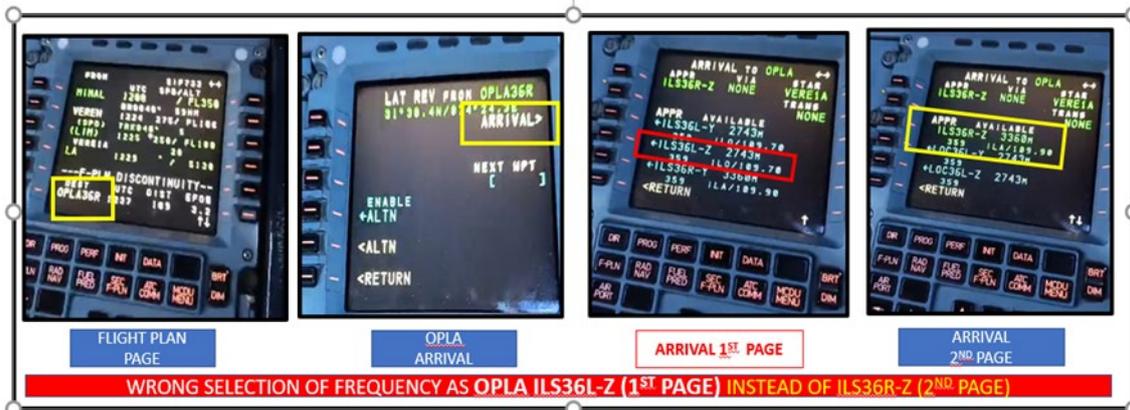
Figure 7 Wrong selection of frequency on FMS

2.2.6. During interview with PM accepted his mistake by wrong selection of ILS frequency. The PM selected ILS36L-Z (109.7) displayed on 1st arrival page (marked in red box) instead of ILS36R-Z (109.9) on 2nd arrival page as shown in figure below: -

3.2.2.2. PM failed to register ILS 36R-Z on the FMS arrival page and incorrectly selected ILS 36L-Z while preparing the diversion flight plan. Moreover, PF exhibited lack of attention while cross checking diversionary route on FMS. Additionally, PM training folder showed persistent performance issues in simulator sessions, poor understanding of the FMA and reliance on rote learning.

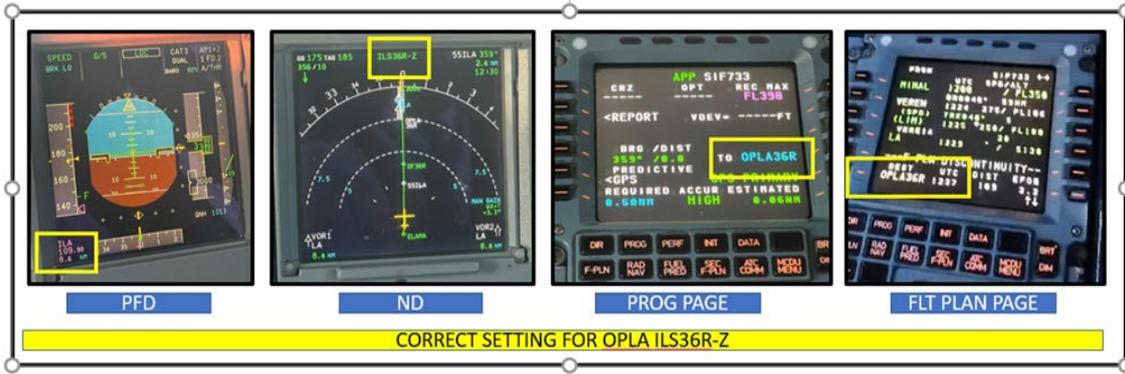
Figure 8 Correct settings for OPLA ILS36R-Z

2.2.7. PF commenced pre-descend briefing while going through FMS where number of times he announced OPLA 36R, ILS 36R Z and at one time announced ILS frequency as 109.7 which was also cross check by PM. Here there is contradiction that PF announcing ILS 36R Z whereas frequency of ILS 36L Z was selected on FMS. During interview with PF & PM, both aircrews accepted their mistake as both PF & PM failed to cross check ILS frequency during descend, approach and landing checks and could not identify from various cues available on FMS, Primary Flight Display (PFD) & ND. Failure to conduct proper checks as both pilots clearly suffered a severe loss of situational awareness. Despite correctly communicating the intended runway with ATC & among themselves, they failed to maintain awareness of their cockpit setting and the correct runway environment. Moreover, PF have been influenced (Anchoring Bias) announcing ILS frequency wrong 109.7 as he has conducted a greater number of landings on RW 25L (JIAP, Karachi) having same frequency.

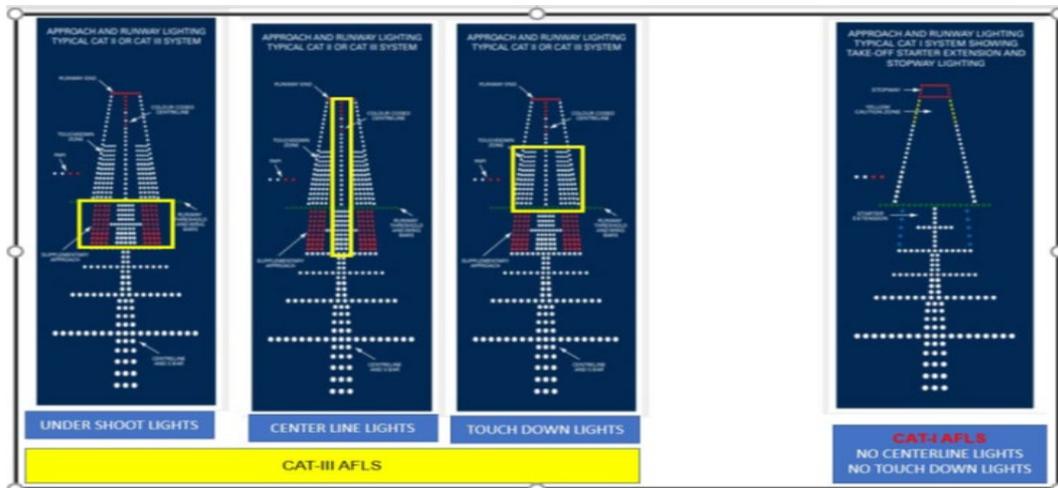
Figure 10 CAT-III AFLS OPLA

2.2.9. As there is huge difference in Airfield Lighting System (AFLS) between CAT-I & CAT-III. The CAT-III AFLS includes undershoot, Center line & Touch down zone well illuminated with high intensity lights. Both pilots failed to recognize the AFLS in RVR 700 m.

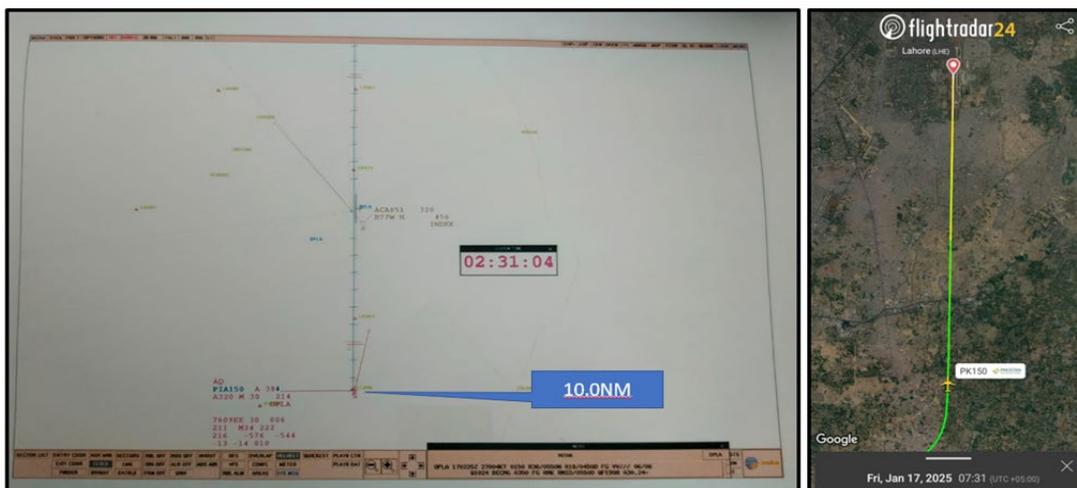
Figure 12 PK-150 established on Glide Slope at 10NM

2.2.10. **ATC Analysis** – Early changed over by Approach controller assuming PK-150 fully established on Glide Slope at 10 NM as announced by PM, however, the aircraft was still turning and remained towards left of track. The changeover to Tower could have been delayed till stabilization of approach, however, as in routine, he shifted his responsibility to tower controller and continued to monitor.

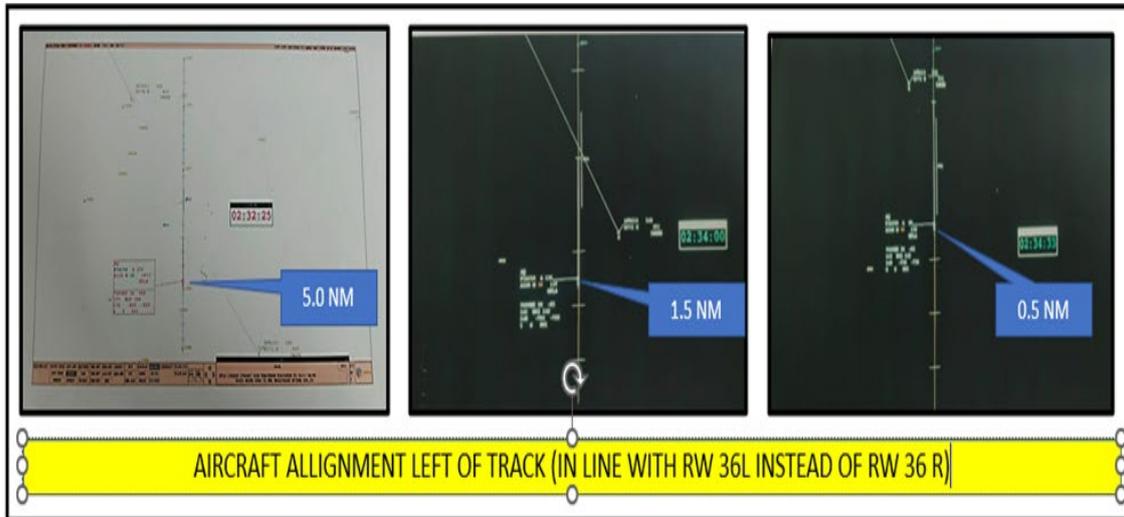
Figure 13 PK-150 observed Left of Track

2.2.11. Tower controller gave landing clearance to PK-150 for RW 36R at 5.6 NM which was acknowledged by PM. However, tower controller being not visual with the aircraft due poor visibility failed to monitor aircraft on Radar Screen displayed in tower until prompted by Approach controller on landline that aircraft is left of track. At this moment, the aircraft was at approx. 1.7 NM from touchdown point. Same was communicated (observed left of track) to PK-150 by tower controller. Seeing the aircraft left of track by tower controller rather than giving Go-round, the tower controller switched ON RW 36L approach light to facilitate landing. During Radio readout of approach and tower controller, it was revealed that both the Approach & tower controller were hesitant (feared) to give “Go-round” to aircraft and they were conversing in fear whether to give Go-round or not, hence, to facilitate, the tower controller switched ON the approach lights, this could have led to disastrous situation

during landing roll. Seeing aircraft clearly aligned with RW 36L either of Approach or tower controller) should have given call for “Go-round”. Moreover, during such situation if Tower controller had included RW 36L in his call (“observed left of track in line with RW 36 left”) that might have alerted the flight crew to initiate “Go Around”.

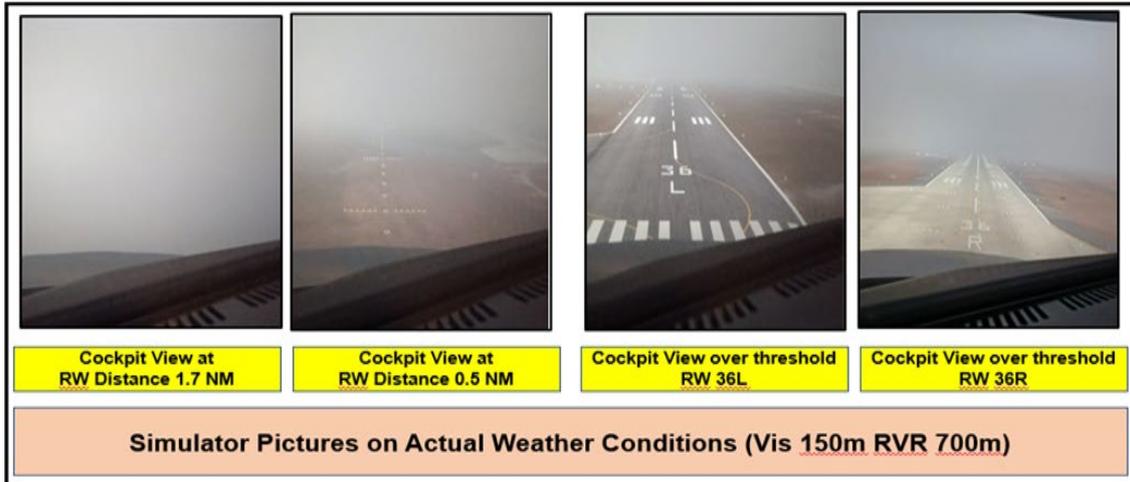
Figure 15 Simulator pics on Actual weather Conditions (Visibility 150m RVR 700m)

2.2.13. **Landing Analysis** – From establishing on Glide slope at 8.6 DME, till landing, both PF & PM were more focus for alignment and flight path on PFD (Glide slope). Despite ATC call “Observe left of track” did not prompted flight crew to verify with other cues available on PFD, ND and FMS, however, just kept reliance on ILS cross bar and diamonds on PFD and continued approach for landing on RW 36L.

2.2.14. Moreover, PM announced field insight at distance of 0.5 NM (3,000 ft) from threshold, whereas, PF did not announce anything. It's a clear violation by PM as it is mandatory to be heads down during CAT-III landing and keep rechecking all parameters.
