## **PRELIMINARY INVESTIGATION REPORT**

**ACCIDENT OF CESSNA 172 REG. NO AP-BLO OPERATED BY  
ASKARI FLYING ACADEMY CRASHED NEAR IIAP  
ISLAMABAD, PAKISTAN ON 16-08-2025**

### ACCIDENT OF CESSNA 172, REG. NO. AP-BLO, OPERATED BY ASKARI FLYING ACADEMY NEAR IIAP, ISLAMABAD ON 16-08-2025

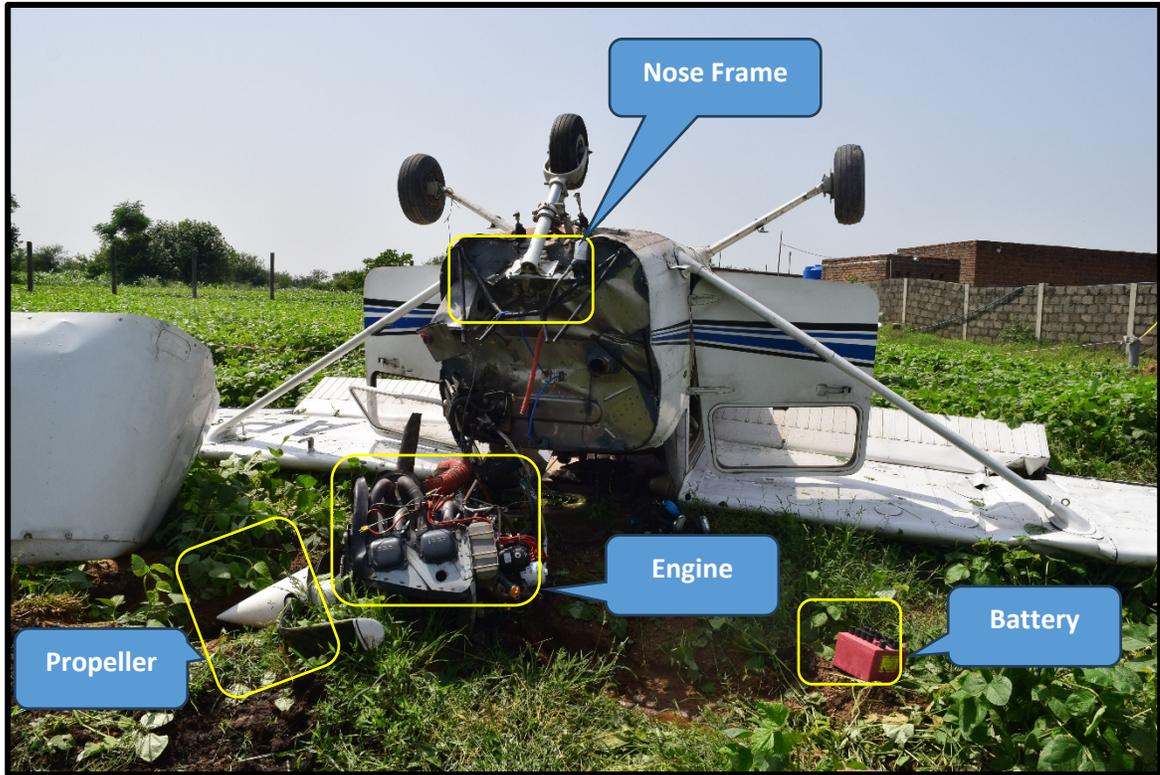
47. The examination of the accident site revealed **extensive structural damage** to the aircraft. The **nose frame was completely destroyed**, with the **engine separated from its mounts** and the **nose wheel mount ruptured and tilted**. The **propeller was damaged** and part of the **left aileron was detached from the wing**. **Buckling was noted on the wings and tail section**, including a **ruptured vertical stabilizer**. The **front windshield was shattered**, and **evidence of heavy ground impact**, including **scraping of both wingtips**, was observed. Moreover, **PAC Kamra structure team has also declared the aircraft structure unfit for flying**.

**Figure 3 - Engine and Propeller Detached From Nose Frame**

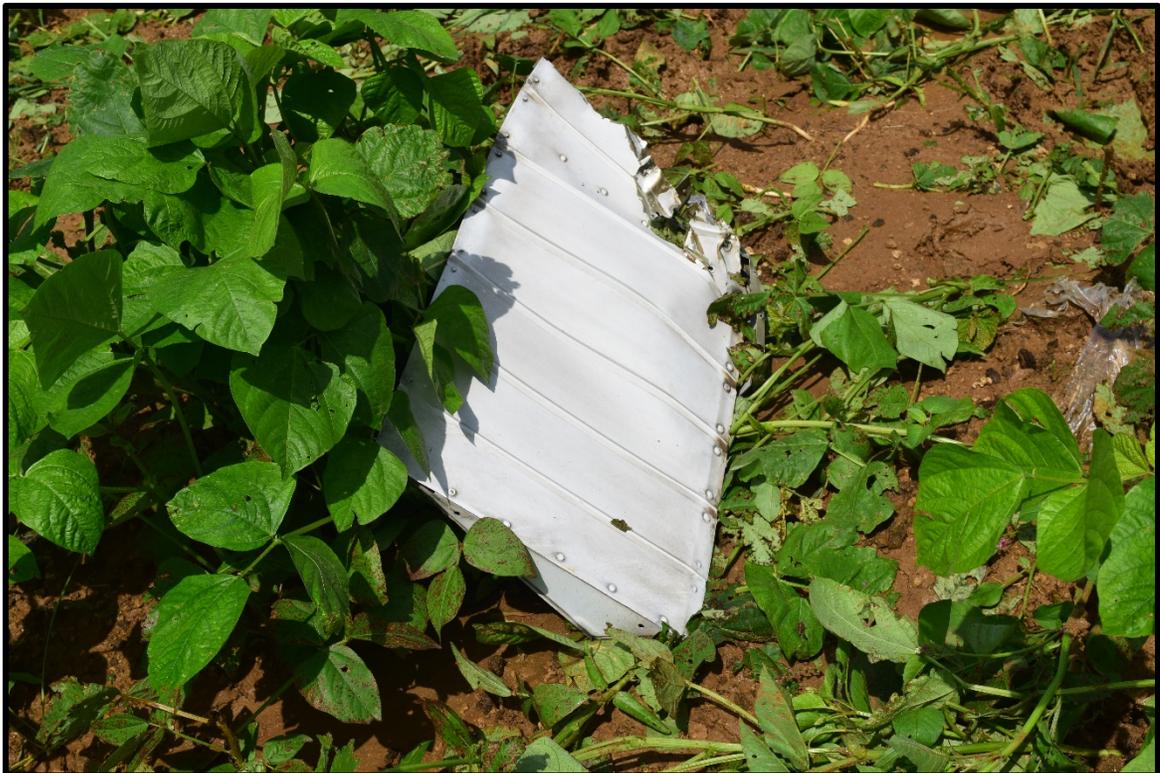
**Figure 4 - Portion of Left Aileron Broken**

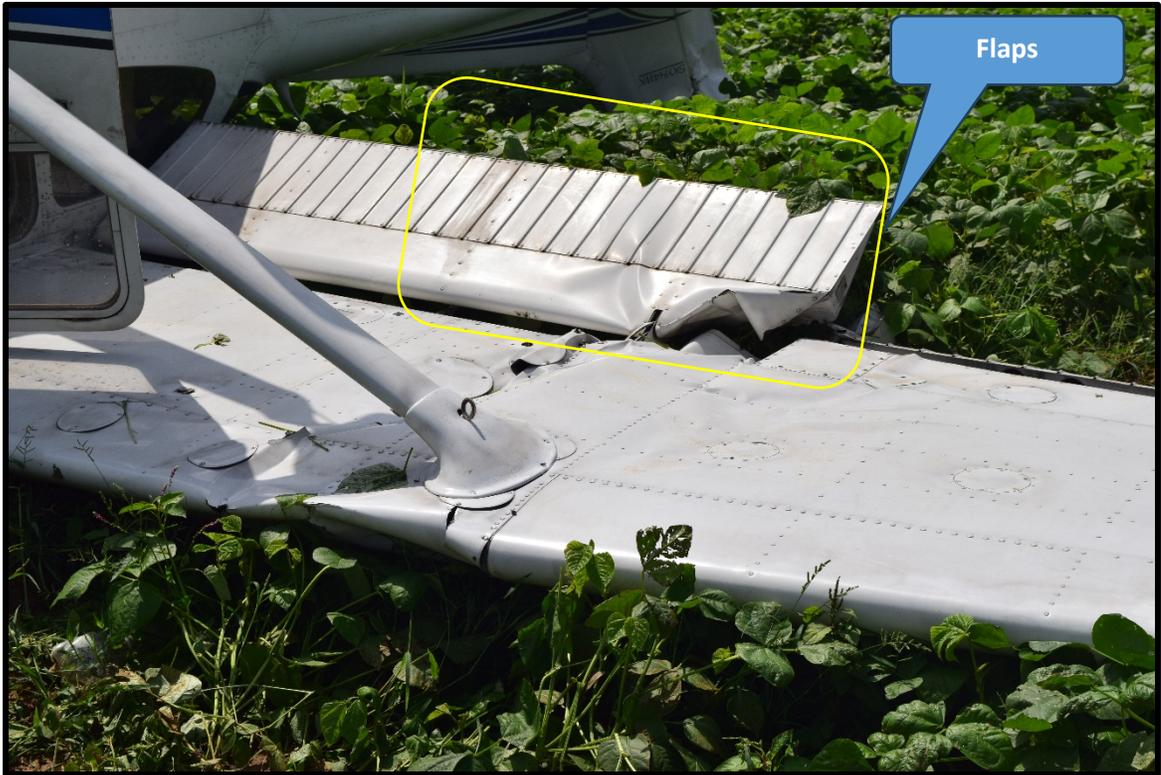
**Figure 5 - Buckling on Right Wing Flaps**

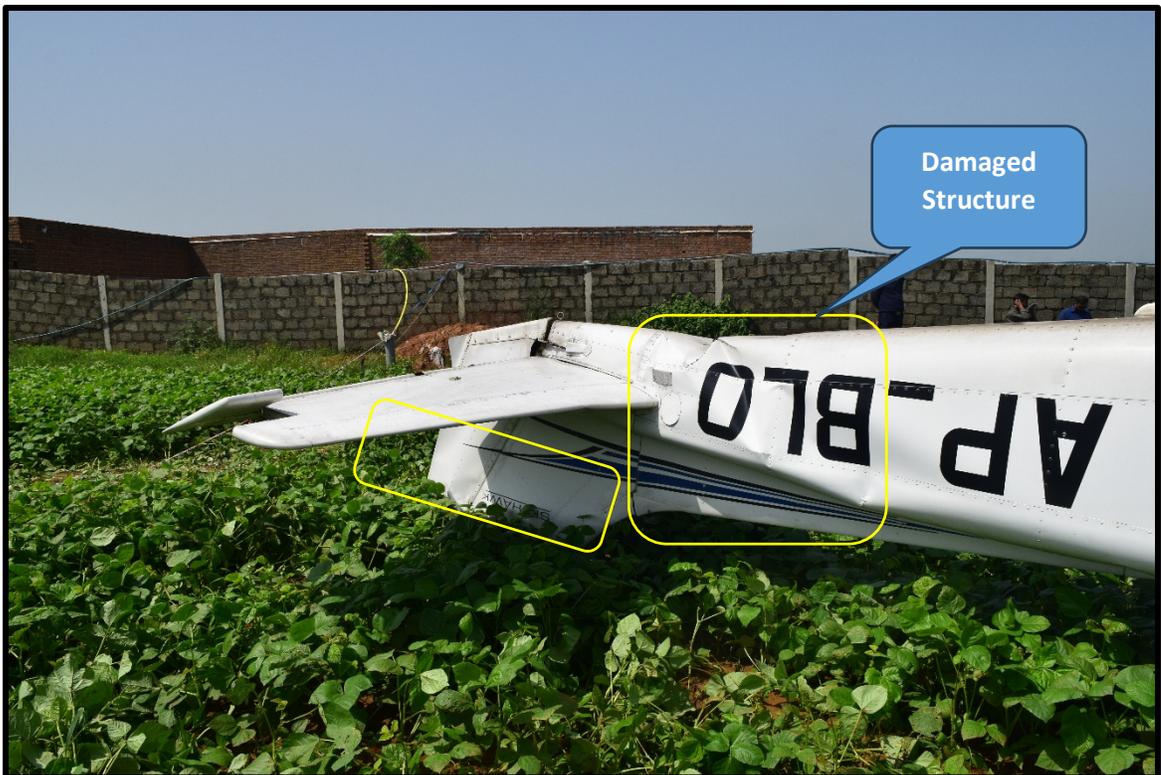
**Figure 6 - Buckling observed on Fuselage and Tail Section**

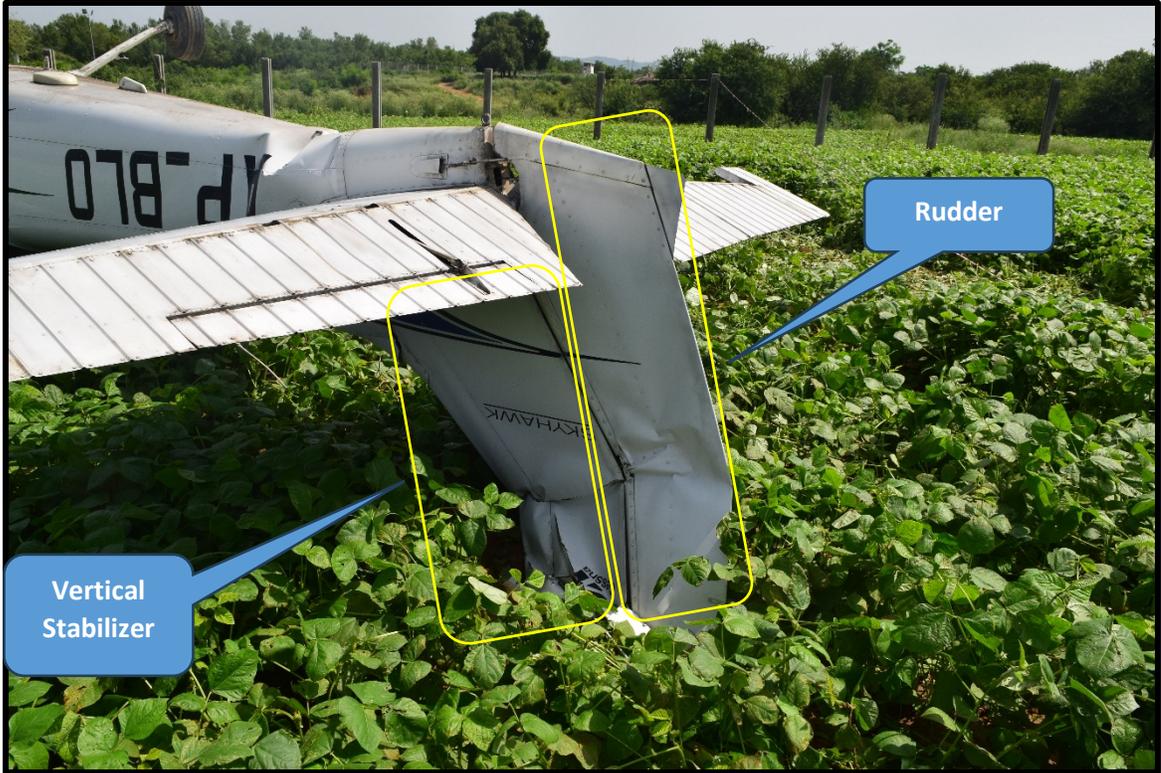
**Figure 7 - Damaged Vertical Stabilizer & Rudder**

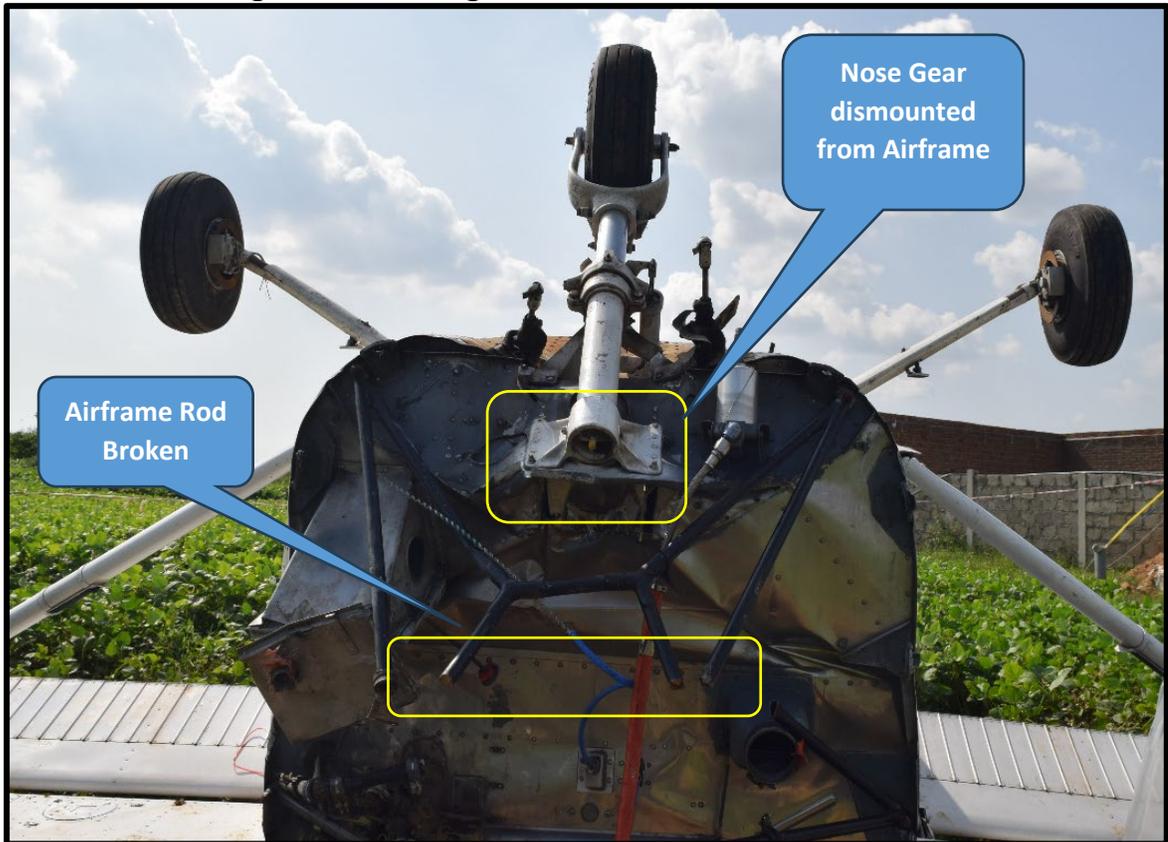
**Figure 8 - Nose Wheel Mount Detached from Nose Frame**

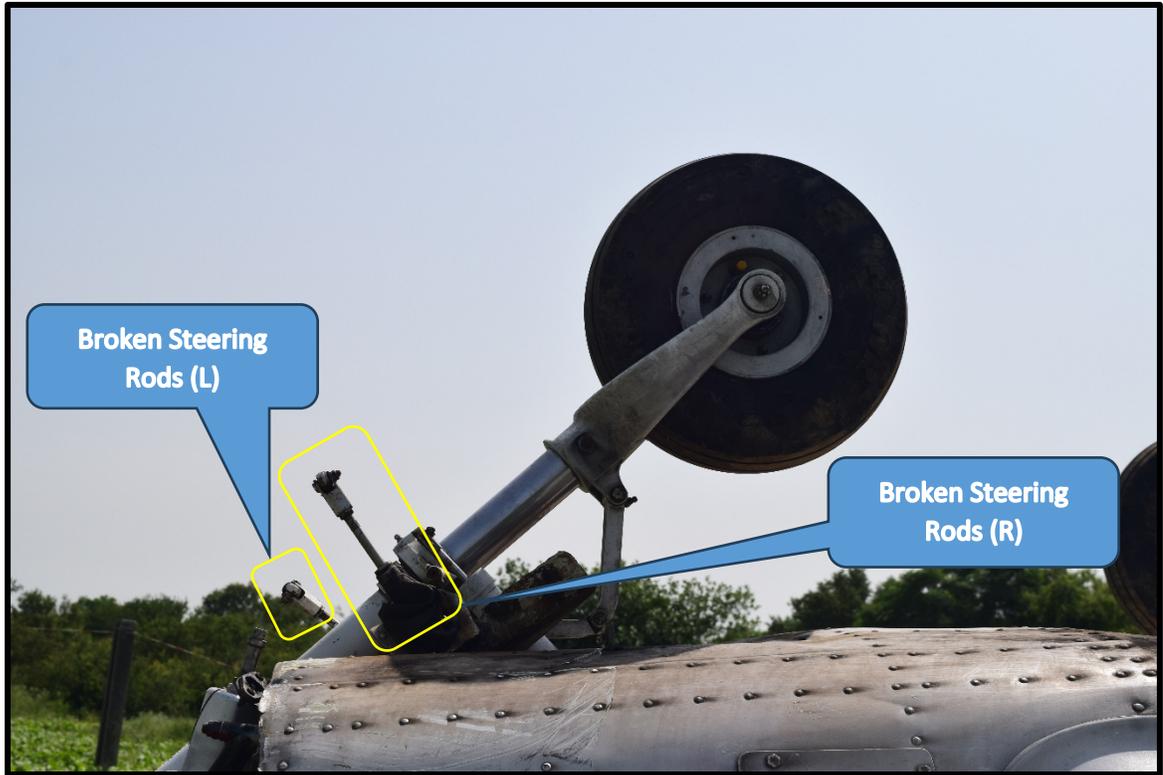
**Figure 9 - Damaged Nose Wheel Steering Rods (Left/Right)**

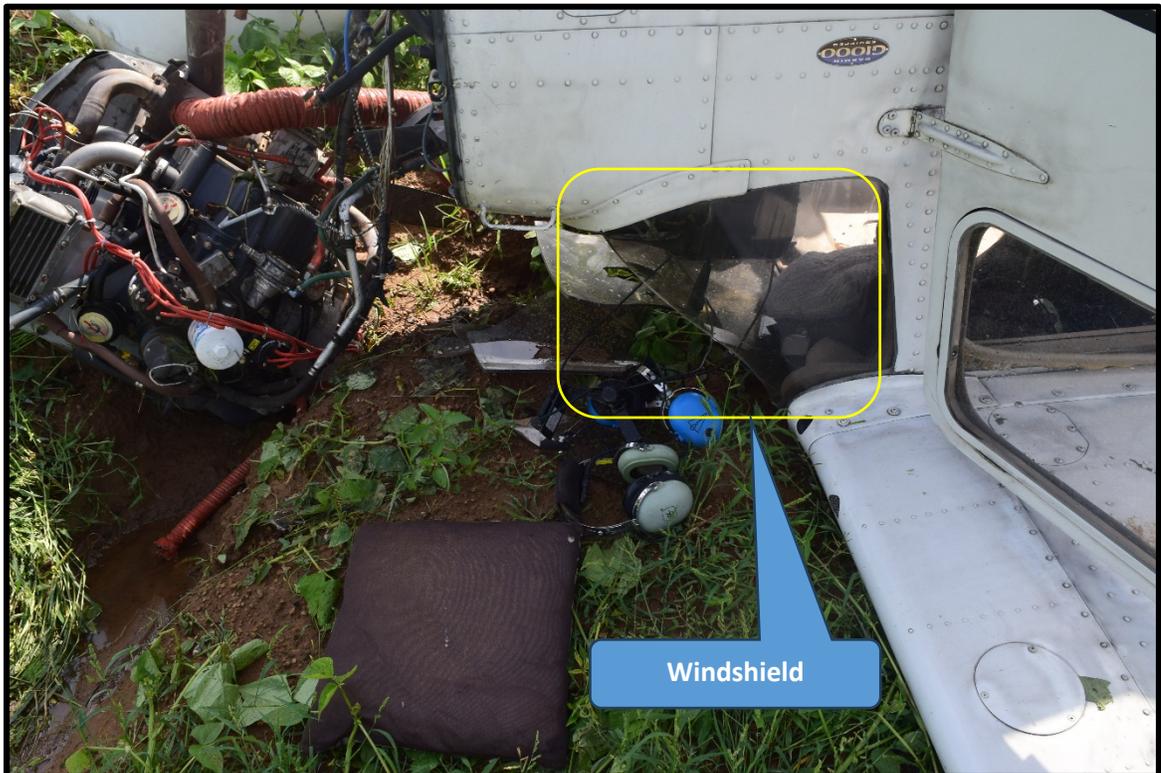
**Figure 10 - Broken Windshield**

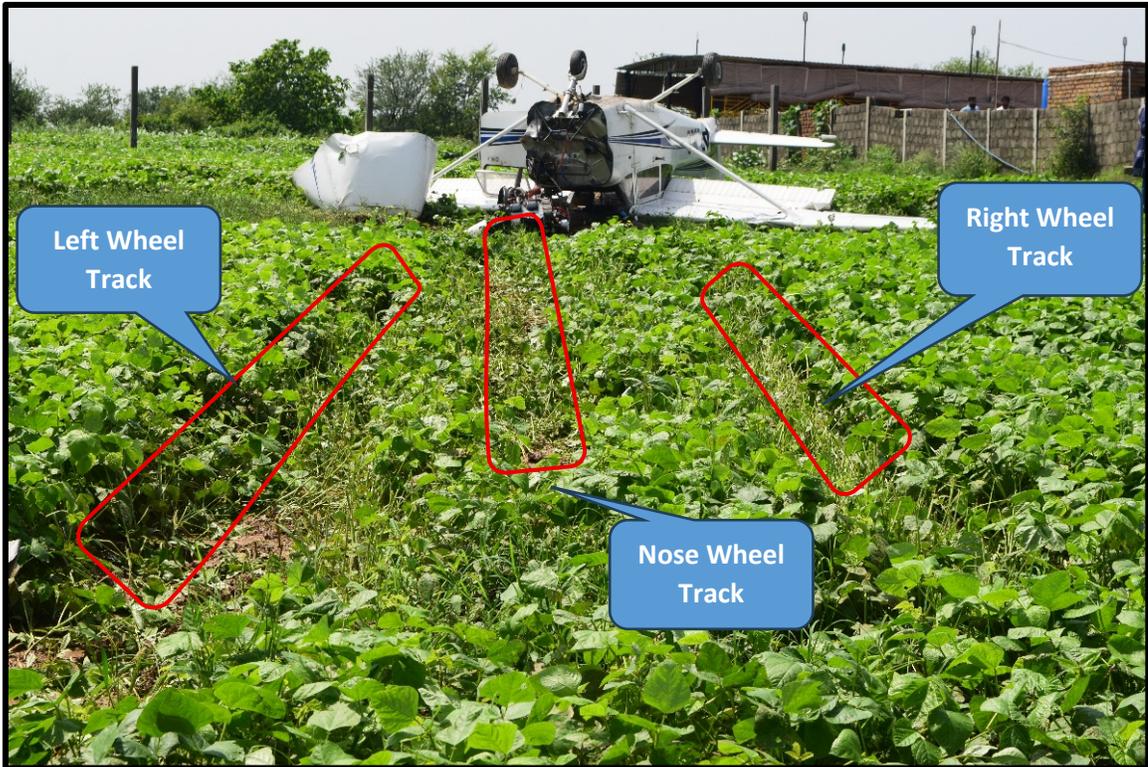
**Figure 11 - Ground track short of aircraft topple**

124. Once sure of landing, full flaps were taken and concentrated on force landing. The agriculture field was wet and soft due to recent rainy spells. The aircraft touch down in **left bank with left main wheel at 44 knots (ground speed)** followed by the **right main wheel approximately 12.9 feet later**. During landing roll, aircraft bounced alternately on the left and right main wheels as per wheel tracks marks and fragments of wing tips were found along the track. After travel of **70 ft** on landing roll within **1.88 second**, the aircraft toppled due raised ground and nose wheel tilted rearward and arrested within **04 feet (total 74 ft from first touchdown)**.

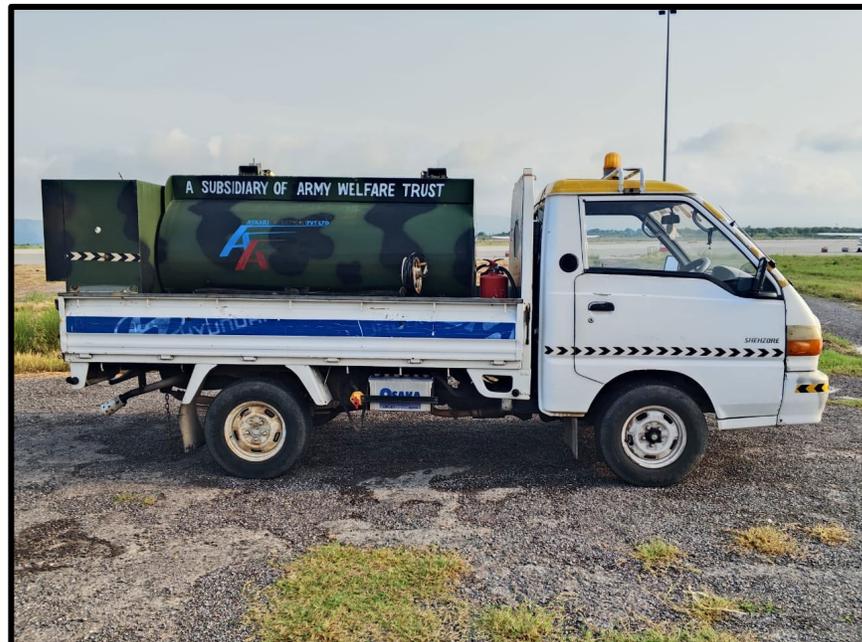
Figure 17 – Fuel Buser without Danger & No Smoking Sign

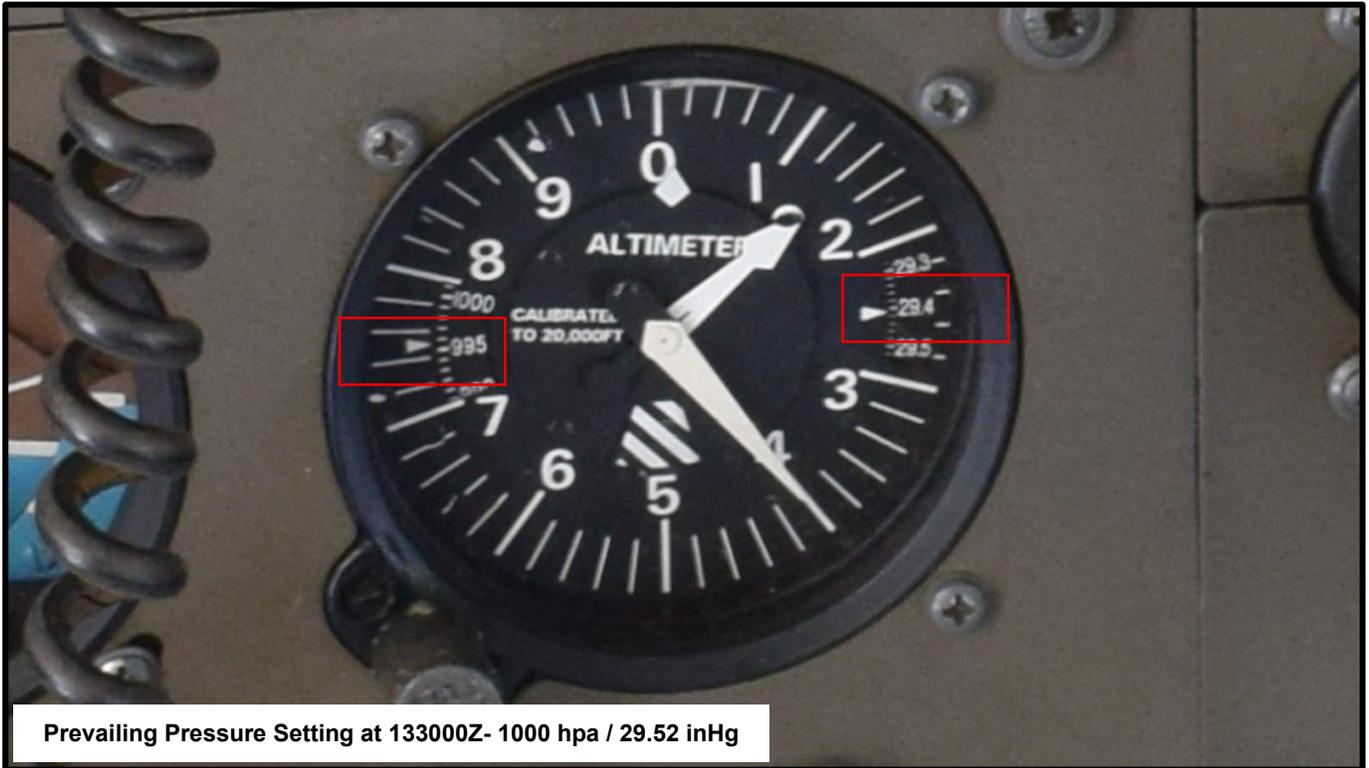
Figure 18 – Stand By Altimeter

86. The investigation determined that barometric settings on the standby altimeter were not being consistently adhered to. During the subject occurrence flight, a discrepancy was noted between the actual prevailing pressure (29.56 inHg) and the altimeter setting in use (29.40 inHg), indicating non-compliance with standard operating procedures and altimeter setting practices.

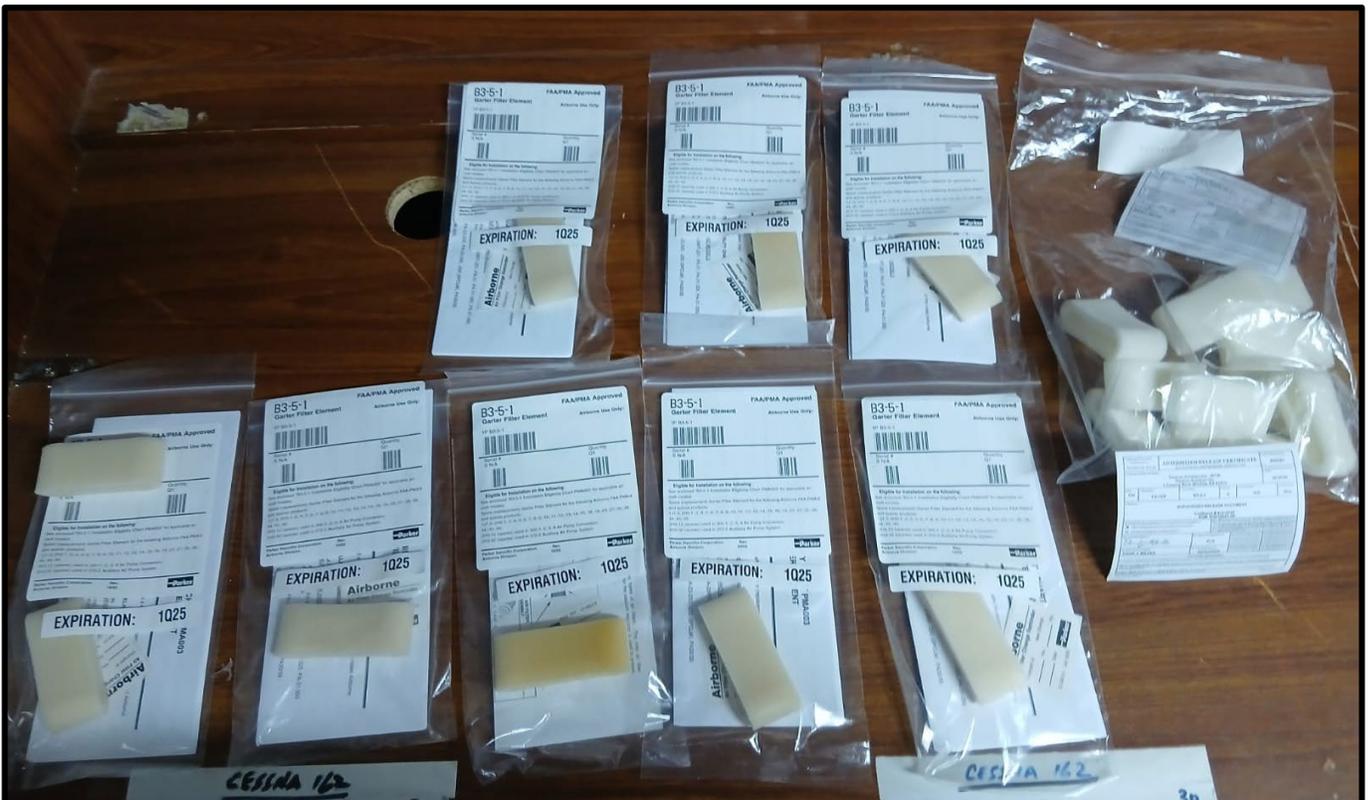
Figure 18 A – Expire items place in tech store Shelves

- (a) Lead pencils are being utilized for entries in aircraft and technical documentation.
- (b) Uncleared aircraft defect entries in technical logbooks.
- (c) Expired consumable items retained in the technical store.
- (d) Missing or altered entries (including lead pencil use) in technical store Performa’s.
- (e) Improper supervision of solo missions, including instances where single sorties were converted into dual or solo flights without proper authorization.
- (f) Flight Safety Meetings were found to be conducted primarily by supervisors, with minimal participation from trainee pilots and maintenance technicians, thereby limiting engagement in safety management practices.

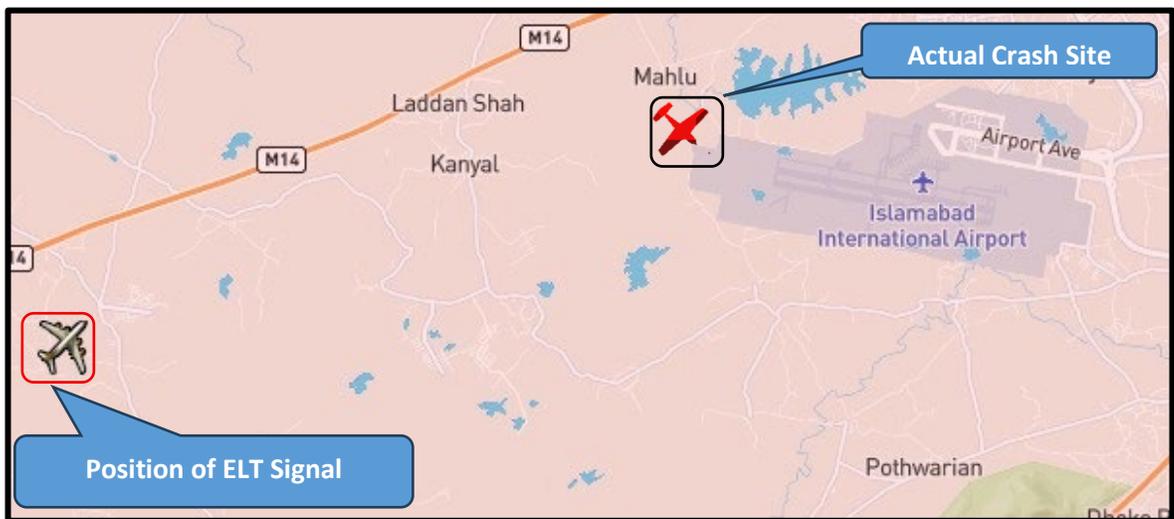
54. ELT was found transmitting at the crash site; however, distress data was not being displayed on SUPARCO Search & Rescue system (COSPAS SARSAT) installed at Rescue Sub Center (RSC). Same data was shown on RSC on **19 August after a gap of 03 days** and well offset by **approx 5-6 NM from exact location**.

Figure 20- Location of ELT Signal received at RSC IIAP

104. The aircraft's Emergency Locator Transmitter (ELT) was found transmitting; however, no signal was displayed on the SUPARCO Search & Rescue (COSPAS-SARSAT) system at the Rescue Sub-Centre until three days later, with a positional offset of approximately 5-6 NM from the crash site.

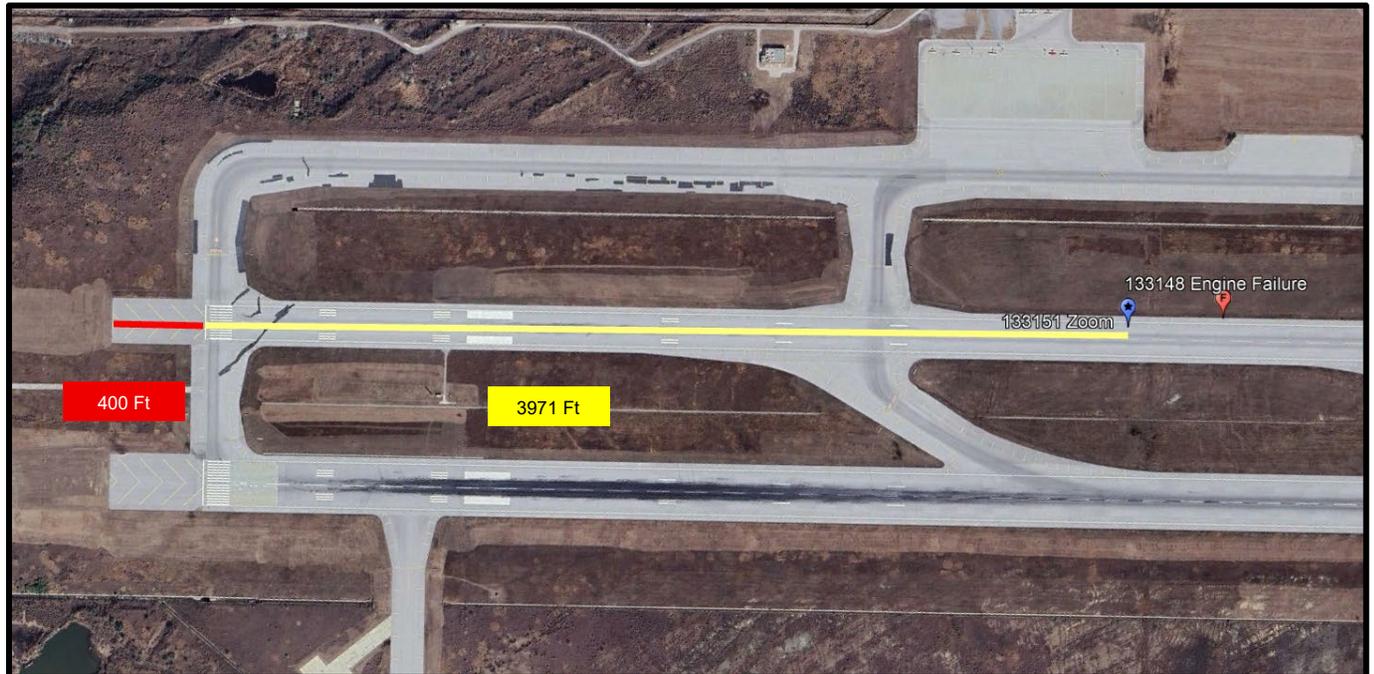
129. At the time of the engine failure (**133148 hour**), occurring at **275 ft AGL with 69 kts (ground speed)**, the remaining runway length ahead of the aircraft was **4321 ft**. With additional **400 ft** of prepared undershoot, the total length available to conduct effective forced landing was **4721 ft**.

130. Keeping in view the uncertainties in pilot technique, runway surface condition, and braking efficiency, the aircraft, which zoomed after engine failure and was approximately **240 ft AGL at 69 kt (groundspeed)** at that time, could have achieved a full-stop landing (glide plus ground roll) within **2,100–3,700 ft** of horizontal distance had the pilot immediately executed the **POH “Engine**

**Failure Immediately After Takeoff**” forced-landing procedure. The calculation assumes initiation from **240–275 ft AGL** in either **flaps-up** or **flaps-30°** configuration. Therefore, the available runway length, including the **prepared 400-ft undershoot area**, was sufficient to bring the aircraft to a complete stop.

**Figure 21- RW LENGTH AVAILBLE**
