FINAL INVESTIGATION REPORT

**SERIOUS INCIDENT – ENGINE FIRE PIAC FLIGHT PK-743,
B777-200ER REG NO AP-BMH AT JINNAH INTERNATIONAL
AIRPORT, KARACHI ON 02ND DECEMBER, 2023**

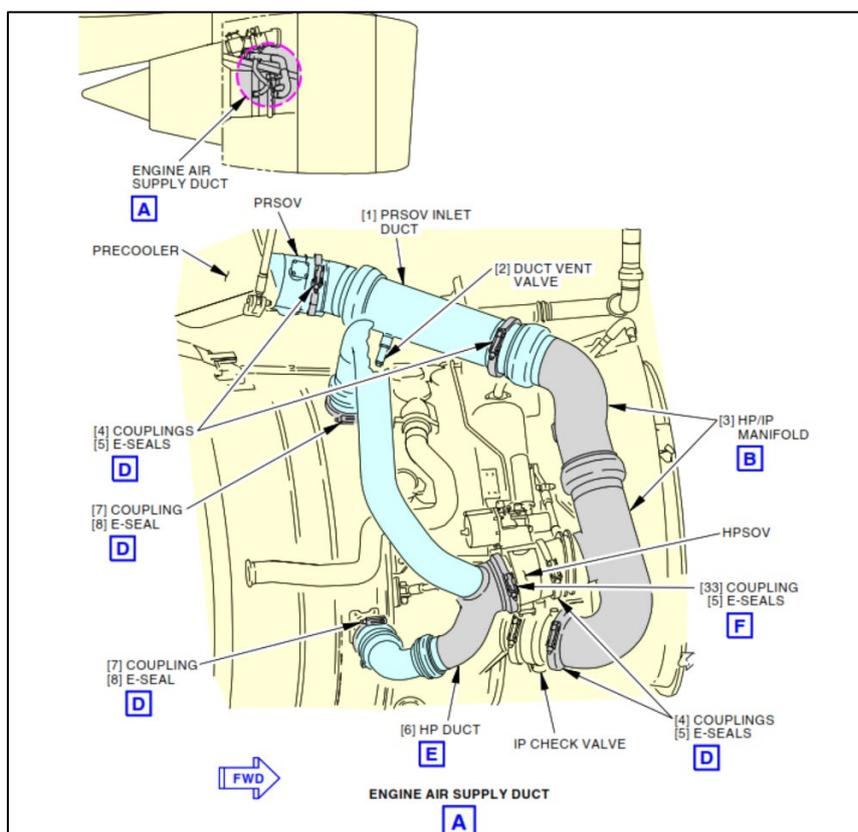
Figure 1 Engine Air Supply Duct

2.3.2. Further inspection of engine revealed a disconnected HP pneumatic duct at 3 o'clock position of the right engine, near the High-Pressure Compressor (HPC) case. The associated duct clamp, which secures the Y-shaped pneumatic duct in the HP bleed air system, was found in the lower engine area near 6 o'clock position.

2.3.3. The right engine's thrust reverser Pressure Relief 02 doors were also found in operated position indicating hot air leak in the area. Secondary damage to the righthand thrust reverser cowling also indicate a pneumatic leak in the area.

2.3.4. The collected evidences point towards a right engine overheat warning during flight caused by a significant bleed air leak from the 14th stage of the HPC.

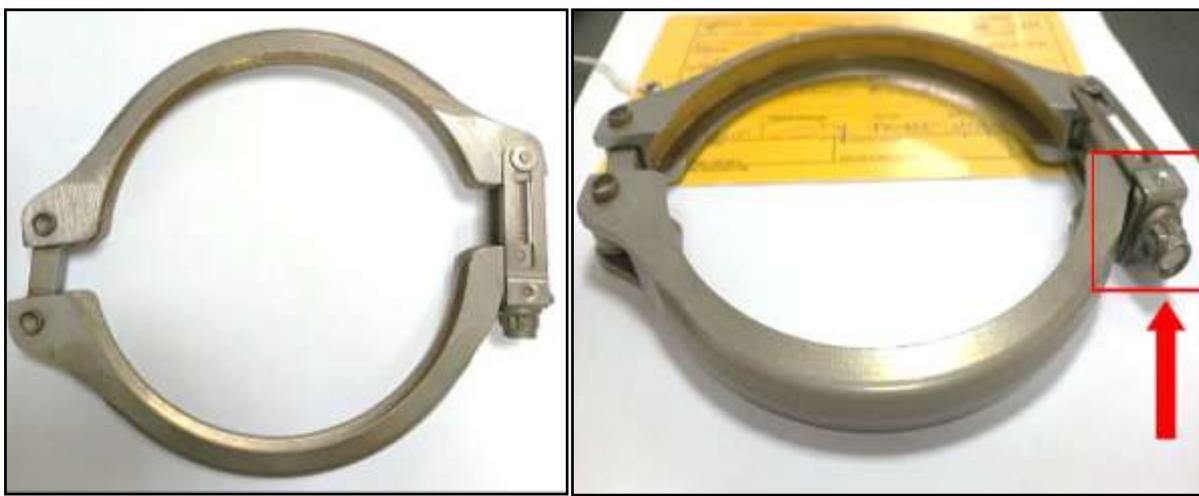
Figure 2 Clamp and Its Locking Mechanism

2.3.5.1. **Material failure or damage to the clamp** – Inspection of the clamp revealed that the clamp was not damaged or deformed, indicating that the disconnection was not caused by material failure of the clamp.

2.3.6. The recovered clamp locking mechanism showed absence of visible threads and the locking nut being excessively loose. This condition rendered the clamp ineffective in securing the duct, ultimately allowing it to detach during engine operation.

2.3.7. Detailed inspection of the clamp's locking mechanism was found to be satisfactory as there were no abnormal threads or any hindrance in the locking mechanism and the nut screwed-in properly. This indicates error in the installation of clamp which is discussed in the Human Factor heading.

3.1.4. Visual inspection of the recovered clamp showed no signs of damage or deformation. However, the clamp appeared to be improperly torqued, as no threads were visible beyond the nut and the nut may have gotten loose due to vibrations, which is contrary to correct torque application standards.

3.3.1. **Improper Installation and Torque Omission** – The clamp securing the HP pneumatic duct was likely loosened during component removal or installation but not re-torqued or verified thereafter. The absence of mechanical deformation on the clamp supports a conclusion of human error during re-installation.

4.1.1.1. It is recommended that maintenance task cards be revised to explicitly include verification of adjacent or potentially affected components even if not directly referenced in the R&I (Removal and Installation) procedure to mitigate oversight of disturbed items such as clamps and ducting.

4.1.2.1. The airline should establish and enforce a dual-verification system for all critical engine and pneumatic system connections, such as duct clamps and valves, during and after engine installation. This should include a documented torque check where applicable.
