PRELIMINARY INVESTIGATION REPORT

**ACCIDENT OF Mi-8-MTV-1 PANH HELICOPTERS
FLIGHT NO PNH9537 / REG. NO RA-24537
CRASHED AT SHEWA NEAR BANNU, KPK PAKISTAN ON 28-09-2024**

MI-8-MTV-1 HELICOPTER CRASH AT SHEWA, KPK, PAKISTAN dated 28-09-24 OPERATED BY PRINCELY JETS, FLIGHT NO PNH9537 PANH HELICOPTERS REG. NO RA-24537

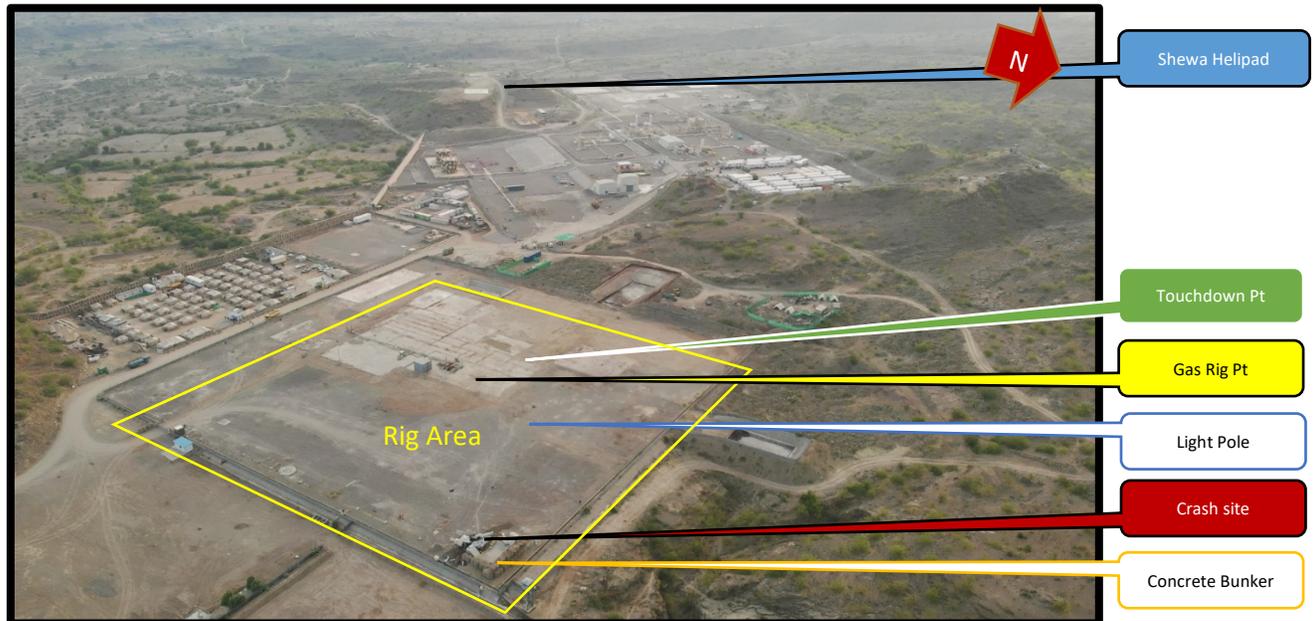
Figure 1 Aerial view (North East to South West)

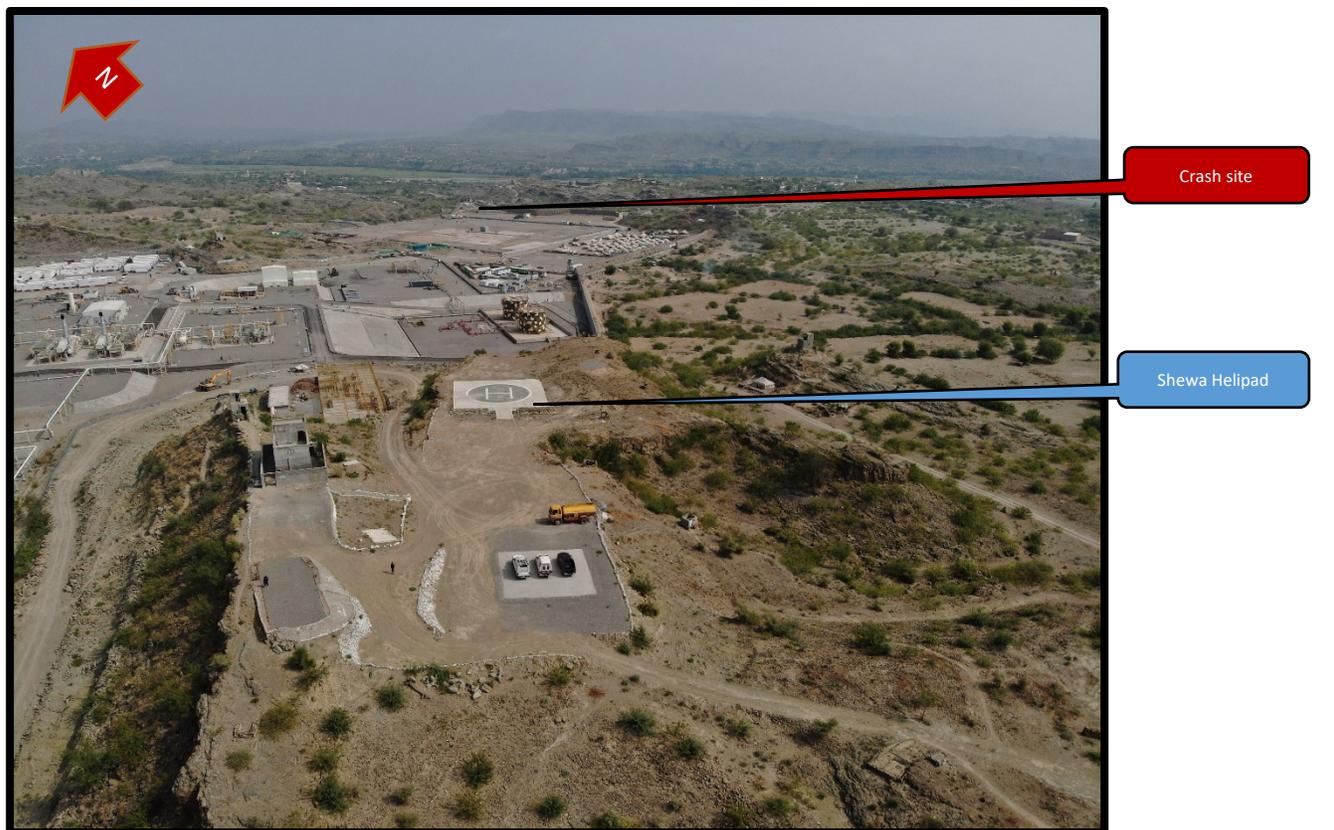
Figure 2 Aerial view (South West to North East)

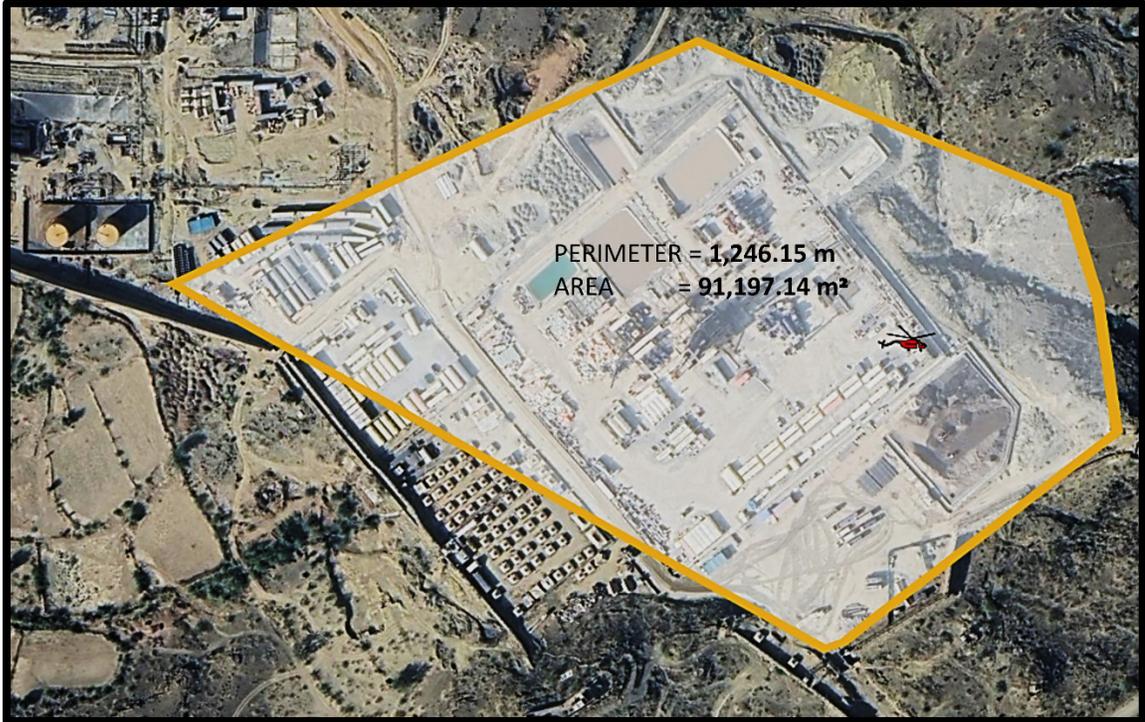
14. Accident site is located 623.4m NW of the Helipad. Helicopter main wreckage lie at position 33°12'42.70" N 70°28'55.41" E within the boundary of MPCL complex. Aircraft parts were spread out in an area of 91,197.14 m² in the perimeter of 1,246.15 m. Figure 1 to 11 below indicating the crash site.

Figure 3 Wreckage Spread Area

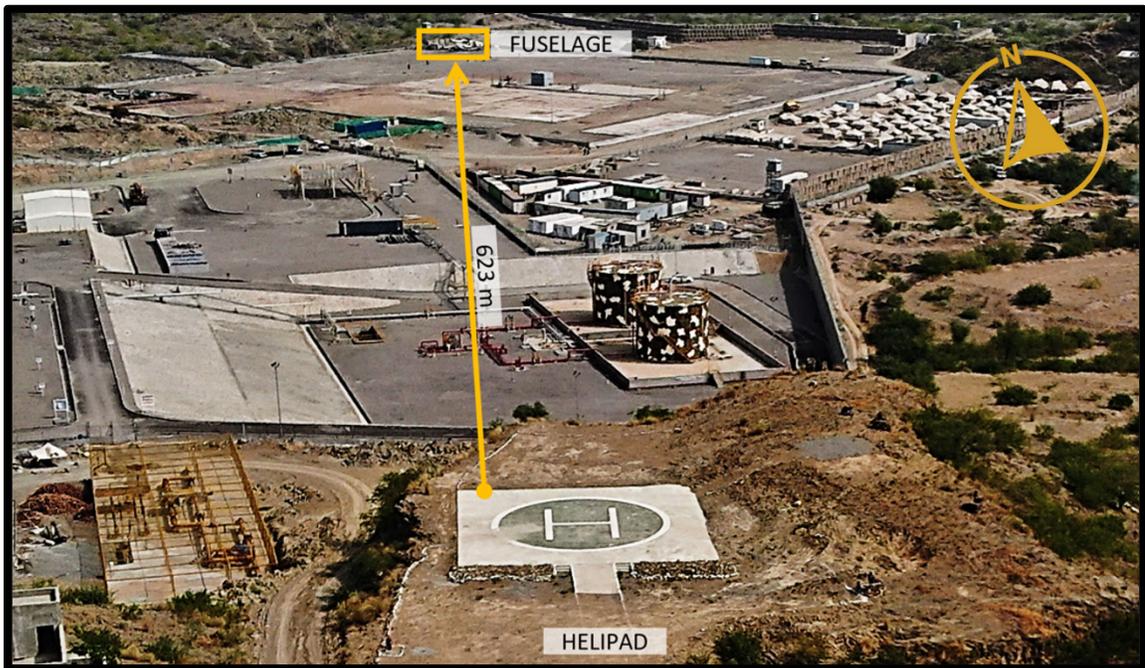
Figure 4 Aerial distance from Helipad to crash site

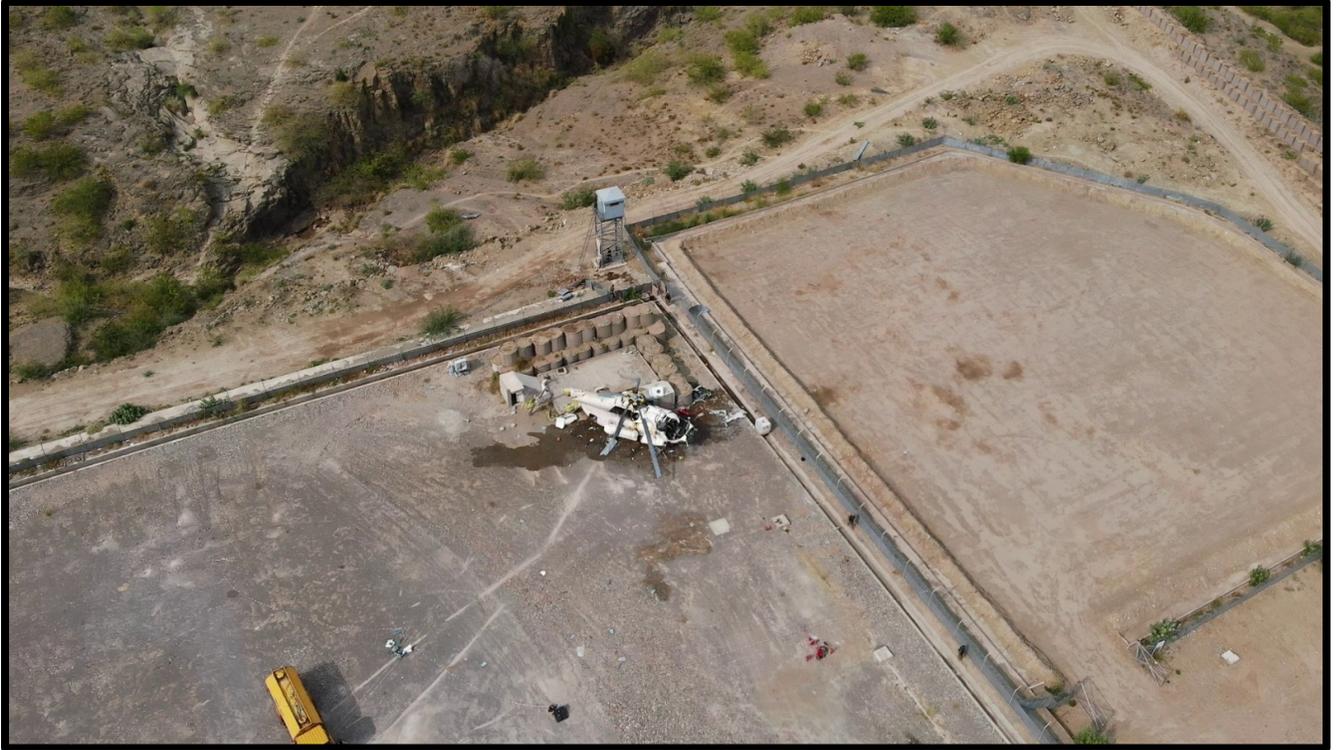
Figure 5 Aerial View of crash site

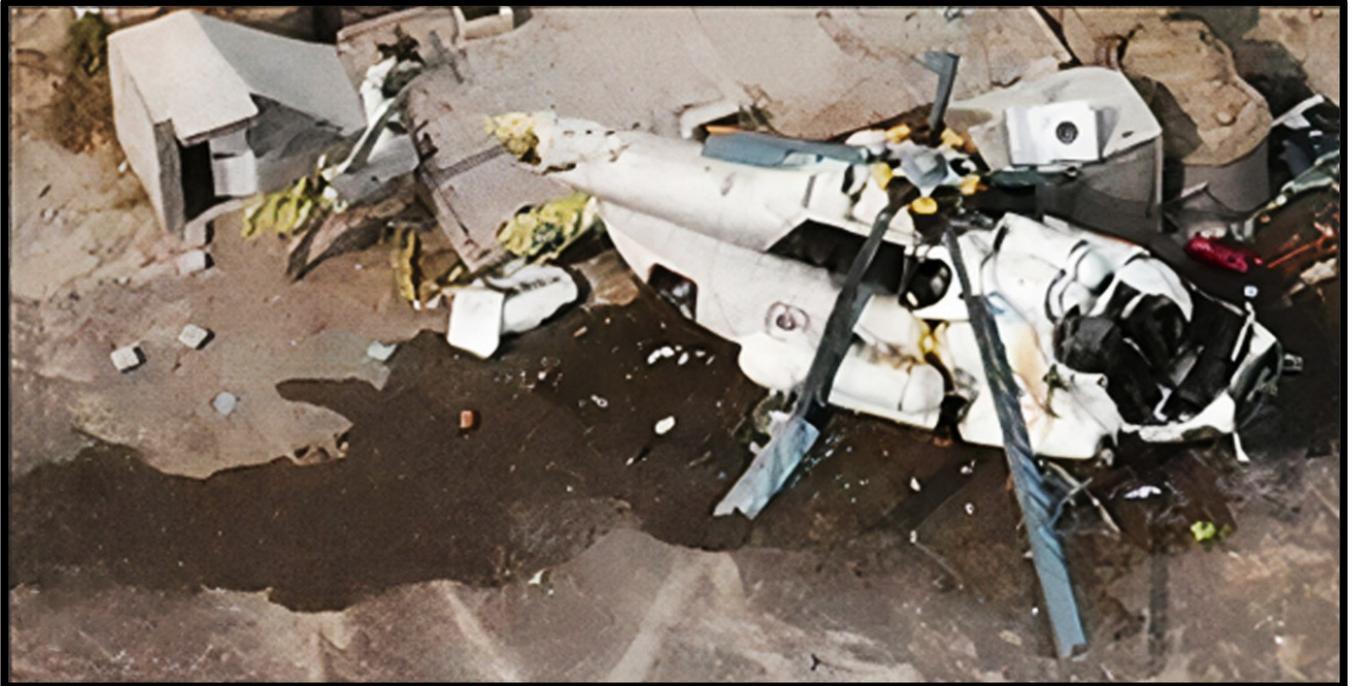
Figure 6 Aerial View of Helicopter

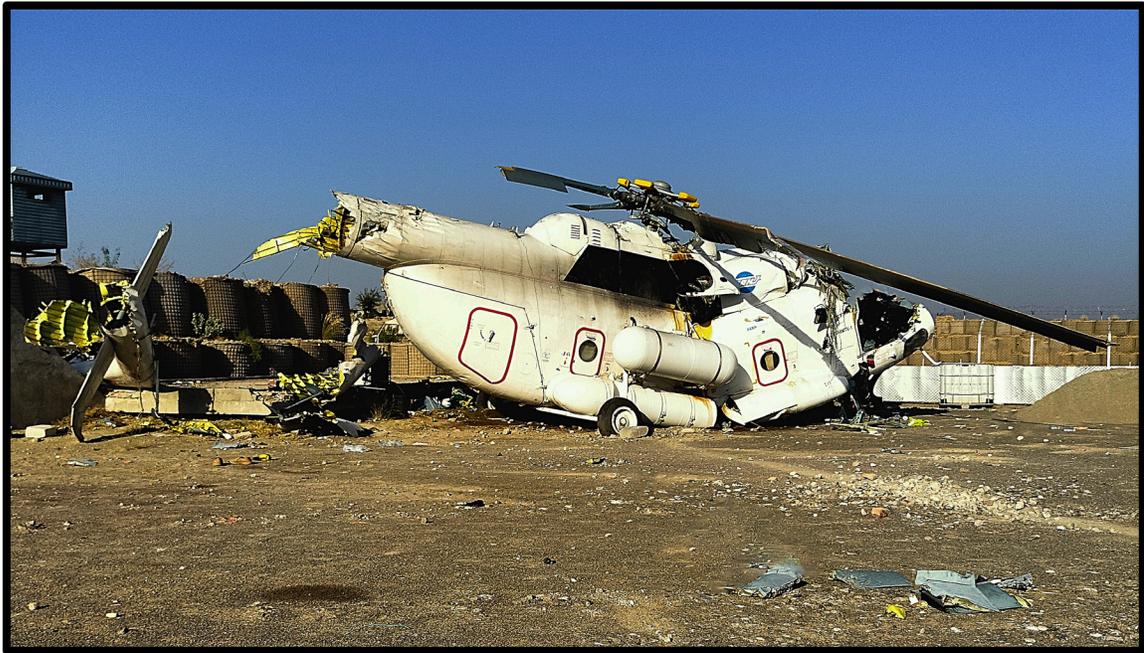
3. As a result of collision of main rotor with the light pole, the light pole broke into six (06) pieces whereas main rotor blade(s) also broke. Subsequently, the helicopter collided with concrete structure, the tail boom got separated and laid close to main fuselage. The right engine and main rotor kept running for the following next eight (08) minutes (min) with no tail rotor caused severe oscillations and heavy vibrations. Moreover, multiple collisions of the main fuselage with the concrete structure resulted into breakage of fuselage in two pieces from center. Due to breakage of main fuselage from center, the front portion of helicopter tilted upward and the main rotor blade struck the top portion of cockpit and cut the cockpit area. The main rotor stopped after approximate three (03) rotations. MPCL/Orient Petroleum Inc. (OPI) & Frontier Corps rescue team reached the crash site immediately. However, rescue operation commenced once main rotor had completely stopped.

Figure 7 Main Fuselage breakage and Tail Boom

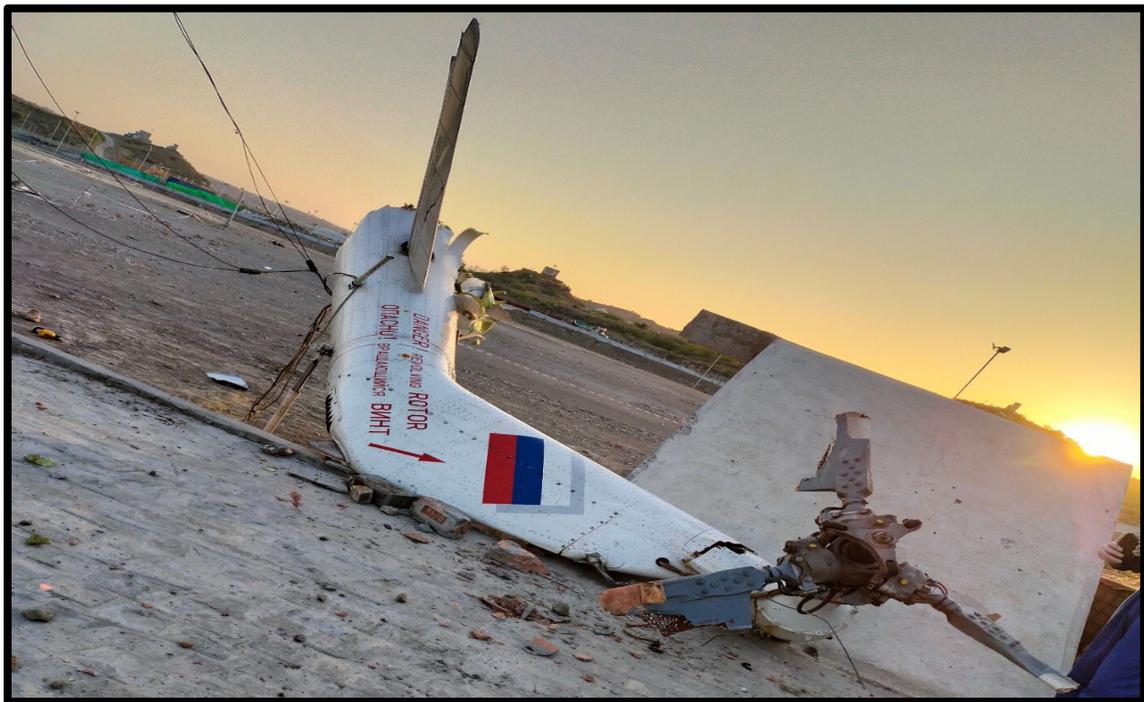
Figure 8 Tail Boom

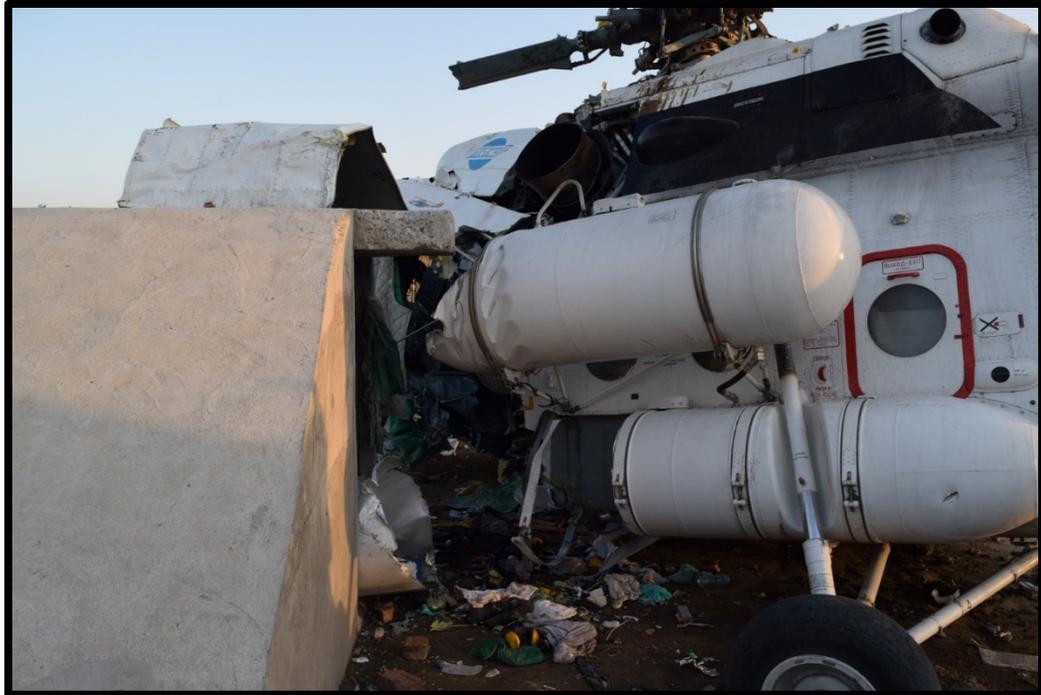
Figure 9 Left side of Fuselage with concrete bunker

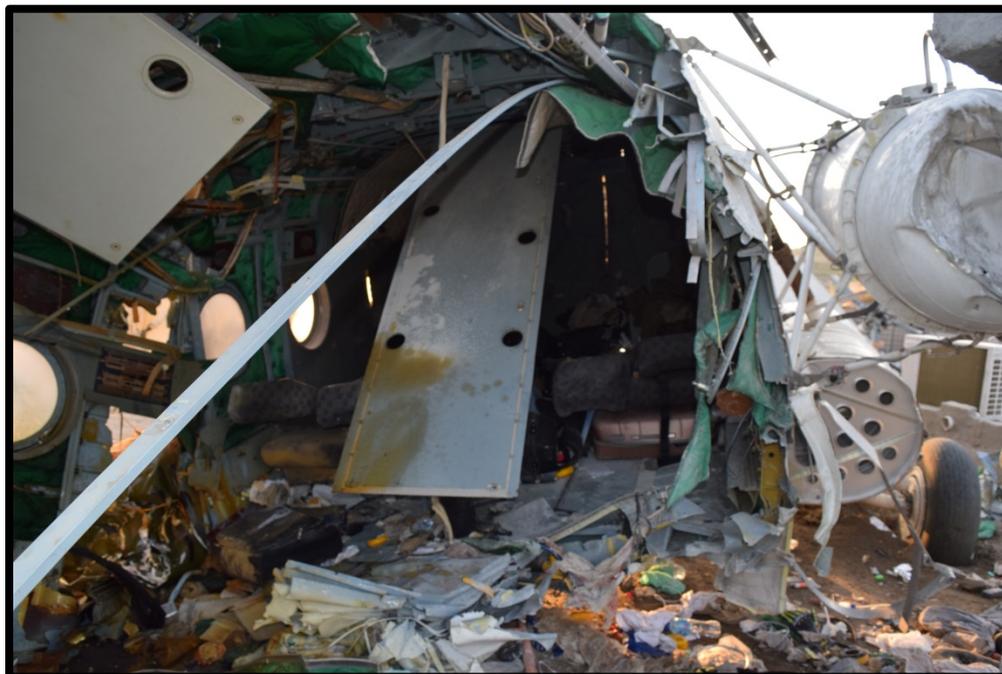
Figure 10 Left side of Fuselage rupture passenger door area

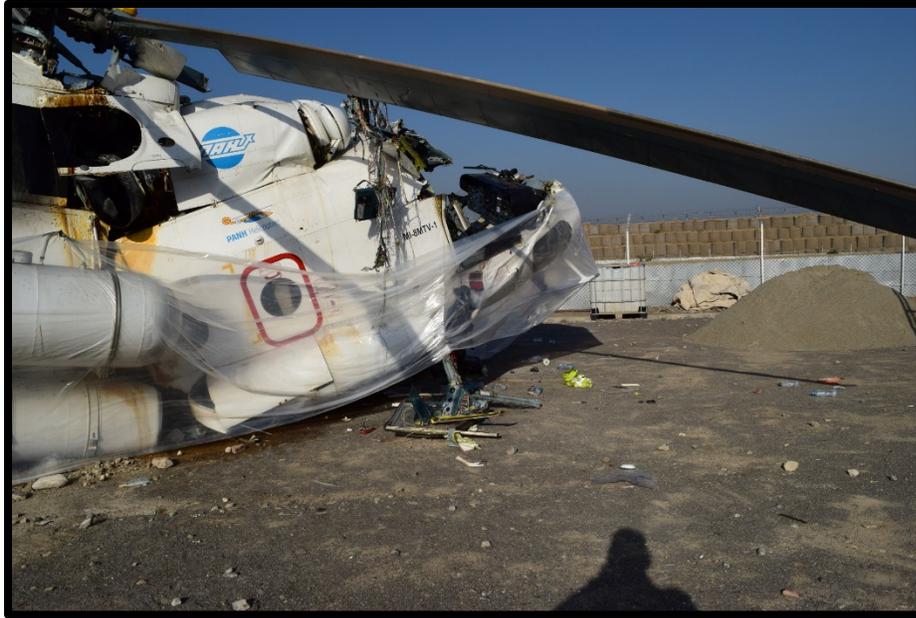
Figure 10 Right side of Fuselage breakage area

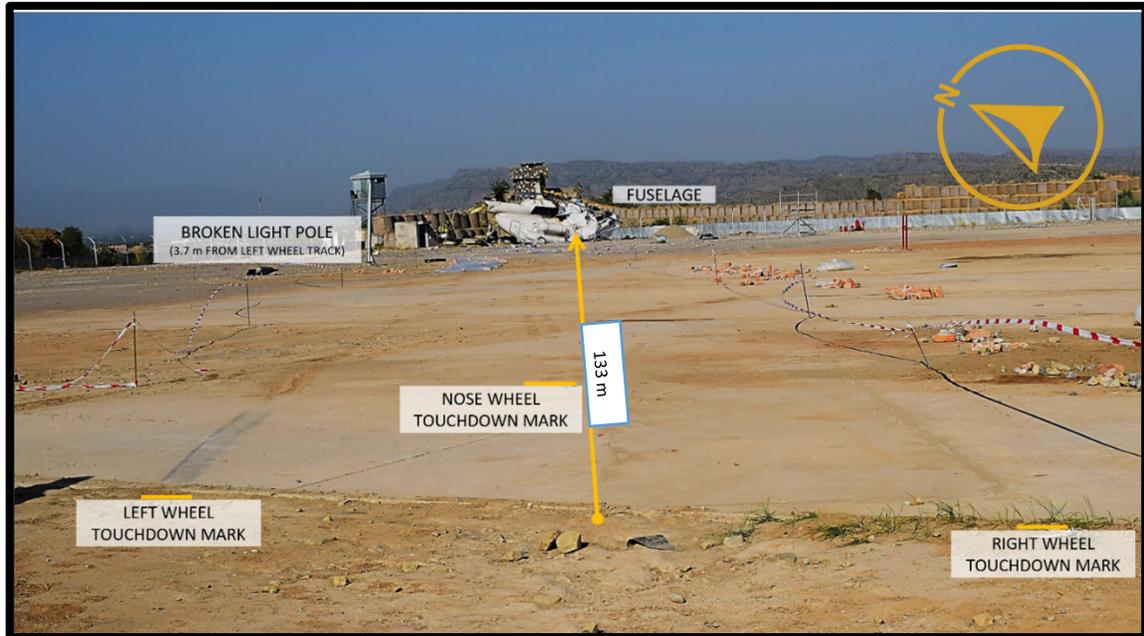
15. Following figures and video link describes the touchdown point, damaged light pole and the final resting point of helicopter main fuselage and tail section right beside concrete bunker. https://drive.google.com/file/d/1KJuglALgGvDAmcJdf_6wWh1YEs2tN04R/view?usp=sharing (video link)

Figure 12 Touchdown point, Light pole and Main Fuselage

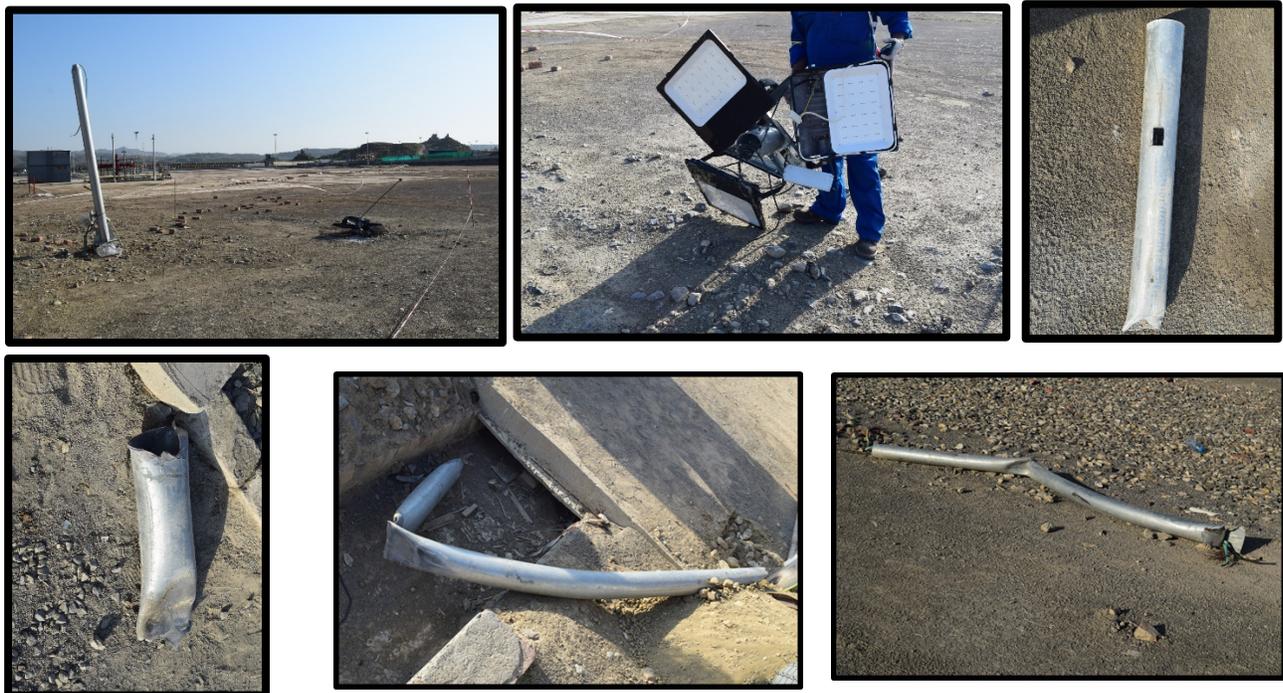
12. 124903. Helicopter main rotor blades collided with the light pole (10m high) on left side (63m from touchdown point)

Figure 13 Broken Light Pole

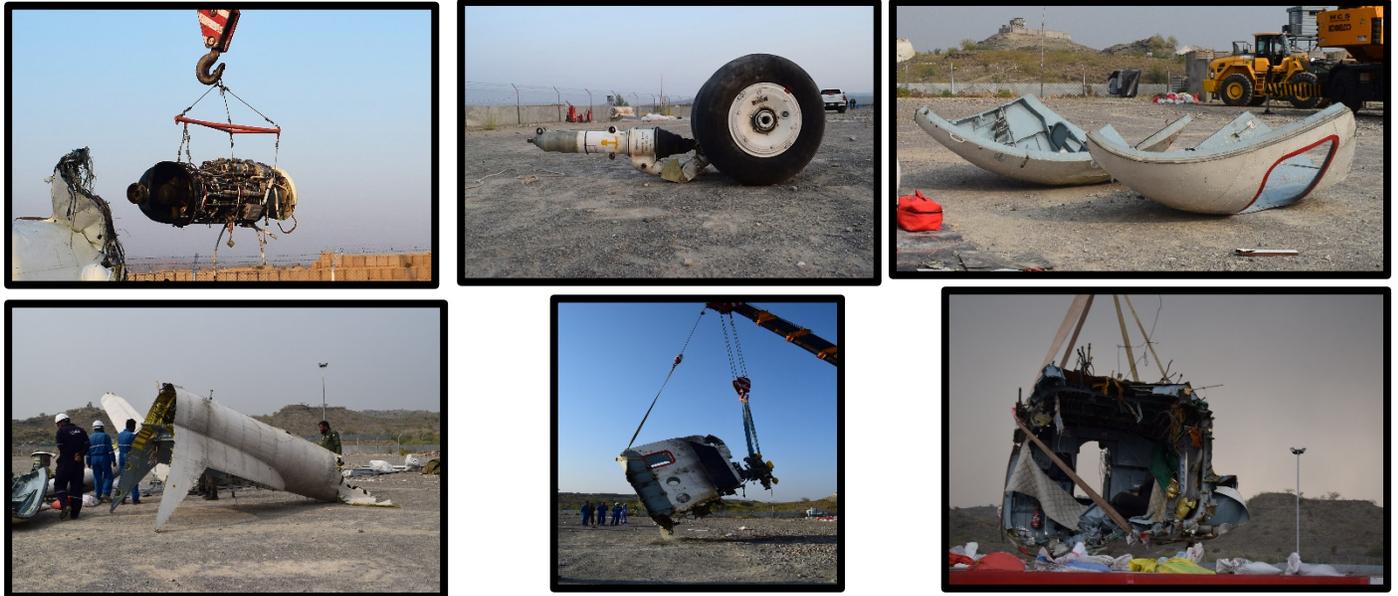
18. Helicopter fuselage was broken in two pieces (before frame 7). Both Engines and Auxiliary Power Unit (APU) were removed and centre fuselage was cut between frame 13-14 to enable road transportation on flat-bed vehicles, fulfilling the cargo heights clearance (max 16 feet to pass under the en-route overhead bridges). All cargo doors, landing gears, struts, main and auxiliary, fuel tanks were removed for easy transportation. Part of tail boom attached with the center fuselage was also separated from frame 17. Helicopter wreckage was transported by road from accident side to place of storage.

Figure 1 Wreckage recovery

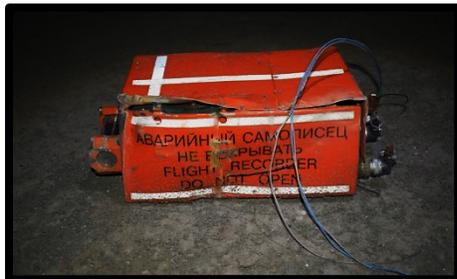
Figure 15
Flight Data Recorder

19. FDR and CVR were retrieved from the accident site in damaged condition. Vital navigation equipment including Satellite Navigation Receiver (TSS) Terrain Awareness Warning System (TAWS). TTA-12h and Air Navigation multiple indication Garmin GTN750 were also recovered for analysis.

21. During the FDR readout it was revealed that **left engine has suddenly stopped (with in 2 sec)** whereas right engine was operating normal till landing. However, cause of left engine failure could not be established. In this regard, it was decided by IAC & BASIP investigation teams, that the left engine would be transported to OEM facility (Ural Works of Civil Aviation Ekaterinburg, Russia 620025) for tear down examination. Moreover, both assemblies would also be transported to OEM facility (Moskovskiy Aviatsionno Remontnyy ZA VOD DOSAAF Moscow Region 143921).
