FINAL INVESTIGATION REPORT

**ACCIDENT OF ETIHAD AIRWAYS FLIGHT ETD-72K,
B787-900 AIRCRAFT, REG. NO. A6-BLF AT ALLAMA
IQBAL INTERNATIONAL AIRPORT, LAHORE ON
27 MAY, 2022**

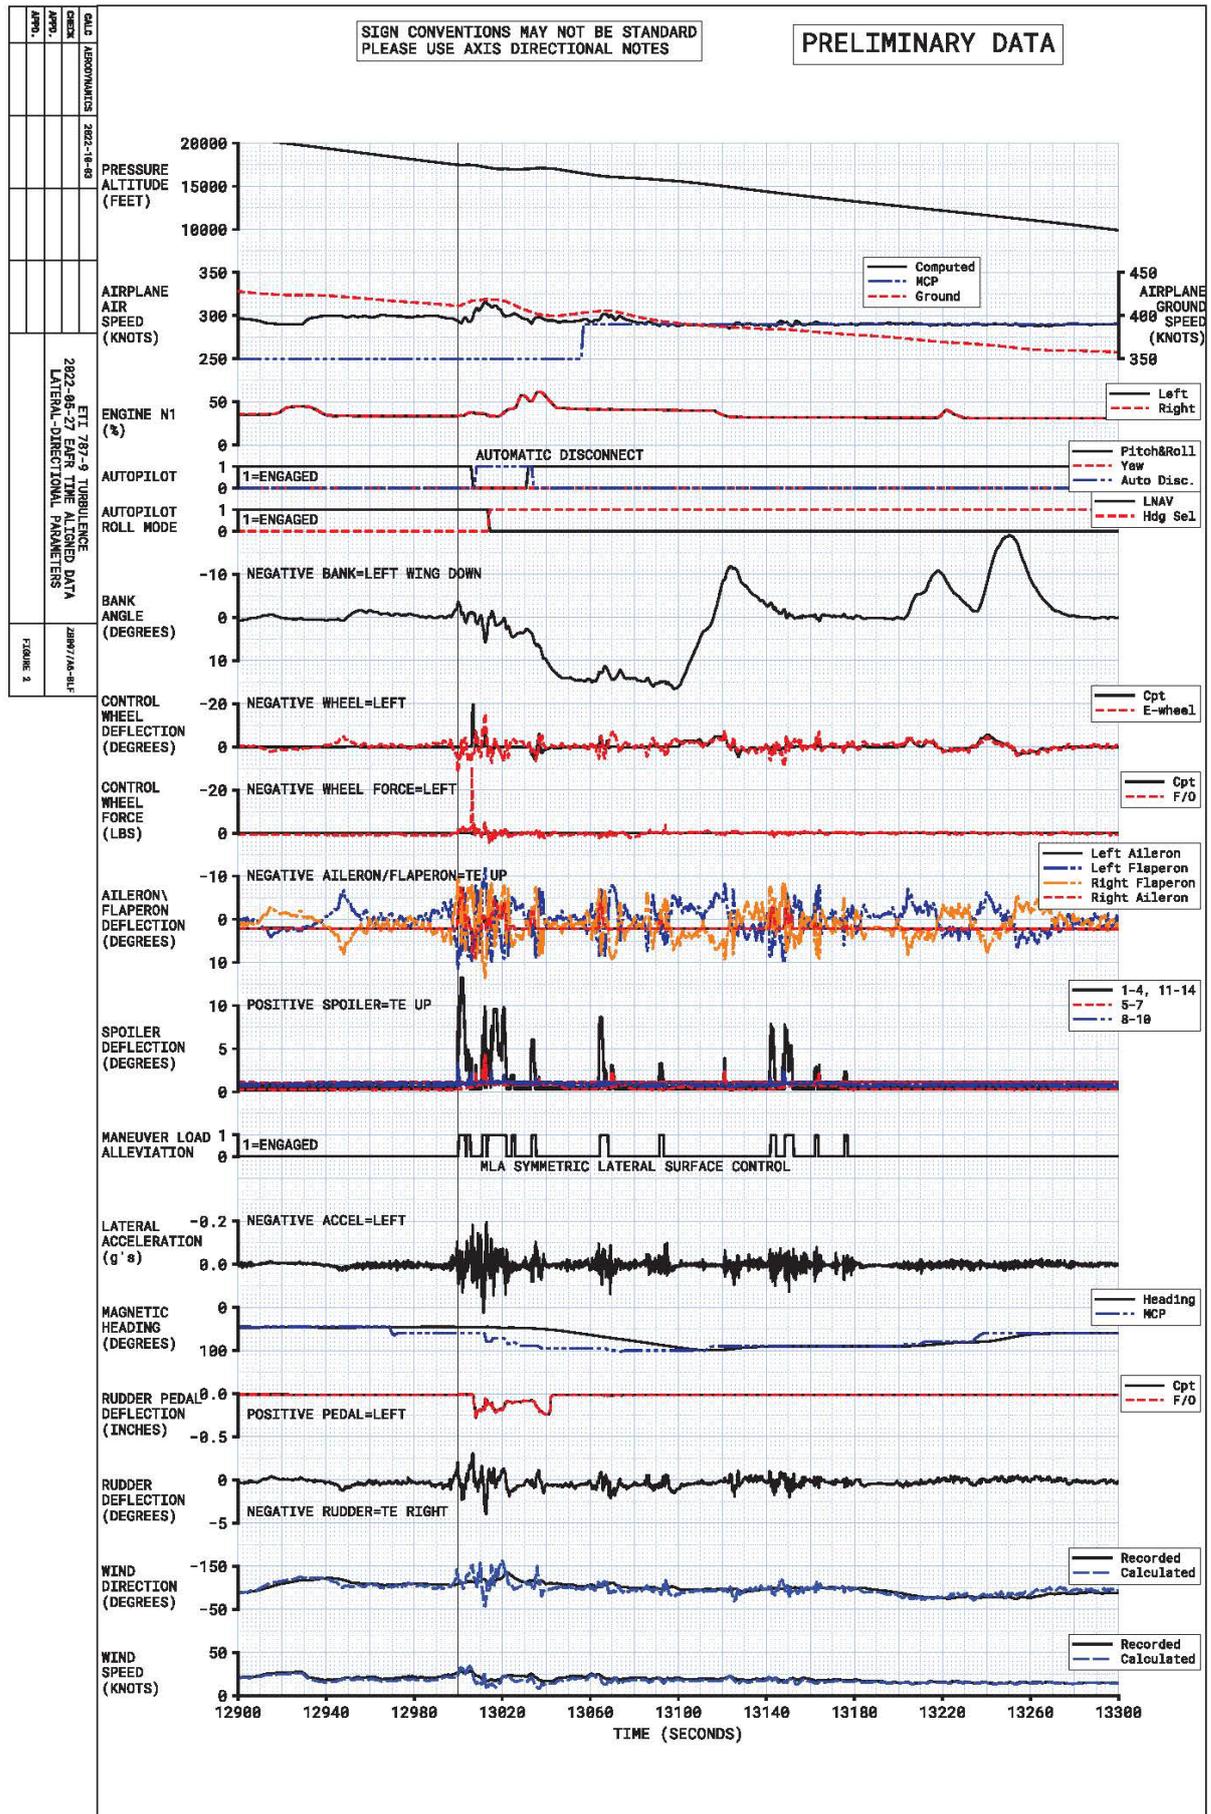
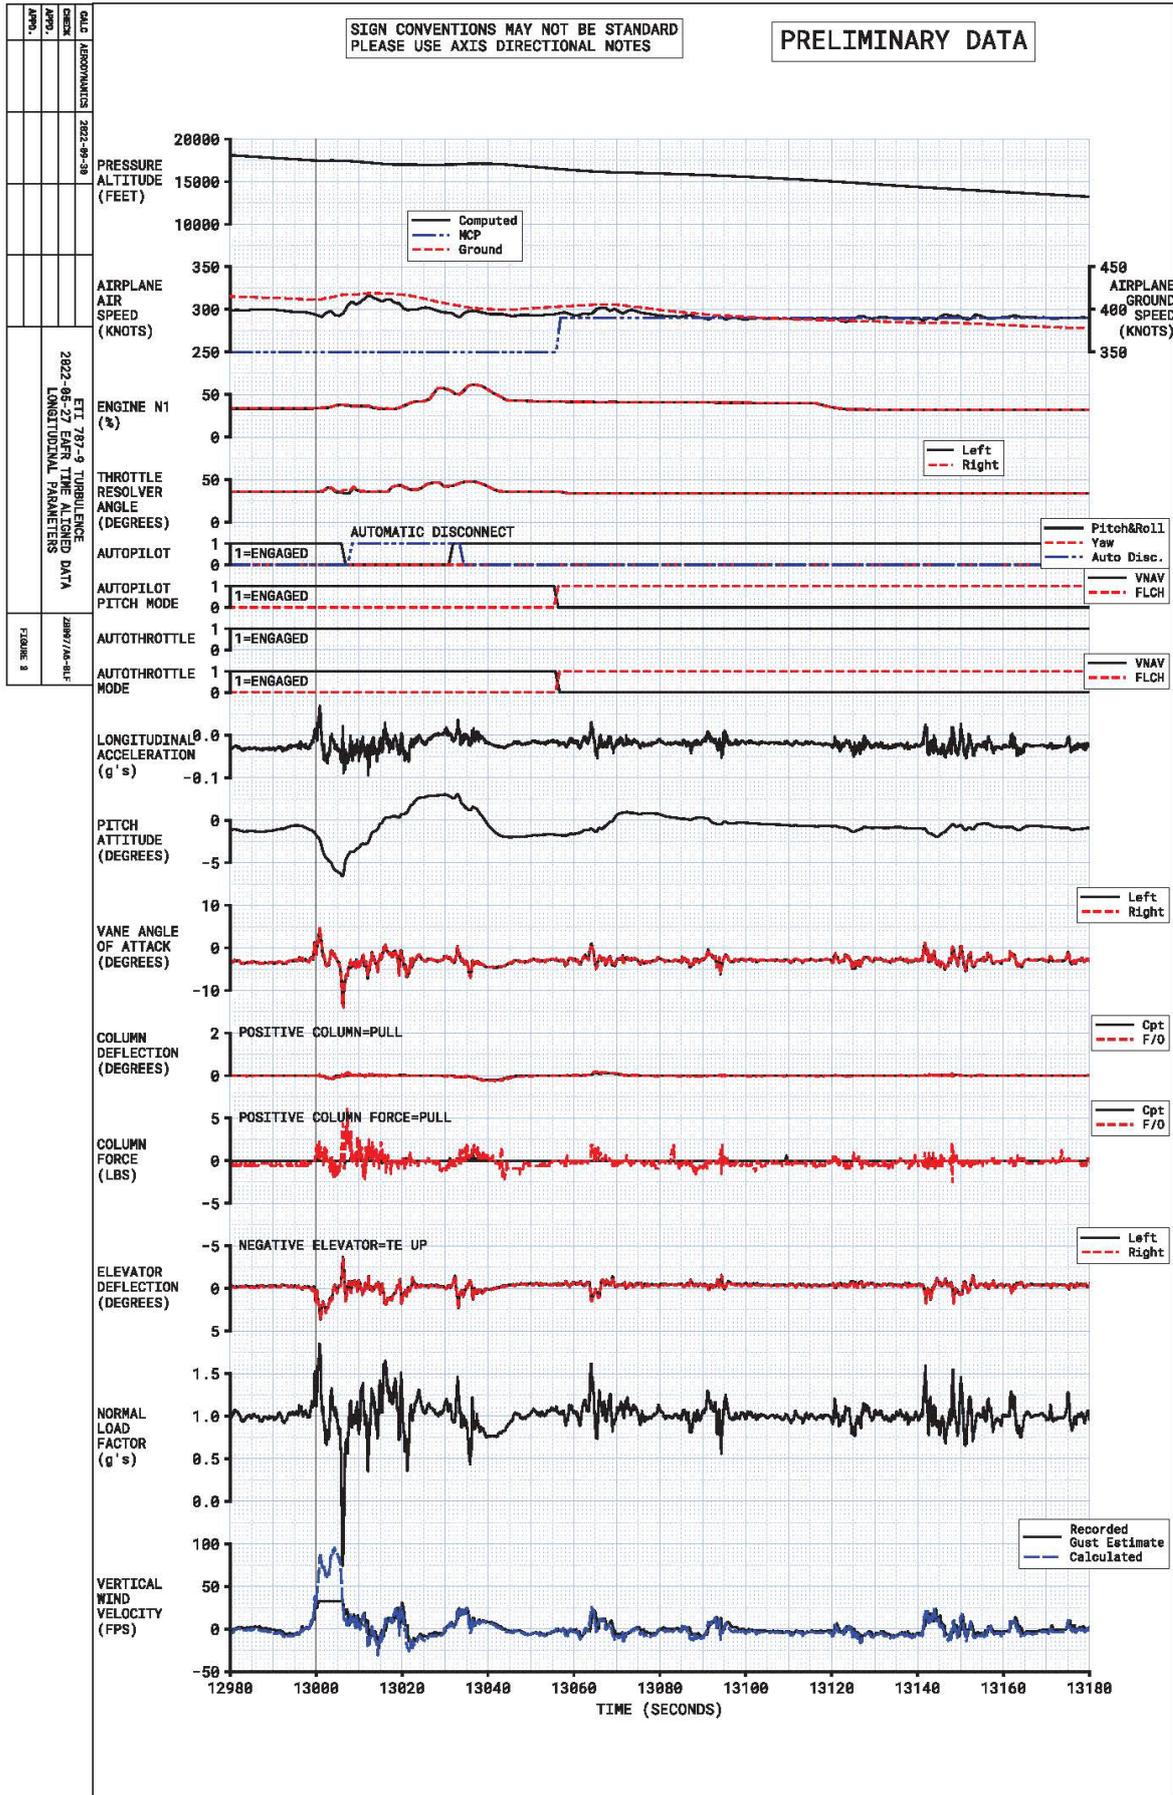
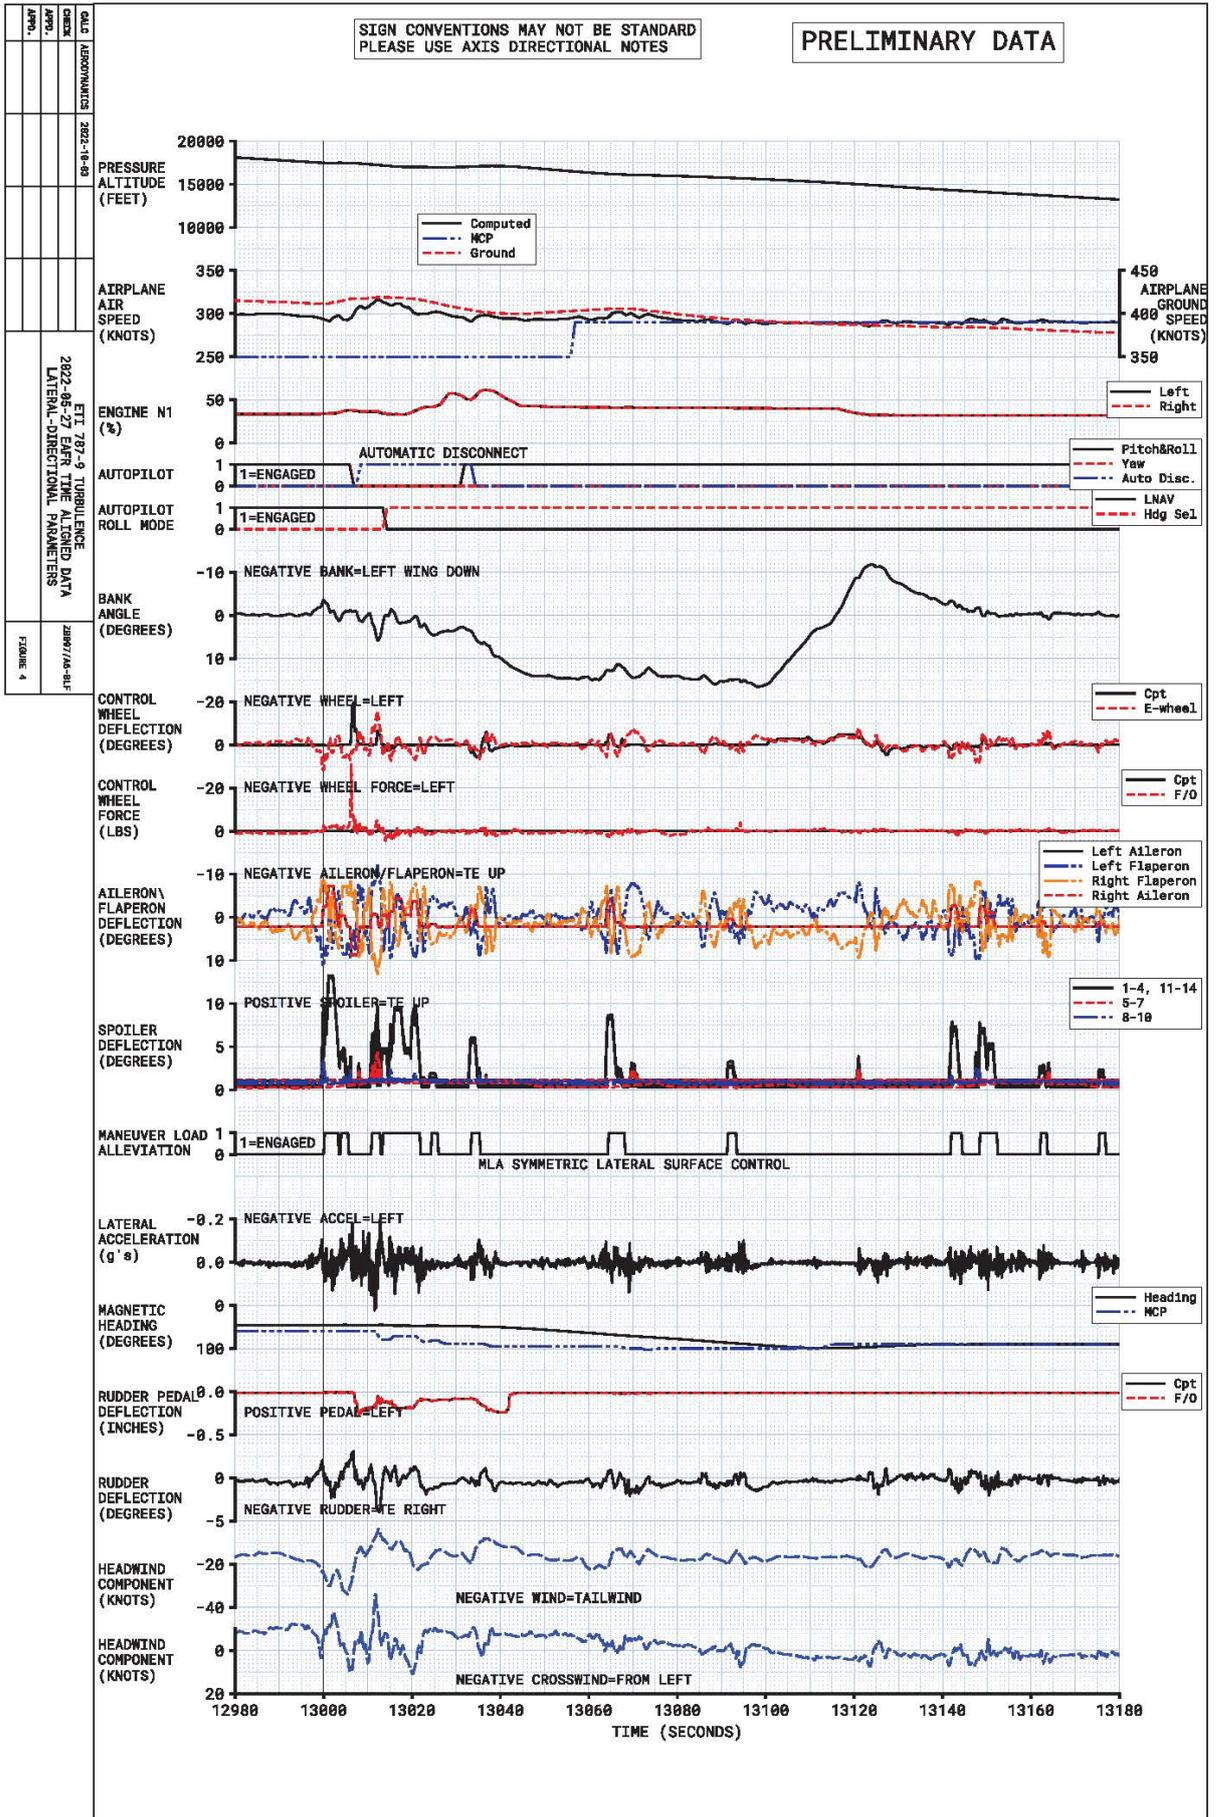
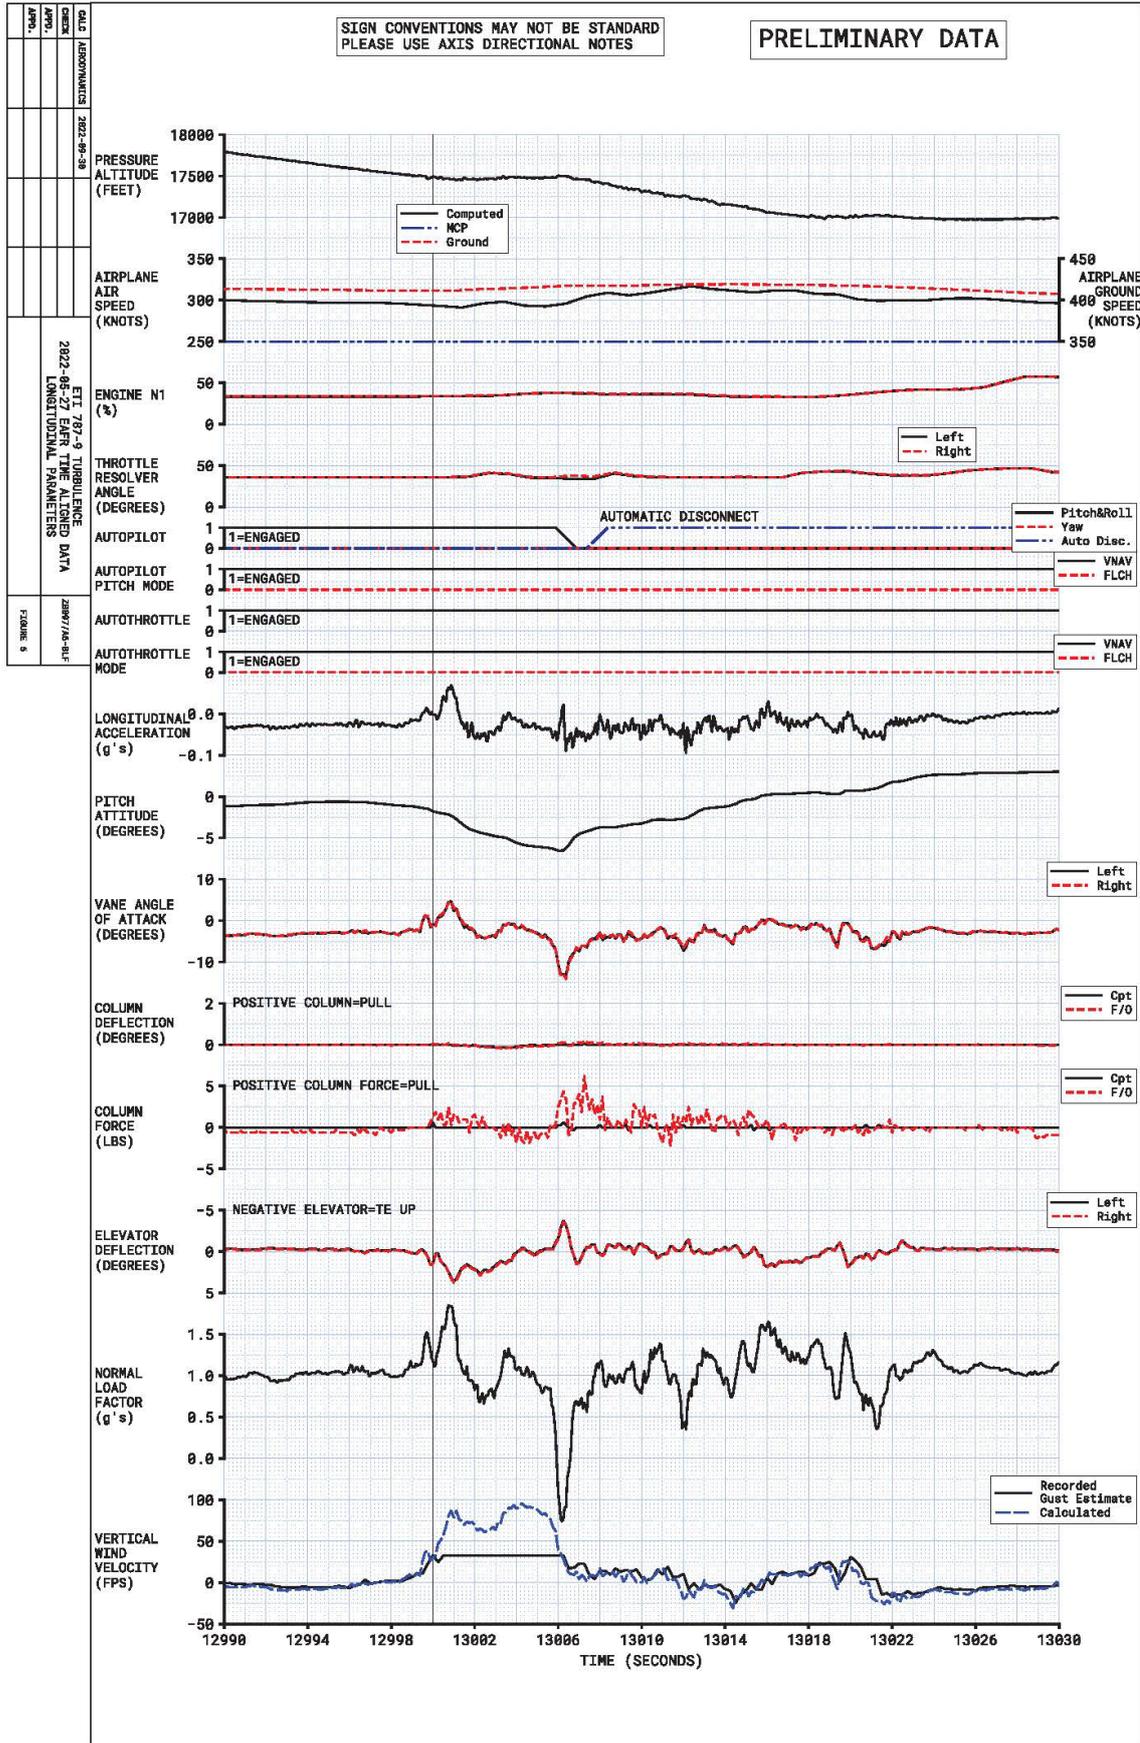
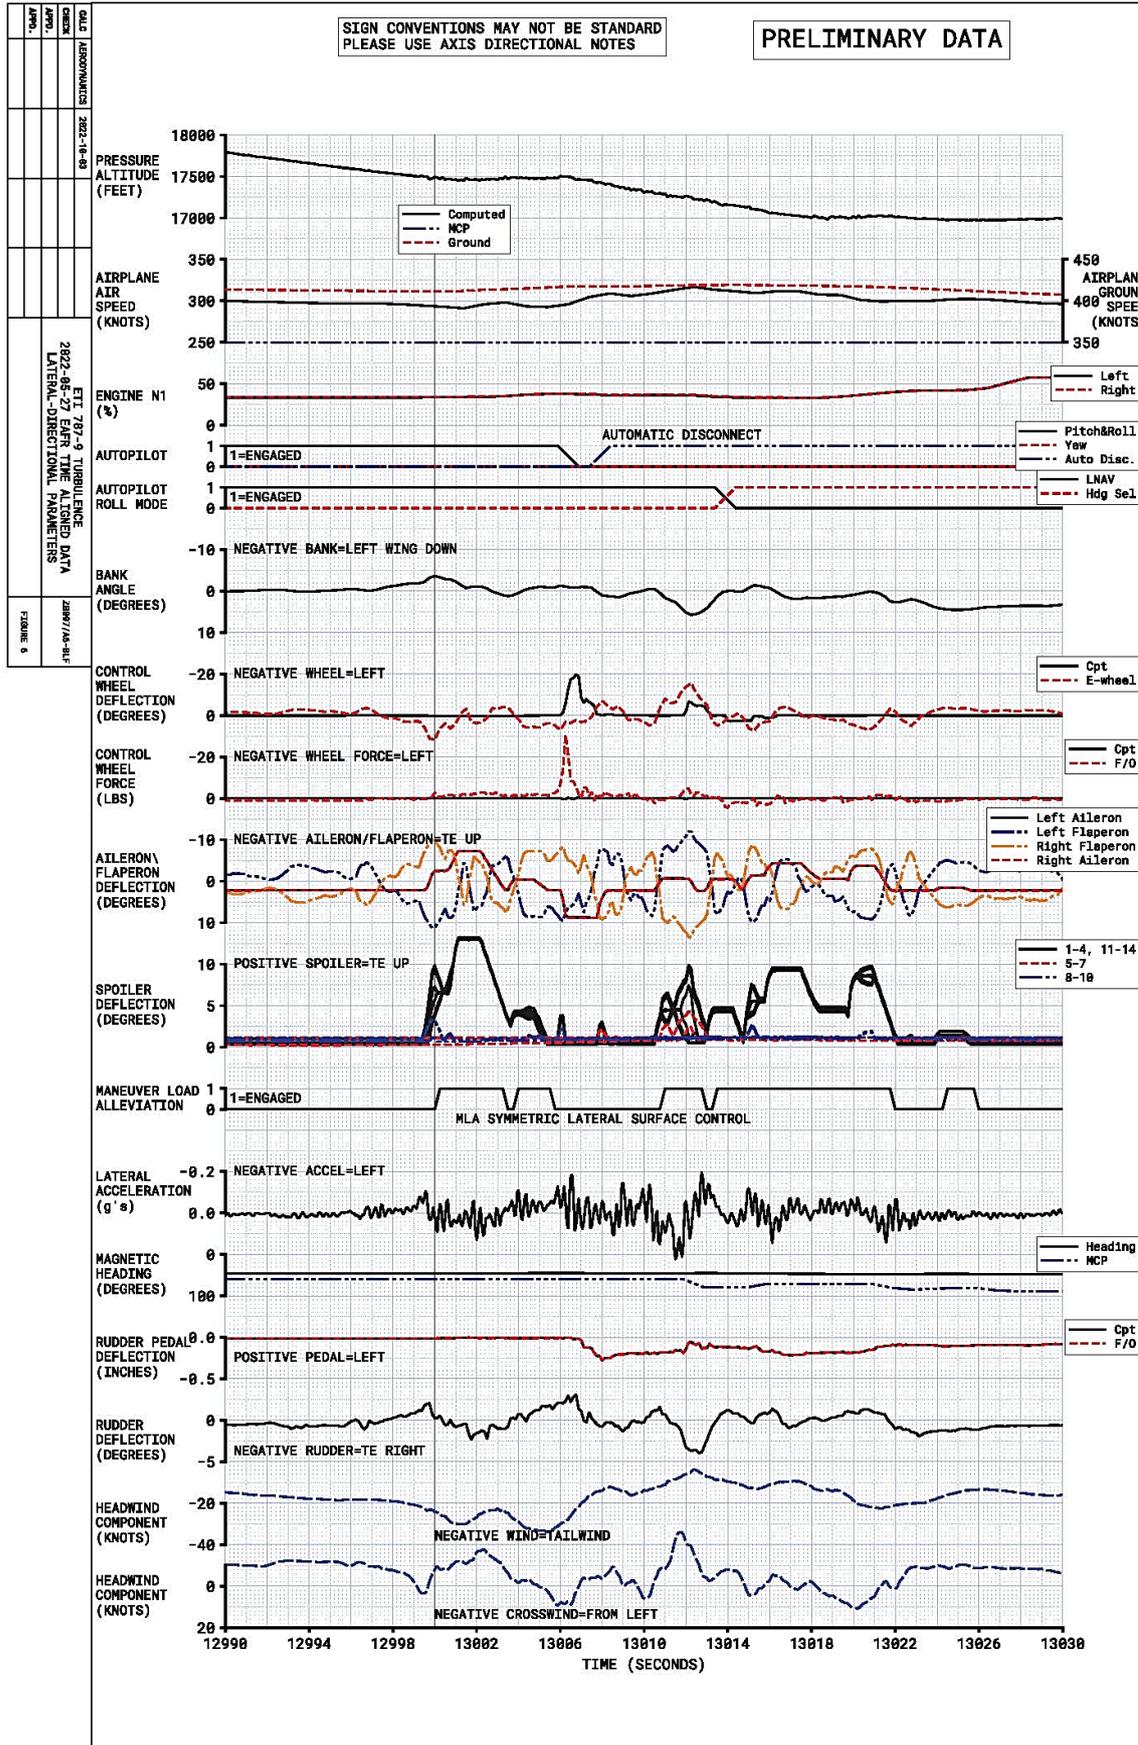
2.3.3. Analysis of DFDR data reveals that the aircraft was subject to the highest load factor at the initial onset of the updraft and during its dissipation. The aircraft was subjected to maximum load factor of +ve 1.8 Gs and a minimum of -ve 0.75 Gs. While positive Gs caused a strain on the airframe and the passengers, the negative G force resulted in the Cabin Crew as well as the passengers to strike against the aircraft fuselage inside the cabin, ensuing in injuries. The Cabin Crew at this time were engaged in service inside the cabin and were not seated or strapped up, which resulted in them striking against the aircraft more severely thereby resulting in injuries of a graver nature.

2.3.4. When the turbulence hit the aircraft, the Flight Crew commanded a sharp left control wheel input which resulted in AP disconnection due to control wheel override force of 26-31 pounds. The aircraft continued under manual control for 30 s during which time there was no exceedance of flight parameters. The AP was subsequently reengaged.

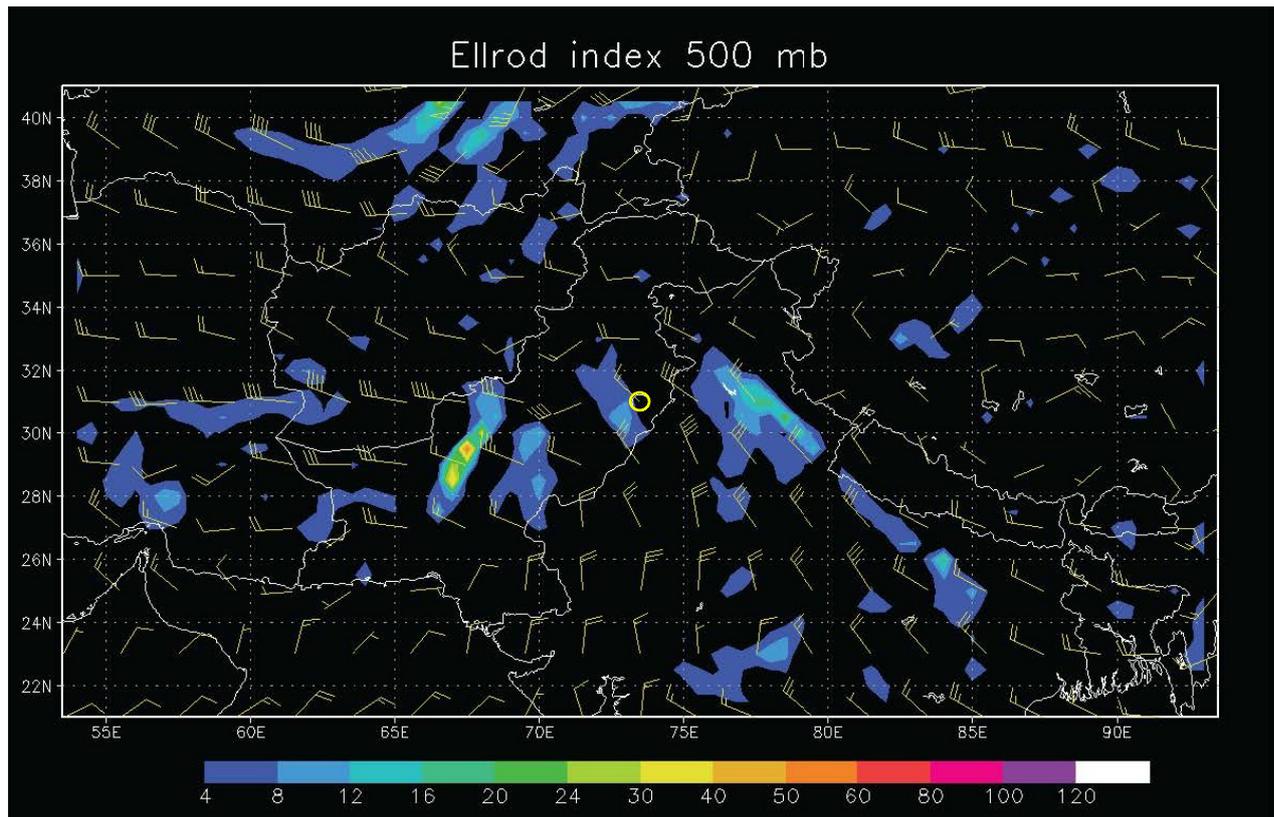
Figure 7 Atmospheric Physics

2.4.6. This is a short-range computer model forecast that depicts wind direction at speed at their incident time and altitude (the yellow wind barbs). Plotted in coloured blobs is a technique used to diagnose large scale turbulence. Large scale turbulence potential was not high, but this model cannot resolve thunderstorm-scale turbulence. Incident position is marked at the centre of the map with a small yellow circle. (Note: they were downwind of the thunderstorm cell.)

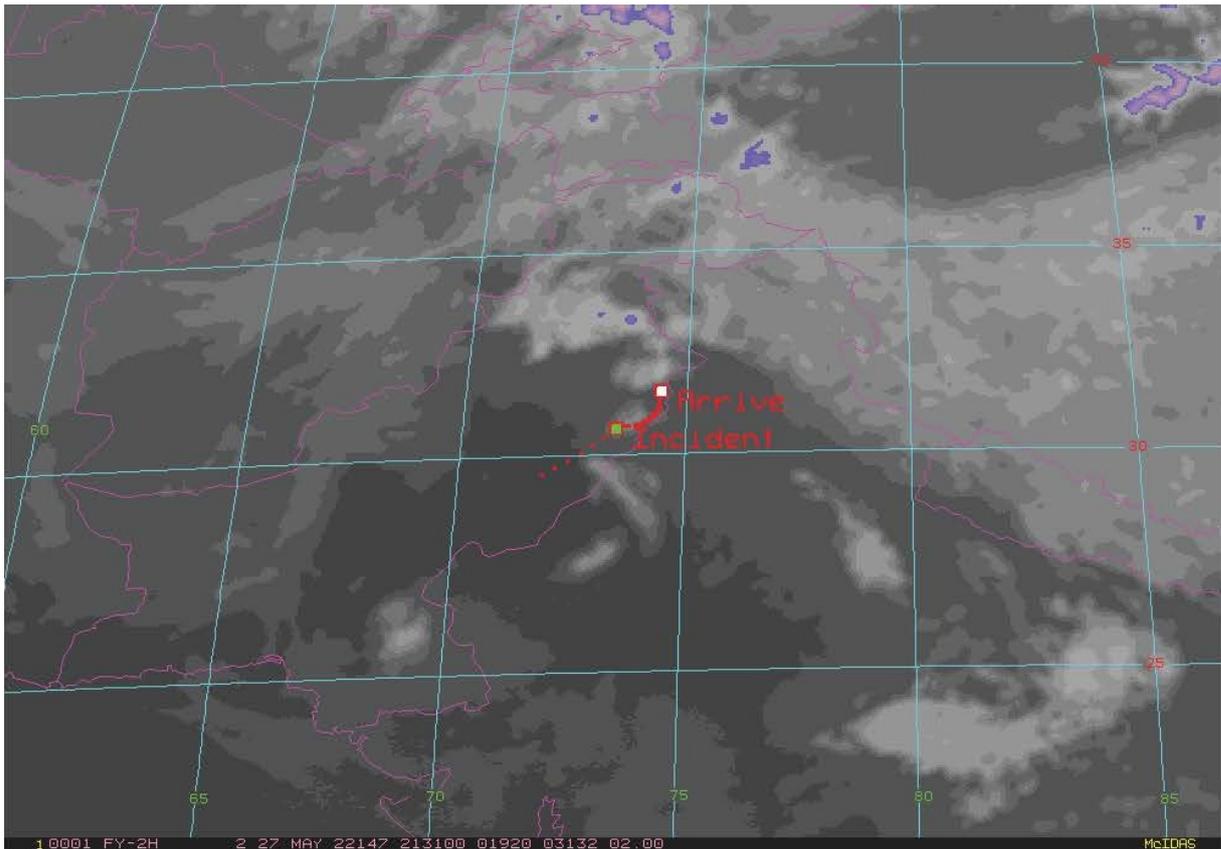
Figure 8 Satellite Image of Incident

2.4.9. This image was taken by a satellite at 2130Z. The red dots (or line where the dots are close together) are the track (from www.flightradar24.com). Coincidentally position data become significantly more frequent at the location of the incident. Bright white colours are associated with cold high cloud tops and stronger cells (gone by the incident time but present just before, see attached loop). At the incident time, a thunderstorm located ~50 NM north of the incident position had just dissipated or was in the final stages of dissipating. An attached loop of a few hours shows the dissipating trend. The aircraft flew through the outflow of this storm, with an outflow boundary probably marked by the small band of clouds at the incident position. These smaller clouds are usually benign.
