FINAL INVESTIGATION REPORT

**SERIOUS INCIDENT OF VISION AIR VIS-1104 (LHE – KHI)
BOEING 737-200 AIRCRAFT REG NO AP-BKE NO 1 ENGINE
FAILURE DURING INITIAL CLIMB ON 9 MAY 2016 AT
AIIAP, LAHORE**

Synopsis

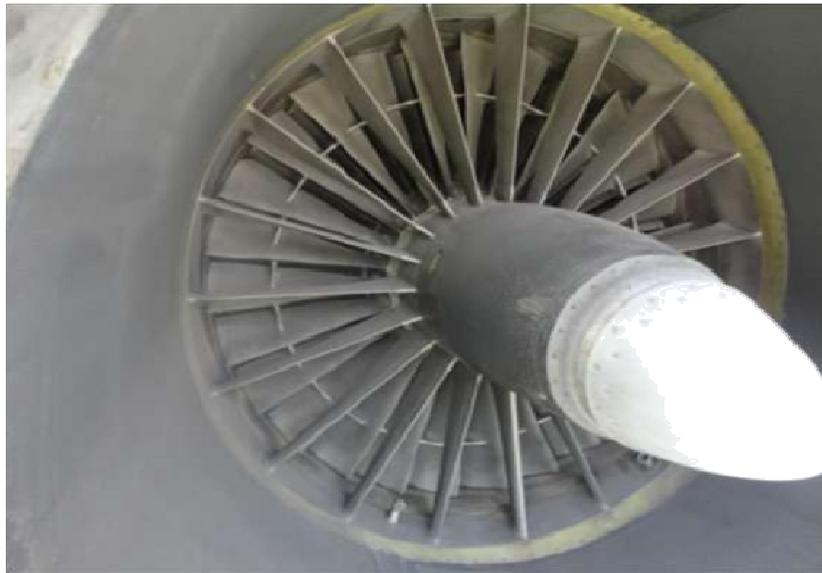
2.1 Post occurrence inspection of the inlet stage of engine compressor was thoroughly examined, however found no damage or any blood spots due bird strike as shown below :

Figure 3 : *First Stage / Inlet of No 1 Engine found clear*

- 3.2 Post occurrence inspection of the inlet stage of engine compressor was thoroughly examined, however found no damage or any blood spots due bird strike contrary to the documented discrepancy by the operator.

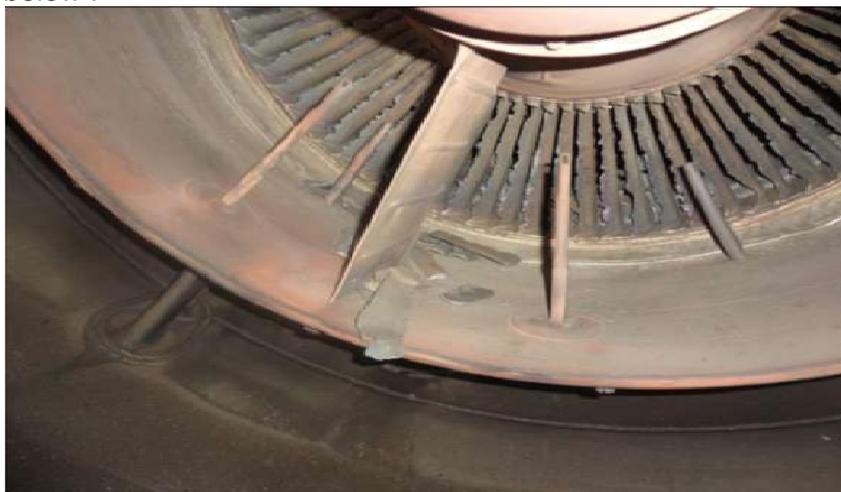
2.2 The blades of last stage of engine low pressure turbine were found damaged as shown below :

Figure 4 : *Visual inspection of the last Stage of No 1 Engine indicates damaged LPT blades and NGVs*

- 3.3 The blades of last stage of engine low pressure turbine were found damaged.
- 3.4 M/s Vision Air tried to dismantle the engine neither having any instructions from AAIB nor in possession of required tools, publications, jigs / fixtures, trained manpower and the infra-structure. The operator couldn't make any access to the failed hot section of the engine.

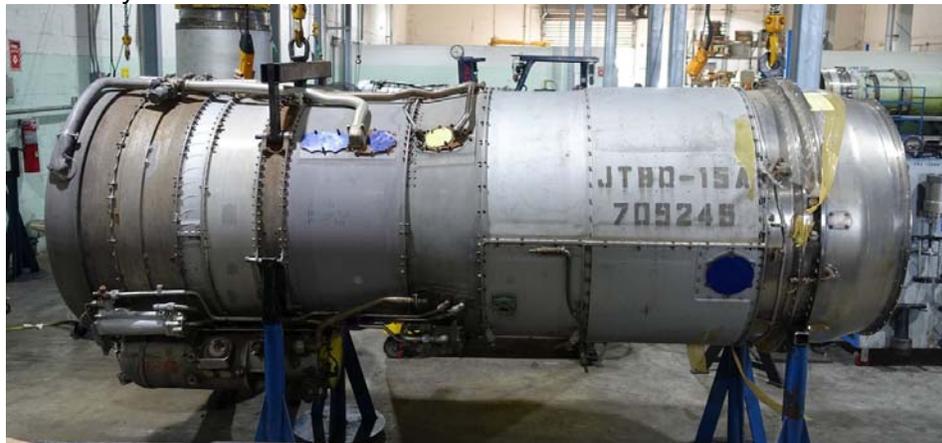
- 2.5 The engine was unwrapped and placed on pedestals prior to the investigation team's arrival (Photos 1, 2, and 3). There were no indications of an engine fire or radial uncontainment. The inlet guide vanes and visible fan blades were complete and in good condition. The inlet case to fan front case flange (flange B) bolts were removed and missing except for a few bolts that were installed to hold the case flange together. The exhaust case forward flange (K) was also missing most of the attaching hardware except for a few bolts. The exhaust case was rotated about 80 degrees in the counterclockwise direction. The fan / N1 spool was seized and could not be rotated by hand.

Photo 1 : Left Side of Engine, as Received

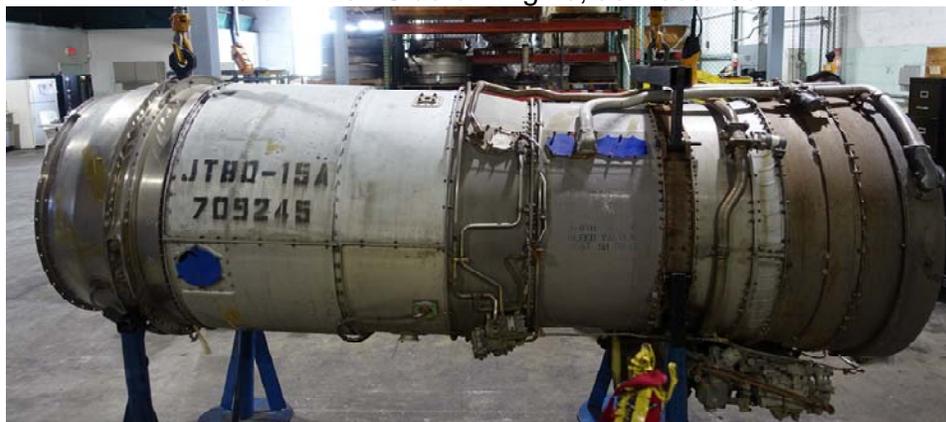
Photo 2 : Right Side of Engine, as Received

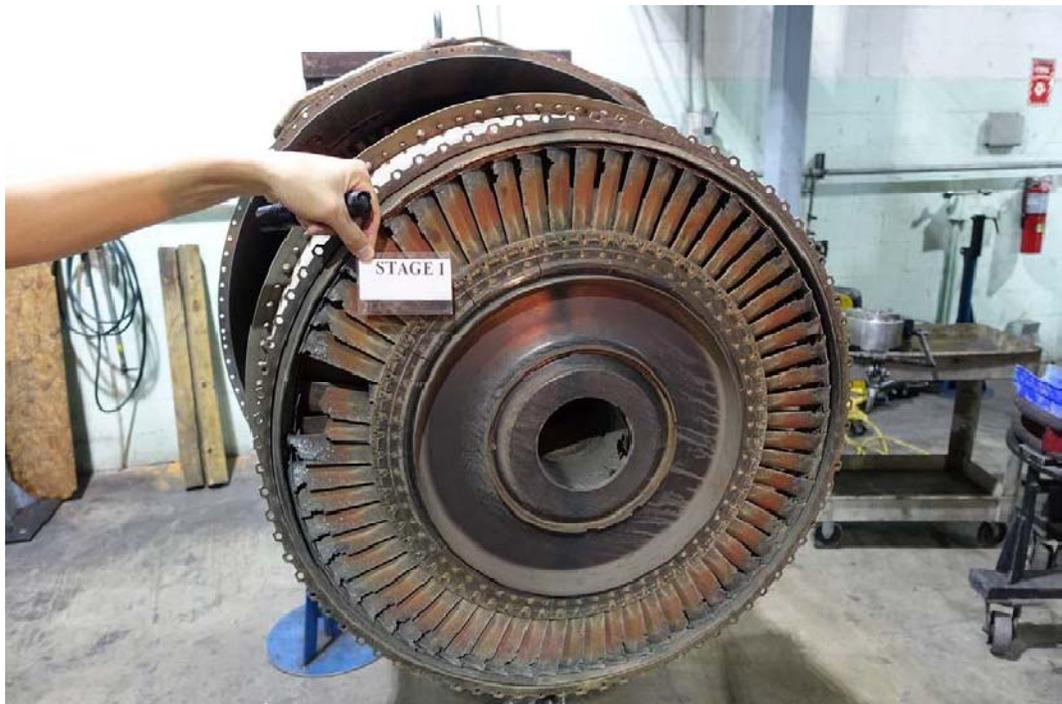
- 2.8 No anomaly was found inside the compressor (LPC / HPC) as well as the combustion chamber areas.
- 2.9 The stripping of high pressure turbine revealed that one first stage HPT (T1) blade was fractured and separated at the blade platform and two adjacent blades were fractured and separated at the mid-span (Photo 3). The outer diameter platform of three additional blades were also fractured and separated. All T1 blades exhibited trailing edge impact damage including material tearing along the blade span, most concentrated near the blade tips. Eight T1 blades exhibited minor leading edge impact damage (small nicks) near the outer diameter platform (Photo 4). The first stage stator / nozzle guide vanes (S1) were all complete with no indications of thermal or impact damage. All these Qty-11 blades were removed and shipped to Pratt & Whitney Materials Process Engineering for analysis.

Photo 3- First Stage HPT Rotor, Aft Side

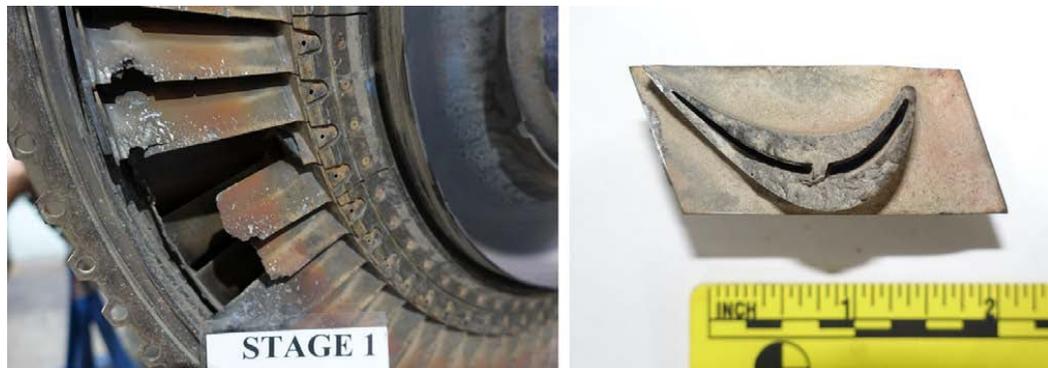
Photo 4- (L) Separated First Stage HPT Blades, (R) Fracture Surface

- 3.13 **Cause of Occurrence.** The engine in-flight shut down took place due to premature failure of one of the 1st stage HPT blade fracture due to fatigue originating from the airfoil trailing edge.

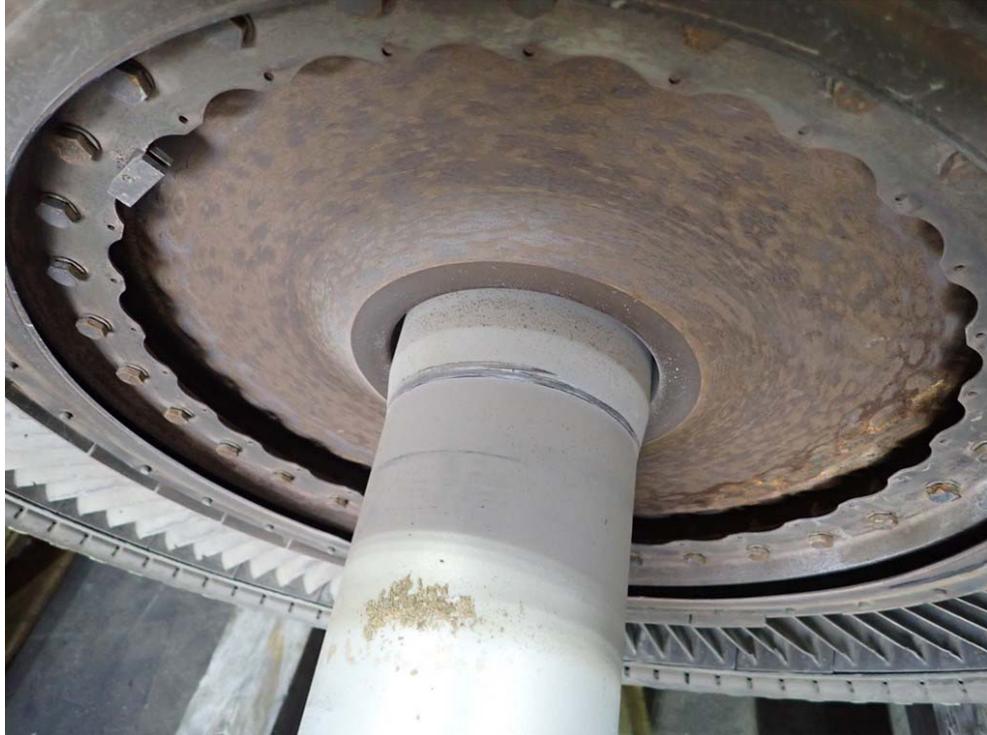
- 2.10 On the last stage of the engine i.e. LPT the N1 shaft exhibited a 360 degree circumferential rub axially coincident with end of the N2 shaft / HPT (Photo 5). Due to LPT case deformation, the LPT could not be disassembled into stages without

Photo 5- N1 Shaft Rub

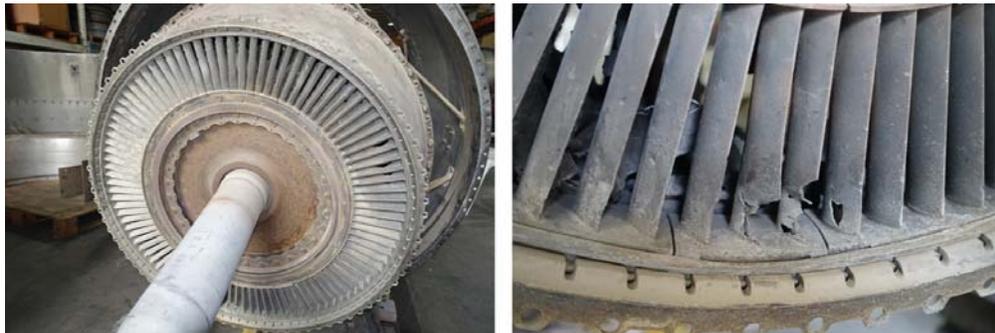
cutting the case. Visual observations of damage were made as viewed aft through the second stage LPT stator vanes (S2) and forward through the fourth stage stator vanes (S4). The S2 vanes were all present and complete. Three consecutive S2 vanes at the 9 o'clock position (6 o'clock position as received) had leading edge damage near the outer diameter platform and the remaining S2 vanes had minor leading edge airfoil damage (Photo 6). All S2 vane had severe trailing edge impact damage and material loss along the vane span.

Photo 6- (L) S2 LPT Vanes, Leading Edge (R) S2 Vane Damage, 9 o'clock

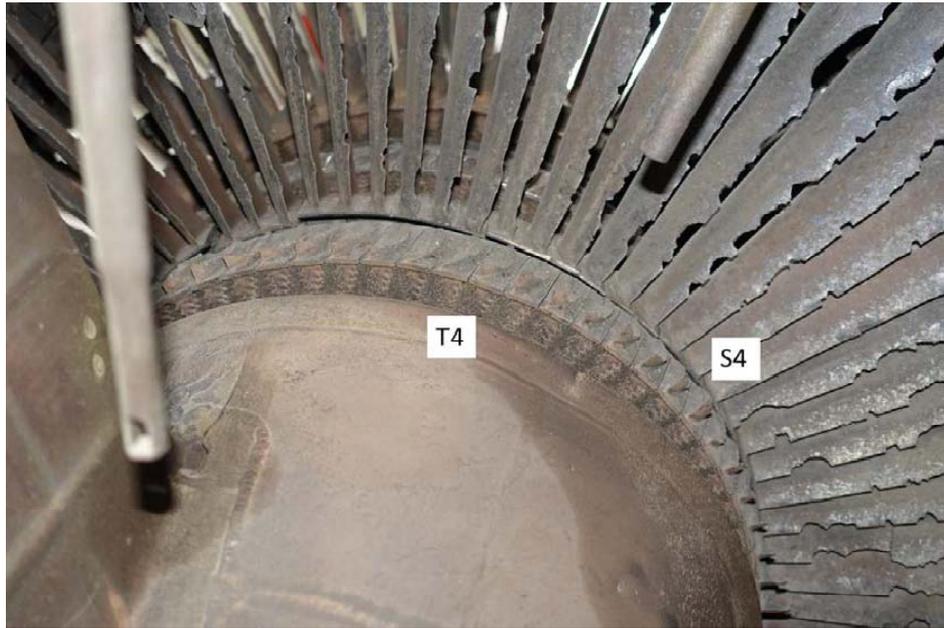
- 2.11 The second stage LPT rotor blades (T2) were all separated at random airfoil span wise locations between the blade platform and the mid-span. The third stage LPT stator vanes (S3) were all fractured and separated, the inner and outer diameter vane platforms remained in place. The third stage LPT rotor blades (T3) were all separated near the blade platform. The fourth stage LPT stator (S4) vanes were present and complete but had severe impact damage on both the leading and trailing edges along the entire vane span. The fourth stage LPT rotor blades (T4) were all separated near the blade platform (Photo 7). Loose metal fragments were resting at the 6 o'clock position between the LPT stages.

Photo 7- 4th Stage LPT Rotor Blades and Stator Vanes

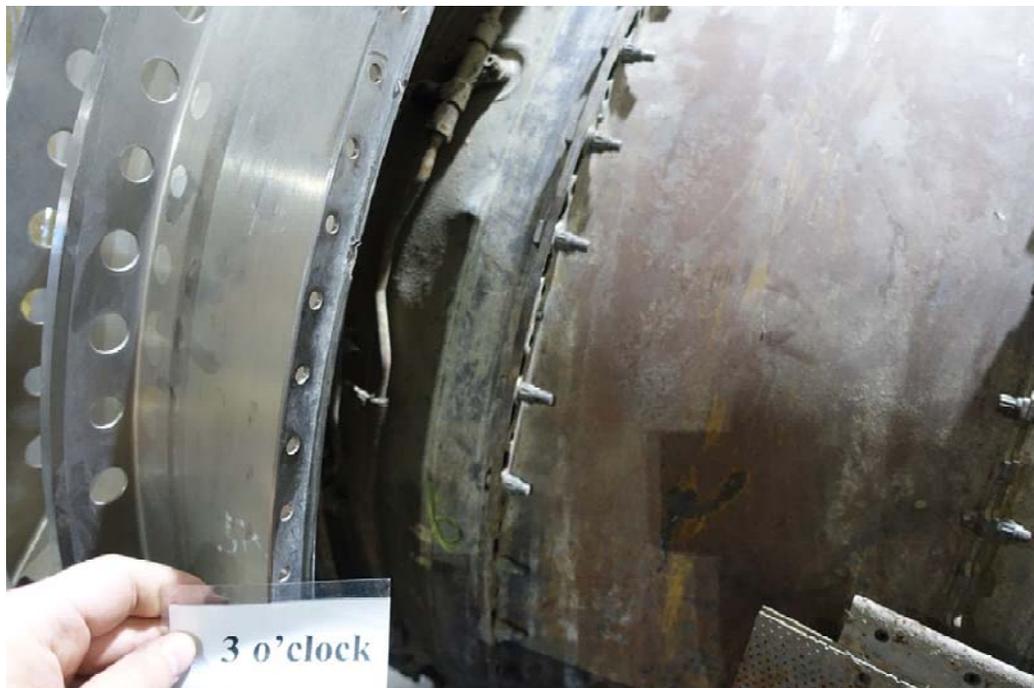
2.12 The LPT case had evidence of internal impact damage resulting in minor deformations directed radially outboard from the engine axis, in line with the T2 and T3 planes of rotation that could be felt tactilely on the case exterior surface. The exhaust case had larger, visible impact deformations radially outboard from the engine axis in line with the T4 plane of rotation (Photo 8). The exhaust case struts exhibited impact damage on the leading edge. All exhaust gas temperature (EGT) probes were intact with minor impact damage.

Photo 8- Exhaust Case Impact Deformation

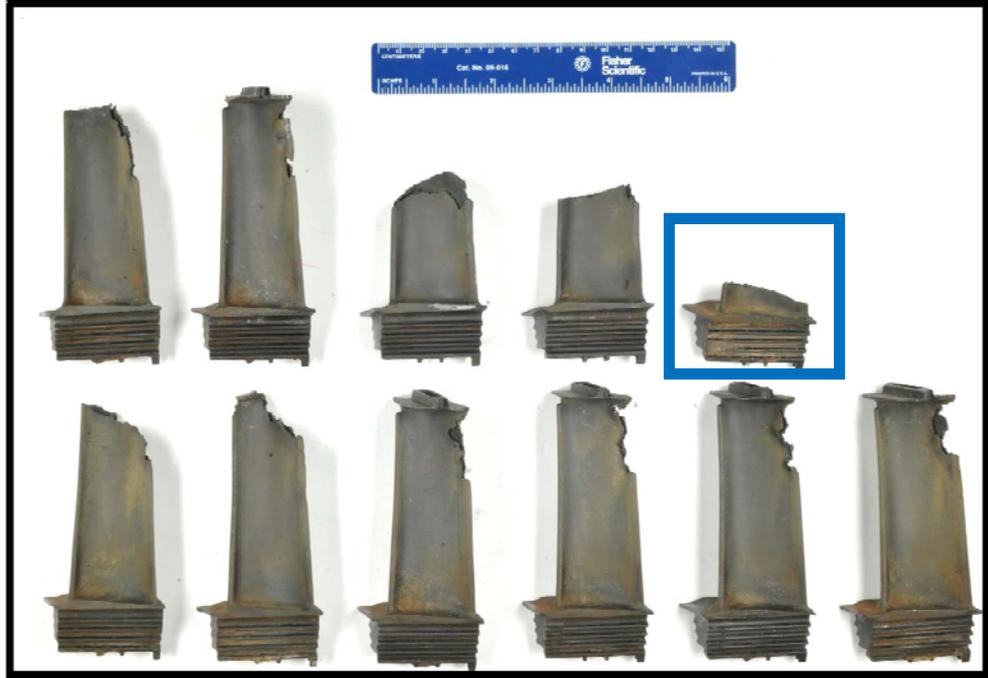
compartment. The No. 6 bearing scavenge pump was missing. During the above strip examination process, 11 HPT blades were isolated to be suspected cause of the engine failure. Accordingly, these 11 HPT blades were examined at the Material Processes Engineering (MPE) facility of the OEM Pratt & Whitney, USA where detailed material testing of these HPT blades was accomplished followed by generating a forensic report. Top image shows the pressure side of the eleven 1st stage HPT blades, while the bottom image shows the suction side. The blue box indicates the blade found to have fatigue on its fracture surface.

Photo 9- HPT Blades (Inner side view)

- 2.14 Eight (8) of the blades had sustained impact damage near the blade tip and outboard half of the trailing edge. Two (2) HPT blades were found to have fractured at ~65% span via overstress. The remaining blade had fractured at ~10% span, and exhibited a fatigue progression immediately adjacent coarse textured region near the trailing edge. The fatigue origin was located on the suction side of the blade, ~0.040" from the trailing edge. The fatigue progression was too severely oxidized to determine if it was high cycle fatigue or low cycle fatigue. Metallurgical examination of the coarse textured region revealed multiple oxide filled cracks that were connected to the fracture surface. Metallurgical examination of the origin area revealed **trans-granular features** consistent with fatigue. The microstructure and chemical composition of the blade were consistent with properly processed Mar-M-247 nickel alloy. The blade coatings were found to be acceptable, and no alloy depletion, sulfidation, inclusions or other material anomalies were observed.

- 2.15 Based on the abovementioned two activities i.e. strip examination and material testing on the eight HPT blades revealed that the entire sequence of events started with a fatigue on one of the HPT blades and rest all damages were consequence of the same. Due to severe oxidation on the HPT blade surface, the OEM couldn't determine if it was high cycle fatigue or low cycle fatigue.

- 4.1 The OEM, M/s P&W, USA is requested to re-visit her already in place preventive measures and incorporate additional step(s) to avoid such failures to further improve the reliability of JT8D engines.
- 4.2 It took more than two years that the operator was able to ship the failed engine to the intended MRO facility in USA. All the presented reasons by the operator were found to be avoidable. In order to avoid such un-precedent delays, CAA Pakistan is requested to issue following specific instructions to M/s Vision Air :
 - 4.2.1 Institute measures to avoid documenting incorrect discrepancies in the aircraft documents.
 - 4.2.2 The aircraft parts / engine involved in an accident or serious incident are adequately preserved and must not be tempered.
 - 4.2.3 The instructions issued by AAIB regarding handling of the aircraft components / engine must be adhered in letter and spirit.

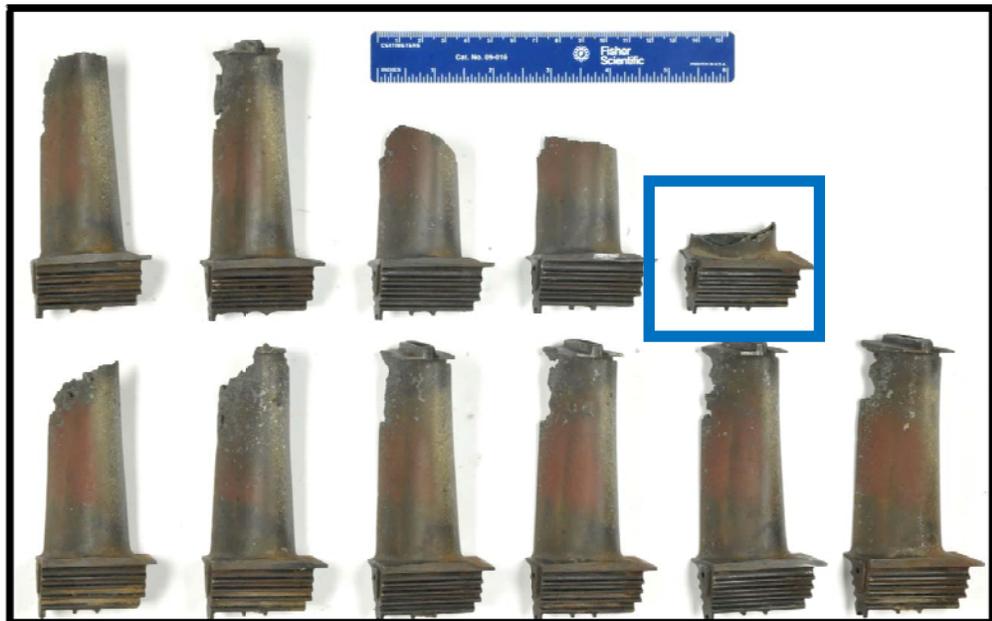
Photo 10- HPT Blades (Outer side view)
