FINAL INVESTIGATION REPORT

**INCIDENT OF PIAC FLIGHT PK-755 (SIALKOT TO RIYADH) A320-200
REG NO AP-BLU FIRE WX IN THE AFT CARGO COMPARTMENT
DATED 11 OCTOBER 2017**

FINAL REPORT

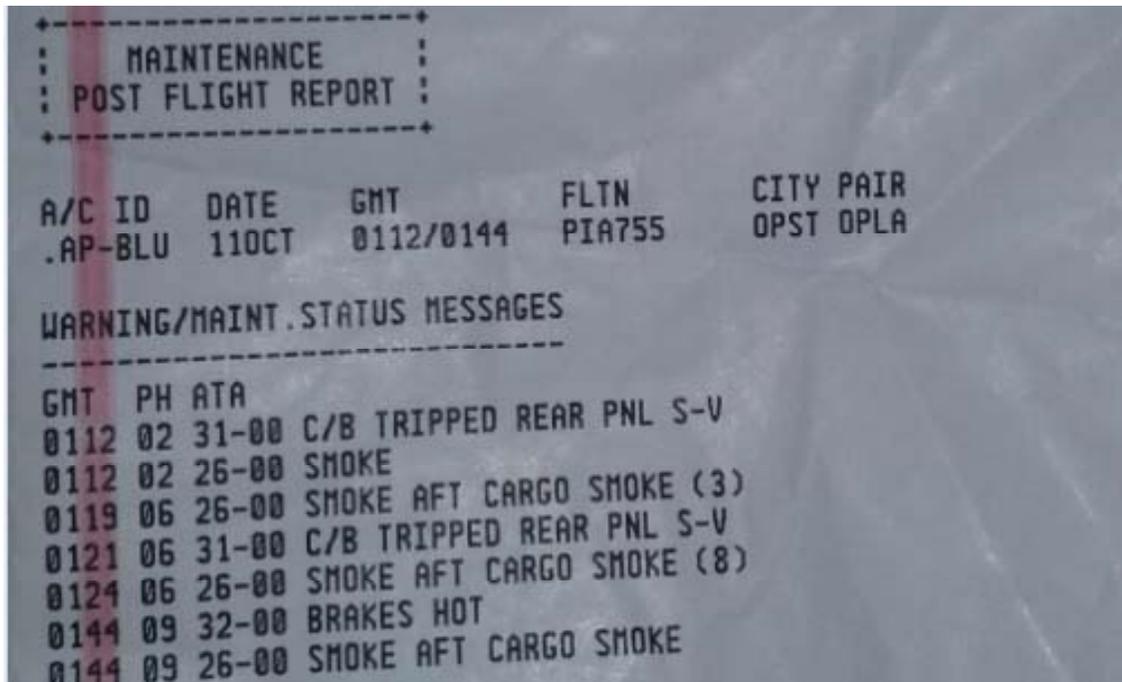
- 2.1. On arrival at Lahore no evidence of any fire, smoke or overheat was found inside the cargo area. Cargo fire bottle was found to be operated and discharged.
- 2.2. The Post Flight Report (PFR) generated by ECAM pertaining to this occurrence is as follows :-

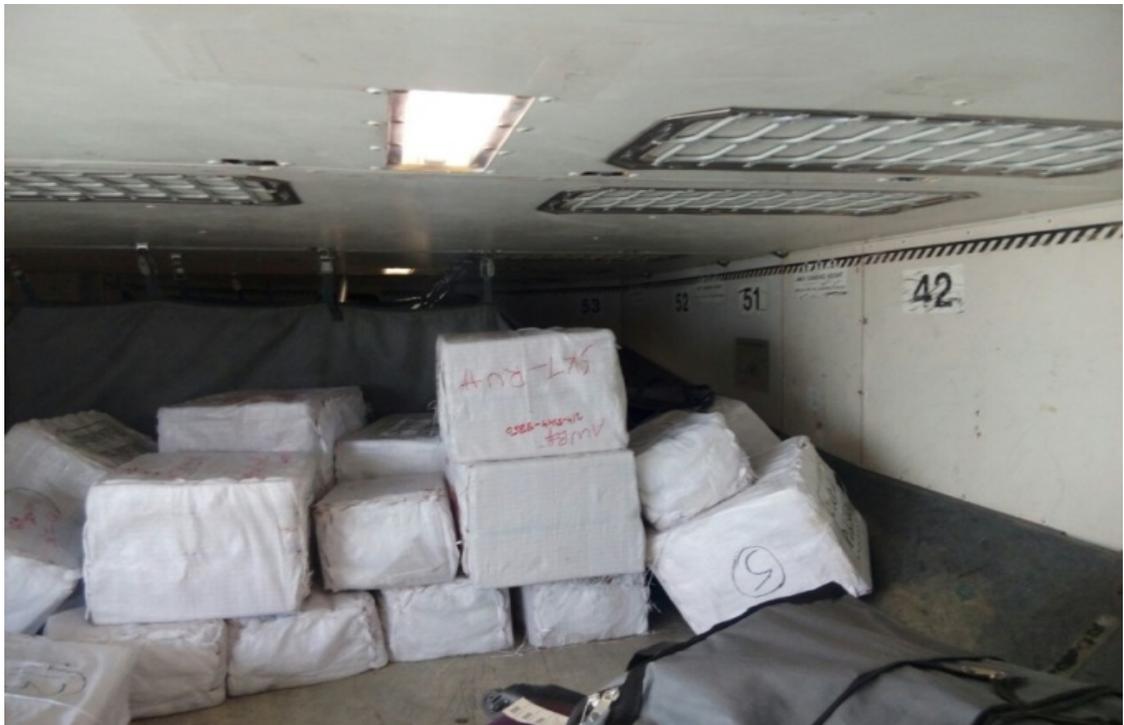
- 2.13.8 Ingestion of engine cleaning agent into the ECS.
- 2.14. During this flight, 444 Kg cargo of horse bridle (a chemically treated item) was placed in rear cargo compartment. Such chemically treated goods (if not adequately packed) can contaminate the environment surrounding the smoke sensors installed in the cargo compartments. During this flight, the mentioned horse bridle was packed as shown below :-

- 3.1.5 In the rear cargo compartment, 444 Kg of chemically treated horse bridle was loaded. Possibly an in-adequate packing / wrapping of such a stuff may have polluted the environment surrounding the fire sensors installed in aft cargo compartment.

- 3.2.1 Loading / placing of the chemically treated leather goods in the AFT Cargo compartment with a possible in-adequate packing.
 - 3.2.2 HI-LIFE of the smoke detectors before getting due for an overhaul / cleaning.

- 4.1 In view of the environmental / technical aspects that increase the susceptibility of spurious warning, a proactive safety oversight mechanism may be devised by PIAC to improve the maintenance troubleshooting.
- 4.2 The packing of all cargo may thoroughly be inspected / verified by PIAC for its adequacy in light of Airbus ISI #26.10.00007.
