# FINAL INVESTIGATION REPORT

**SERIOUS INCIDENT OF PIAC FLIGHT PK-390 (KARACHI TO SUKKUR)  
ATR72-500 REG NO AP-BKY ENGINE SHUTDOWN ON LINE UP AT  
JIAP KARACHI ON 4 SEPTEMBER 2017**

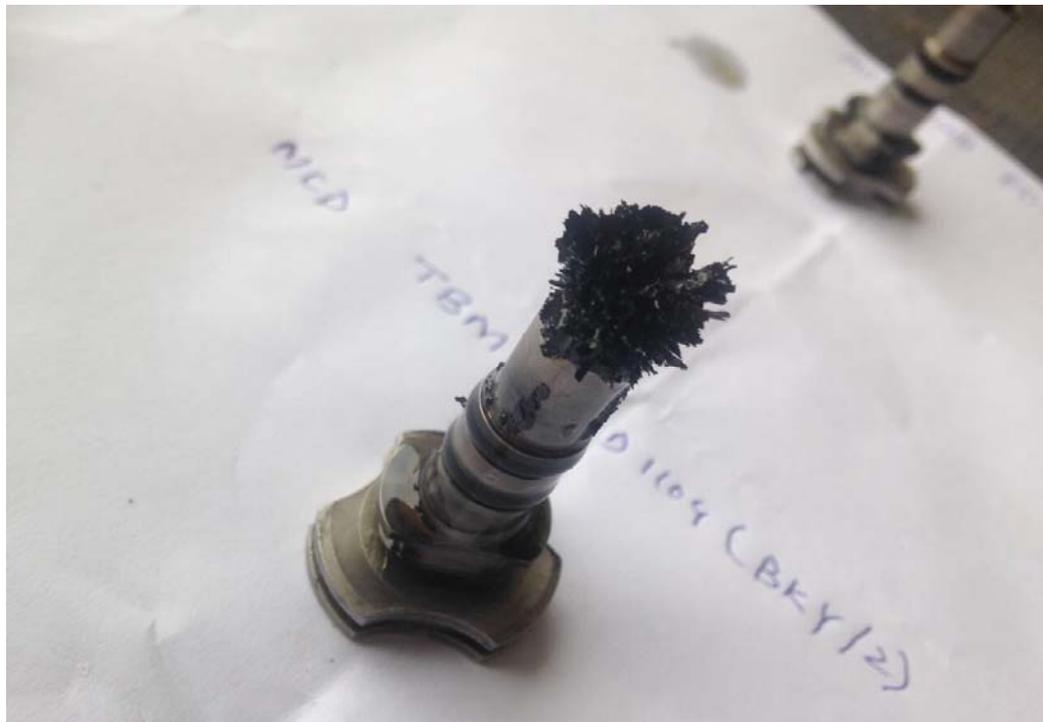
2.1.3 The aircraft recent history revealed that on 03 September 2017 (on the night prior to this occurrence), a defect of “Pressure Filter by-pass Indicator Popped Out” was reported. This by-pass indicator is provided in the assembly of Oil filter and it pops out if the filter element gets clogged.

2.1.4 This previously reported defect of “Pressure Filter by-pass Indicator Popped Out” was cleared by replacing the filter element. In this maintenance activity, instructions given in the maintenance manual PW MM 72-0-05 fault isolation-2, Table-101, Fig-111 weren’t adhered and missed out an essentially required activity of inspecting the Metal Chip Detector (MCD).

2.1.5 PIAC in its preliminary report acknowledged this omission.

2.1.6 The aircraft was released to service with the aforementioned un-safe airworthiness status. Consequently, the engine failed after taxi out.

3.1.3 After reporting of the defect PIAC Engineering replaced the filter element without checking the MCD of Turbo-machinery contrary to the instructions given in the maintenance manual.

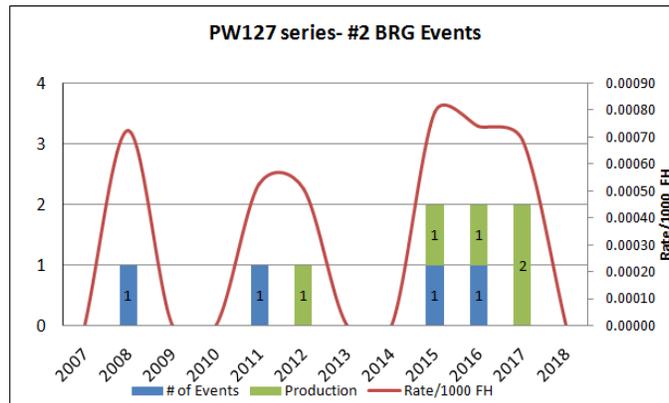
## PW127 series #2 bearing events

2.1.10.2 The industry data reveals that between 2007 and 2018, the event rate for No 2 bearing distress has been found to be 1 event per 2.58 million hours. The damaged condition of the bearings in the events to date has been such that root cause of the bearings distress has yet to be formally identified.

Event rate for 2007-2018 period 1 per 2.58MHRS

Extensive damage to the bearing is preventing P&WC to formerly identify root case of the bearing distress

P&WC currently monitoring the fleet

- 4.1 The OEM (Pratt & Whitney, Canada) is recommended to accelerate their efforts for identifying the intrinsic reason(s) leading to failure of No 2 bearing and make required improvement(s) with an aim to improve the engine reliability / safety.
- 4.2 PIAC is required to carry out refresher training of its maintenance engineers and technicians with a special emphasis on adequate troubleshooting of the reported defects as per guidelines given in the maintenance manuals.
