FINAL INVESTIGATION REPORT

**ACCIDENT OF M/S SHAHEEN AIR FLYING TRAINING
SCHOOL CESSNA-162 AIRCRAFT, REG # AP-ZBQ ON
24TH FEBRUARY, 2017 AT FAISALABAD**

ACCIDENT OF M/S SHAHEEN AIR FLYING TRAINING SCHOOL CESSNA-162 AIRCRAFT, REG # AP-ZBQ ON 24TH FEBRUARY, 2017 AT FAISALABAD

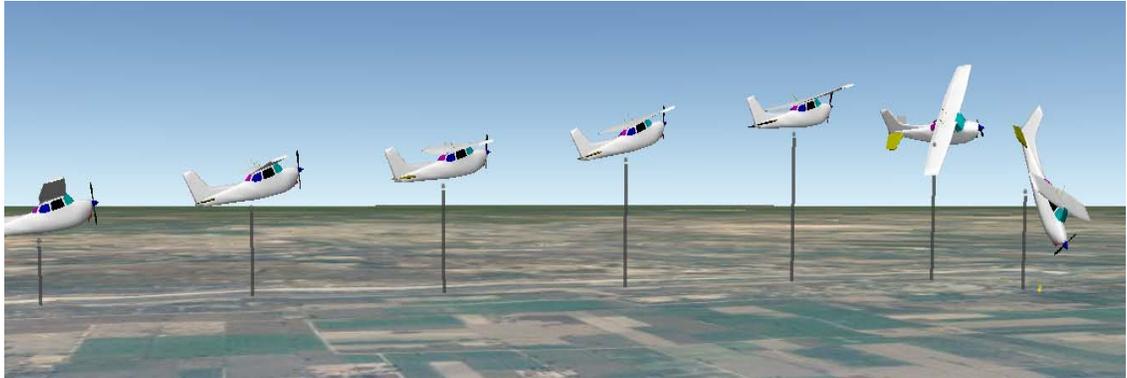
2.1.18 During this abnormal engine behaviour the aircraft was initially observed to gradually pitch down along with a little roll of 3 to 4 degree left. When the engine developed sudden and sharp drop in its parameters, the aircraft was observed to reverse its roll from left to right side all the time increasing to 87 degree and nose pitch down to 43 degree and beyond.

2.1.22 The aircraft attitude / flight path during entire emergency situation is pictorially depicted below :-

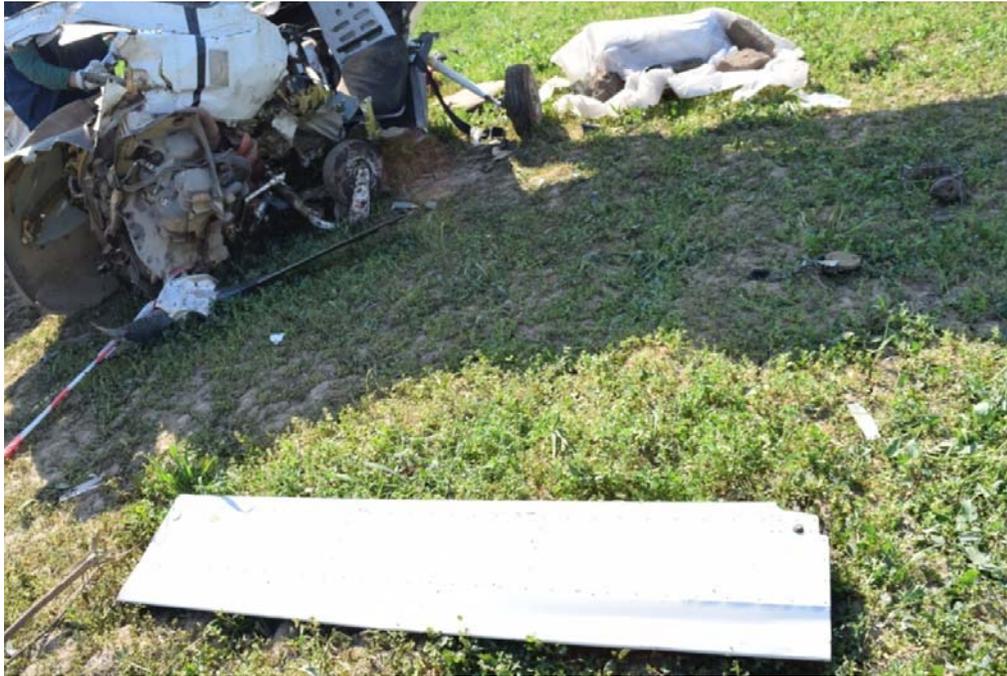
2.2.3 **Structural Integrity of the Aircraft / Flight Controls.** Entire wreckage of the aircraft was confined to a limited area and all four corners of the aircraft were well accounted. Since, it was a short duration lift off, the entire track of the aircraft was scanned for any lost structure prior to the crash site, however, nothing was found. Moreover, the flight parameters analysis also revealed nothing un-usual that could have been recorded especially due to an in-advertant loss of any lift generating or flight control surfaces etc. Therefore, crash of the aircraft due lost structural integrity has been ruled out. All primary and secondary flight surfaces were intact. Left aileron was detached and lying under the left wing, however, it was due to aircraft impact with the ground. Rest of the left wing and left flap was intact.

Fig. Detached Left Aileron lying under the Wing

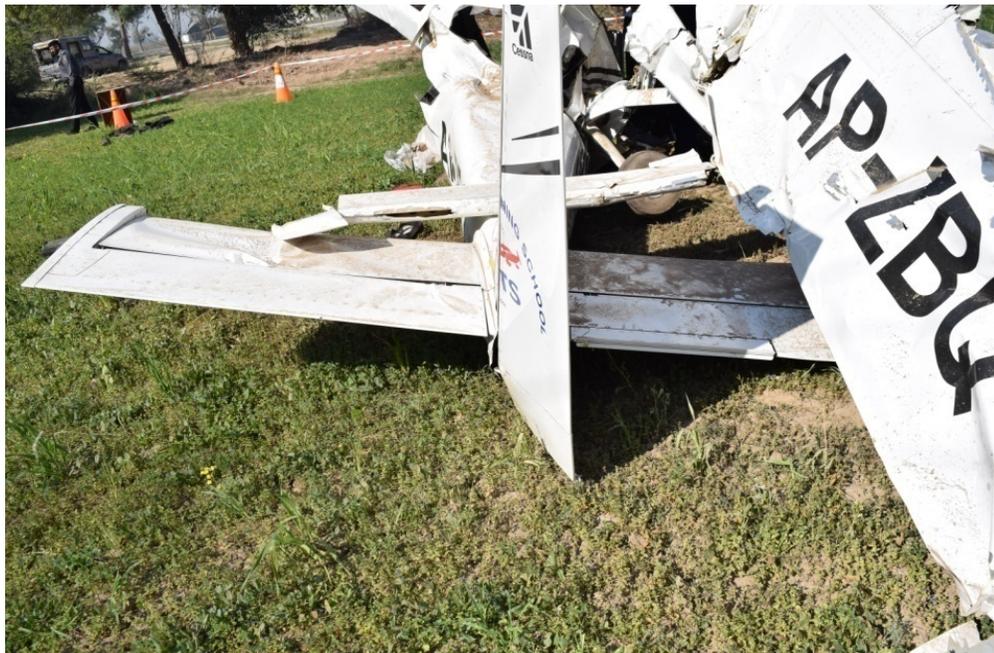
2.2.3.1 Right wing was badly damaged beside aircraft nose as it seems to have hit the ground first. Tail section of the aircraft was in good shape and so were the horizontal stabilizers and the rudder.

Fig. Tail section of the aircraft and badly damaged right wing

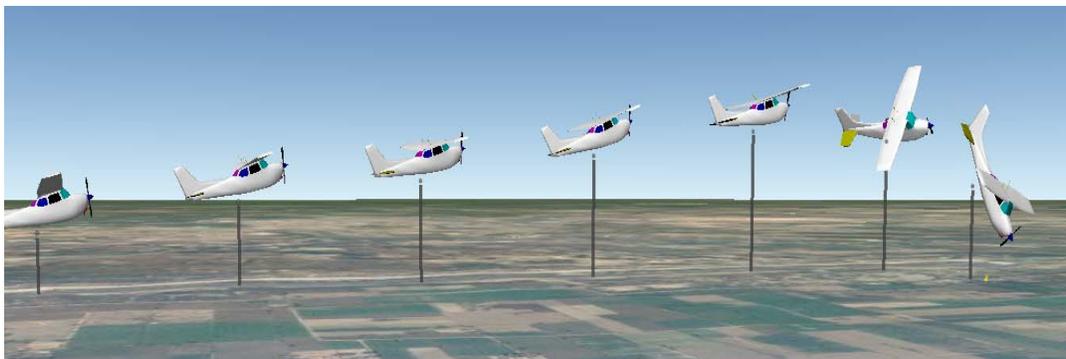
3.1.17 During this abnormal engine behaviour the aircraft was initially observed to gradually pitch down along with a little roll of 3 to 4 degree left. When the engine developed sudden and sharp drop in its parameters, the aircraft was observed to reverse its roll from left to right side all the time increasing to 87 degree and nose pitch down to 43 degree and beyond. There was no communication between aircraft and ATC during entire this event till aircraft impacted ground.

3.1.21 The aircraft attitude / flight path during entire emergency situation is pictorially depicted below :-
