FINAL INVESTIGATION REPORT

**SERIOUS INCIDENT OF PIAC FLIGHT PK-369 (ISB TO KHI) A320-200
AIRCRAFT REG NO AP-BLV CABIN PRESSURE LOST FOLLOWED
BY OXYGEN MASKS DROPPING : DATED 18 OCTOBER 2017**

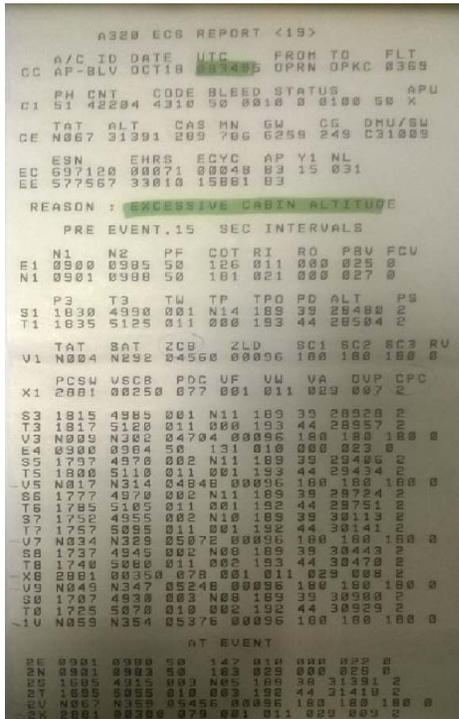
Figure 2 : 1st report - Cabin Excess ALT

- 2.1.10 The three reports were generated due to ‘Excess cabin attitude’ warning which appeared thrice. During first two warnings, all relevant parameters were well within range. But during third warning, an abnormal gradual rise in Cabin Vertical Speed (V/S) was noticed.
- 2.1.11 The fourth report was generated as ΔP had crossed its safety limits of 8.5 psi and as a result, safety valve had opened automatically to avoid aircraft structural damage.
- 2.1.12 During this complete scenario, CPC # 2 was in control of the auto pressurization. Neither CPC # 1 was switched automatically nor manually by crew for auto control. Furthermore, no manual control was obtained by the cockpit crew. The “MAN” push button switch was pushed / exercised 4 to 5 times with a delay of 1 sec.

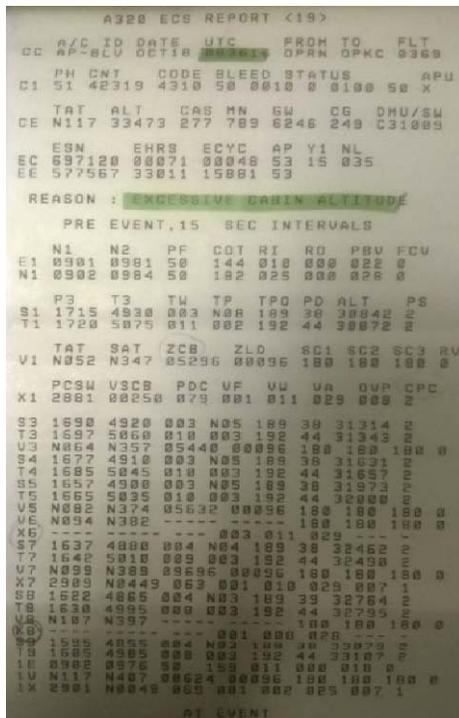
Figure 4 : 3rd Report - Cabin Excess ALT

- 2.1.15 As per available reports, during first two warnings parameters of both the cabin altitude and cabin vertical speed were within normal range. But during, third warning an abnormal gradual rise in “Cabin Vertical Speed (V/S)” was noticed, from 850 ft/sec till 4200 ft/sec.

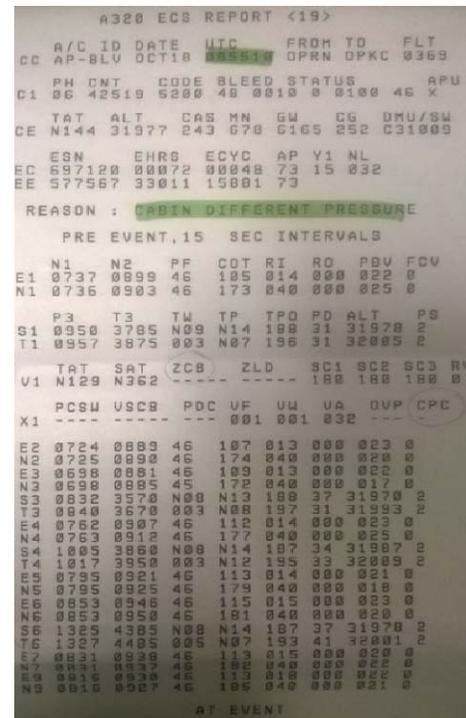
Figure 5 : 4th Report - Cabin DIFF PRESS

- 2.1.17 During third warning, after approx 4 minutes since first warning, purser informed the crew that Oxygen masks had dropped.
- 2.1.18 17 minutes since crew took manual control of pressurization, the ΔP (Cabin differential pressure) had crossed its safety limits of 8.5 psi and a cabin altitude increased more than 14,000 ft, consequentially as per design, the safety valve was operated on auto to avoid damage of aircraft structure. A more detailed analysis on Pilots’ actions has been covered in the operational analysis.
