FINAL INVESTIGATION REPORT

**SERIOUS INCIDENT OF PIA FLIGHT PK-311 (QUETTA TO KARACHI)
ATR 42-500 REG NO AP-BHM NO 1 ENGINE IN-FLIGHT SHUT DOWN
DURING FINAL APPROACH AT JIAP KARACHI ON 09-06-2017**

SERIOUS INCIDENT OF M/S. PIAC FLIGHT PK-311 (SECTOR UET – KHI) ATR42-500 REG NO AP-BHM AT JIAP KARACHI ON 09-06-2017

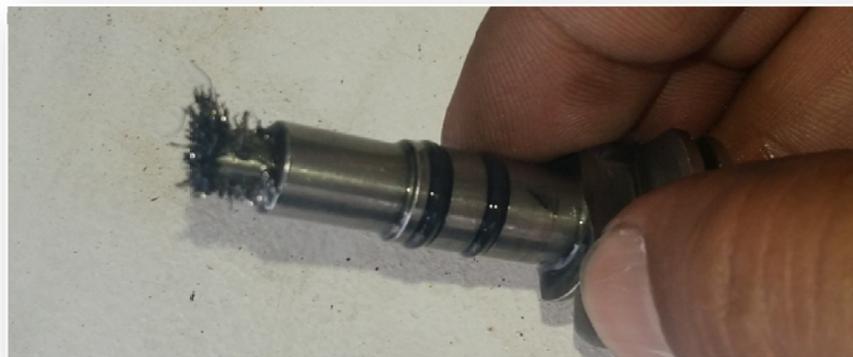
- 2.5 Engine No1 Inlet and exhaust were checked, found no abnormality.
- 2.6 The Magnetic Chip Detector (MCD) of Turbo-machinery was found with metal particles as shown below:

- 3.1.1 The Magnetic Chip Detector (MCD) of Turbo-machinery was found with heavy metal particles once checked after the incident.
 - 3.1.2 The tear down examination and investigation at the OEM premises revealed that the engine shut down process was due to failure of No 30 bearing installed on the tower shaft inside AGB.

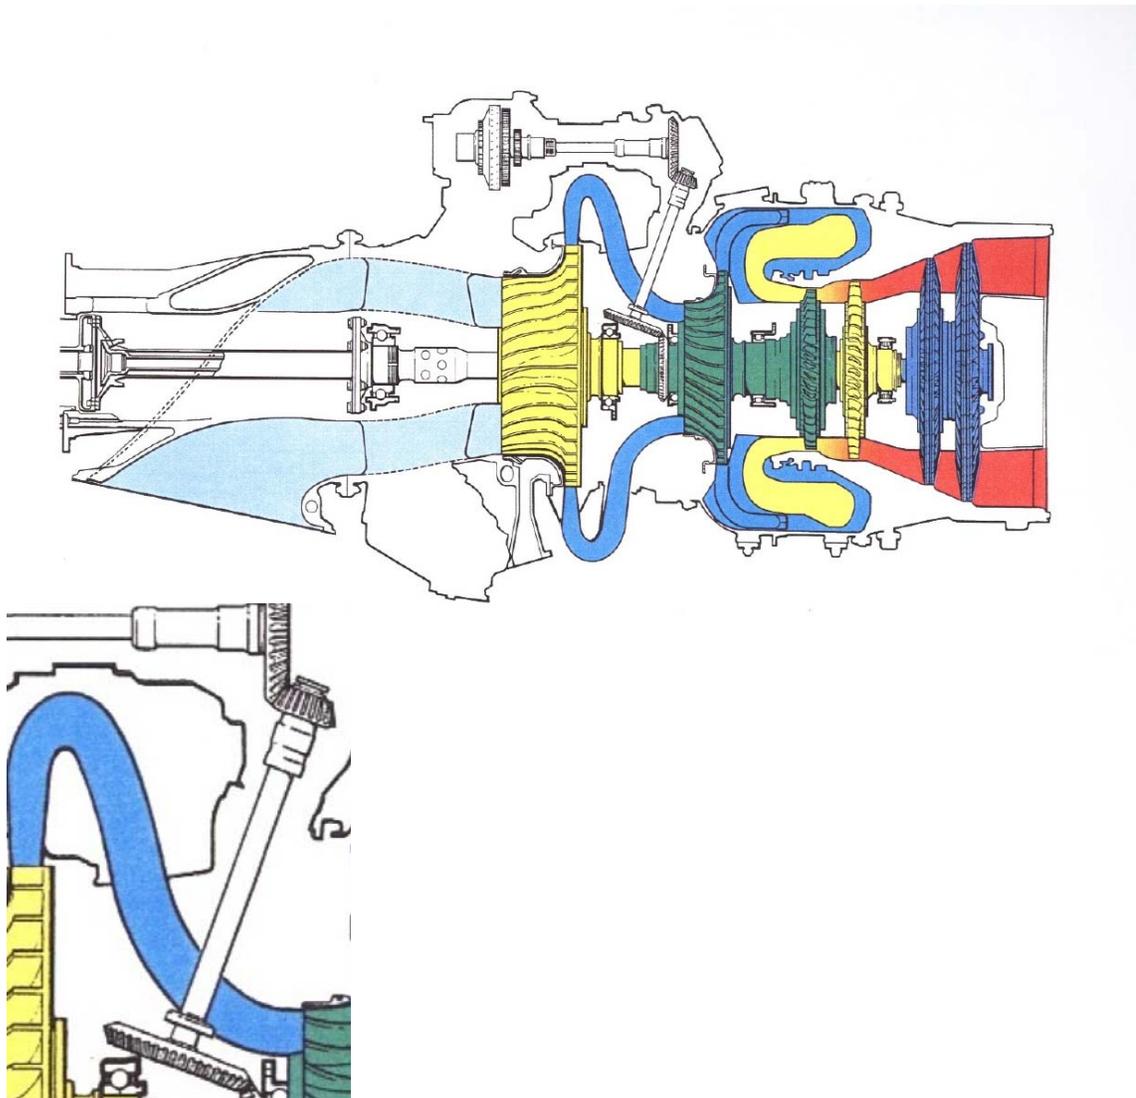
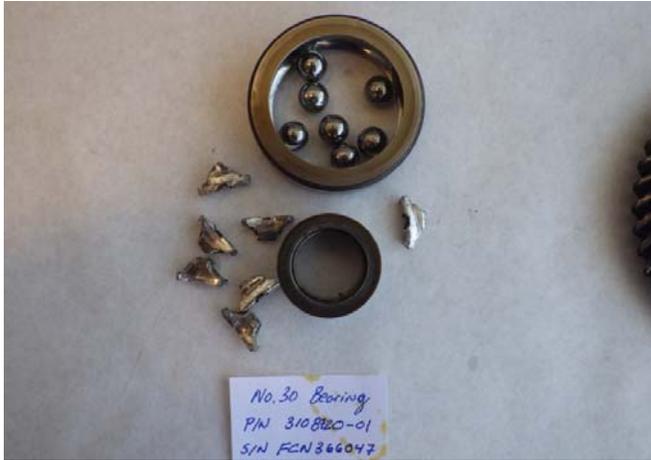
- 2.7 Abnormal sound and irregular movement of the Accessory Gear Box (AGB) was observed in Engine No 1. In order to avoid any damage to the evidence, the initial investigation at Karachi was stopped and the engine was sent to the OEM for a detailed tear down examination and investigation.
- 2.8 Pratt & Whitney Canada conducted the tear down examination in the presence of representatives from SIB Pakistan and Transport Safety Board Canada.
- 2.9 During tear down examination of the engine, it was established that the event was a result of failure of No. 30 bearing which is installed on tower shaft of Accessory Gear Box (AGB). Owing to this failure, drive from the engine was lost which lead to IFSD due stopping of all driven components (Oil & Fuel Pumps etc).

2.10 The failed No 30 bearing was sent to the Engineering Lab of TSB for a failure mode analysis which concluded that :

“The bearing failed due to bearing cage cracking. The mode of failure of the cage could not be determined due to the extensive rubbing damage observed on the fracture surfaces and the rivets”

- 3.2 **Cause of the Occurrence.** The occurrence was caused due to failure of No 30 Bearing of the engine however the exact cause of No 30 Bearing failure couldn't be established due to excessive damage.

- 4.1 The OEM (Pratt & Whitney Canada) is recommended to accelerate their already initiated efforts to re-design / re-shape the Tower Shaft and its bearings so as to eliminate the chances of failures triggering from this area.

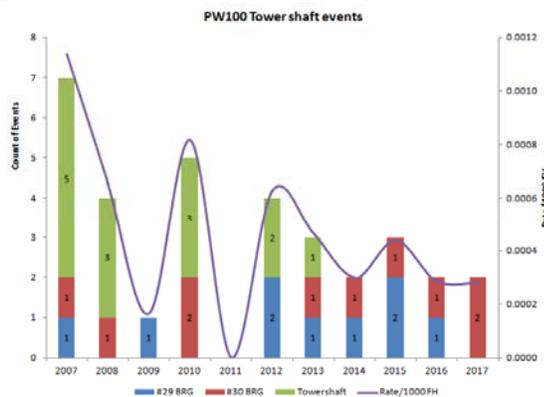
FIELD EXPERIENCE

Design and distress mode of the tower shaft components are consider similar across platform and all PW100. All Small, medium, Large) are included in this review.

10 year review revealed 34* tower shaft deterioration events

7 unscheduled removal following MIO
26 low oil pressure resulting in IFSD

Last 10 year rate for Towershaft "area"
0.0005/1000hrs considering 70.8MHRS

#29 bearing 1 event per 7.9MHRS
#30 bearing 1 event per 7.1MHRS
shaft 1 Event per 4.7MHRS

Cumulative rate of 1 event per 2.15MHRS

IFSD Overall rate = 1event per 2.2MHRS

2.13 The above data for the period 2007 ~ 2017 reveals that there have been failure cases related to tower shaft and its two bearings (No 29 & No 30 bearings). There's overall a decreasing trend of such failures on the entire fleet. Based on the above failures, the OEM (Pratt & Whitney Canada) is already working on re-designing / modification of the tower shaft and bearing No 29. These modifications

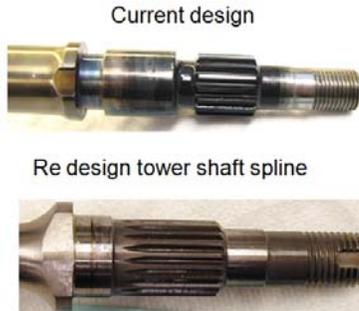
DESIGN IMPROVEMENT

In a pursue to improve Towershaft area, changes are made to prevent similar deterioration mode. hardware testing and validation currently ongoing.

Modification highlight;

- Tower shaft;
 - incorporate new spline layout
 - Improved wear resistance
 - improve fit and hardness
 - improved #29 bearing inner race hardness
 - increase assembly load
- #29 bearing
 - increase roller and cage size
 - increase tolerances for better roller stability
 - minimise damage induce assembly risk
