FINAL INVESTIGATION REPORT

**SERIOUS INCIDENT OF HYBRID AVIATION AIRCRAFT DIAMOND
DA-42 REG NO AP-BMR REAR PASSENGER DOOR FLYING OFF
IN AIR NEAR WALTON AIRPORT LAHORE ON 20-07-2018**

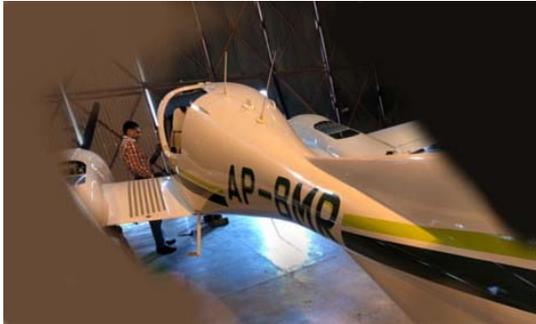
2.1.1 The passenger door was missing from the aircraft.

Passenger door missing after the incident

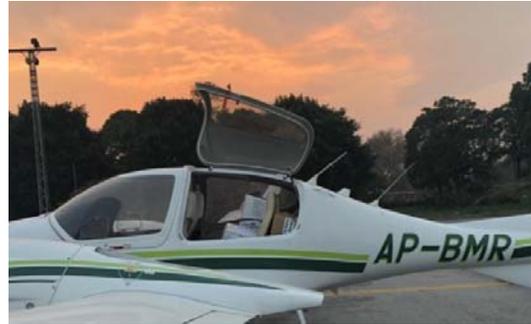
Door intact on a serviceable aircraft

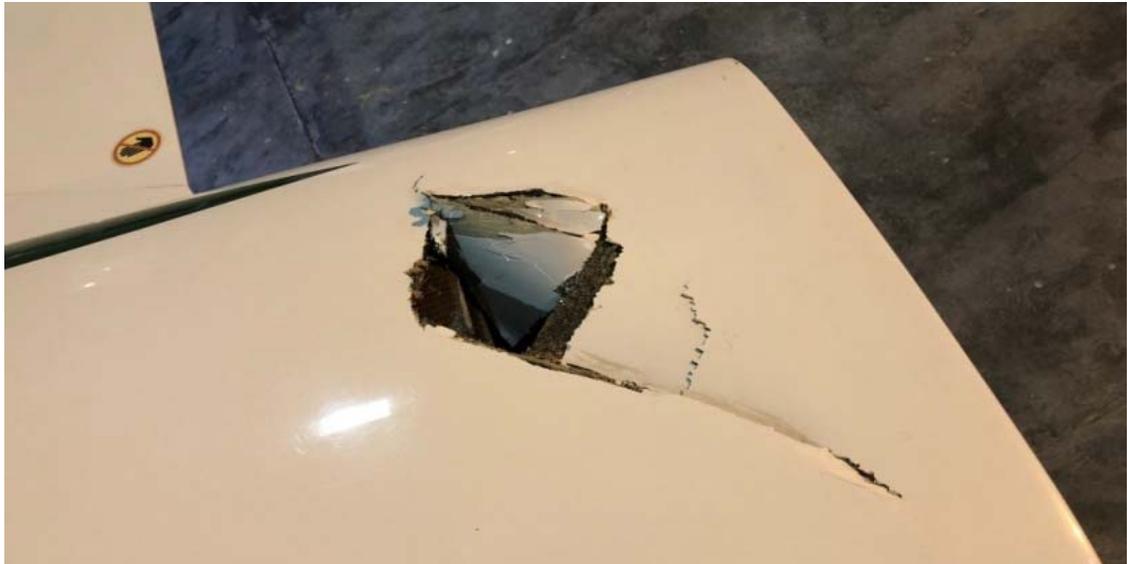
2.1.2 Right engine cowling was found damaged as a consequence of door flying off in the air and hitting the cowling.

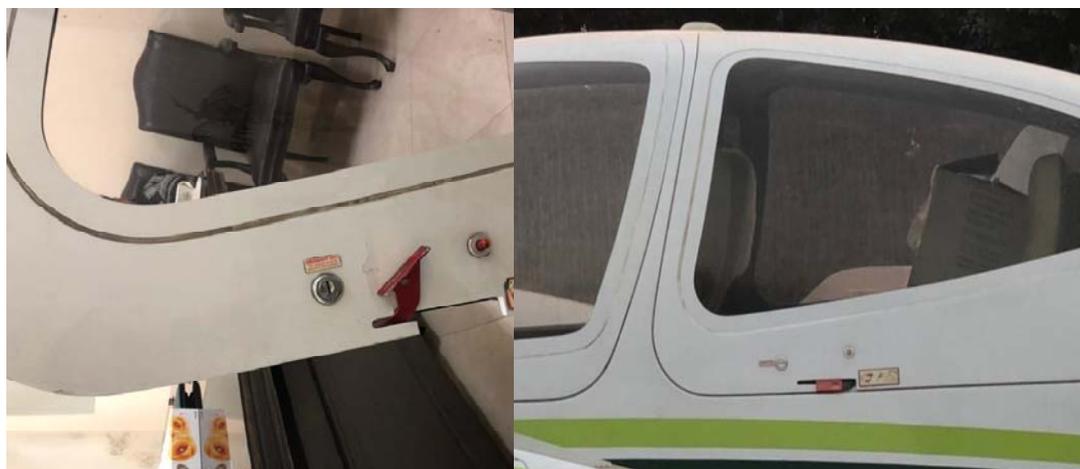
2.1.4 Locking handle of the passenger door was observed to be de-shaped due to its impact on ground and at open position.

Door handle found de-shaped in open position after the incident

Door handle in closed position on a serviceable aircraft

- 2.1.5 The de-shaped locking handle was re-shaped and the door was placed back on the aircraft to check the door locking mechanism.
- 2.1.6 The door locking mechanism was found in a serviceable condition and no anomaly was observed with the door or its locking mechanism.

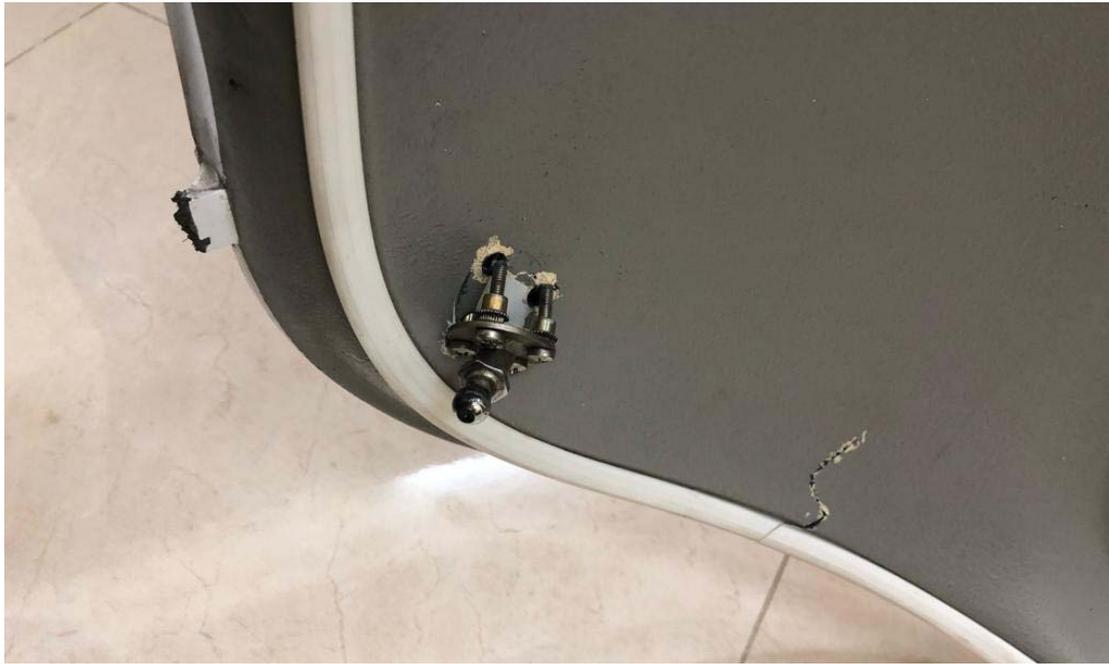
- 2.1.8 The condition of door hinge indicates that it didn't fail. It rather got sheared away from the aircraft skin. This infers that the door locking handle first got unlocked at its own and then the door flew off in the air by shearing off its hinges from the aircraft skin, as shown below:-

- 4.1 The involved Flight Instructor is to undergo DA-42 aircraft normal & emergency procedures refresher training. The compliance report may be submitted to Directorate of Flight Standards CAA Pakistan upon completion, with intimation to SIB.
- 4.2 Directorate of Flight Standards CAA Pakistan may issue instructions to General Aviation flying units for compliance of OEM recommended procedures mentioned in QRH and regulatory procedures as per PCAA approved Ops Manual and to informing ATC of any in-flight incident / abnormal situations in order to alert the emergency services.
- 4.3 DDG (Reg) CAA Pakistan may issue instructions to all General Aviation Flying Units about timely reporting of occurrences / abnormal situations to CAA Authorities as per in-vogue procedures.
