## FINAL INVESTIGATION REPORT

### **SERIOUS INCIDENT OF EMIRATES FLIGHT EK 615, BOEING 777-31(ER) AIRCRAFT, REGISTRATION NO A6-END AT BENAZIR BHUTTO INTERNATIONAL AIRPORT, ISLAMABAD ON 27<sup>TH</sup> FEBRUARY, 2018**

Dated: 30<sup>th</sup> October, 2023

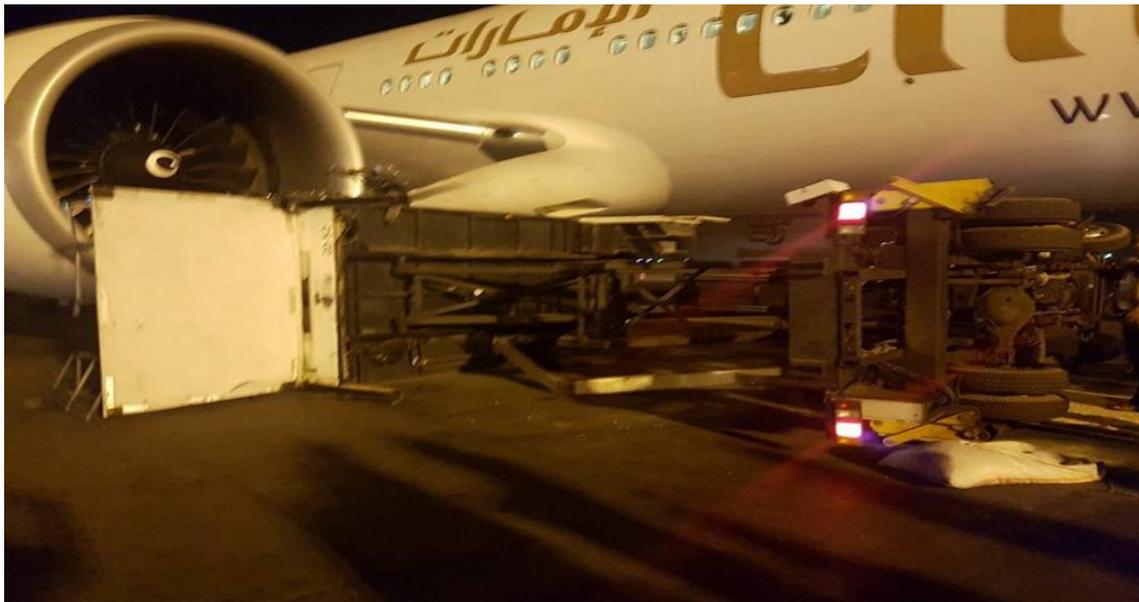
Figure 1 Ambulift Fallen on Ground Infront of Engine No. 2

2.2.3.4. After few minutes the cabin crew opened the aircraft door, meanwhile ambulift became unbalanced and started falling on left side, eventually it collided with air inlet cowl of Engine No. 2 and fell on ground.

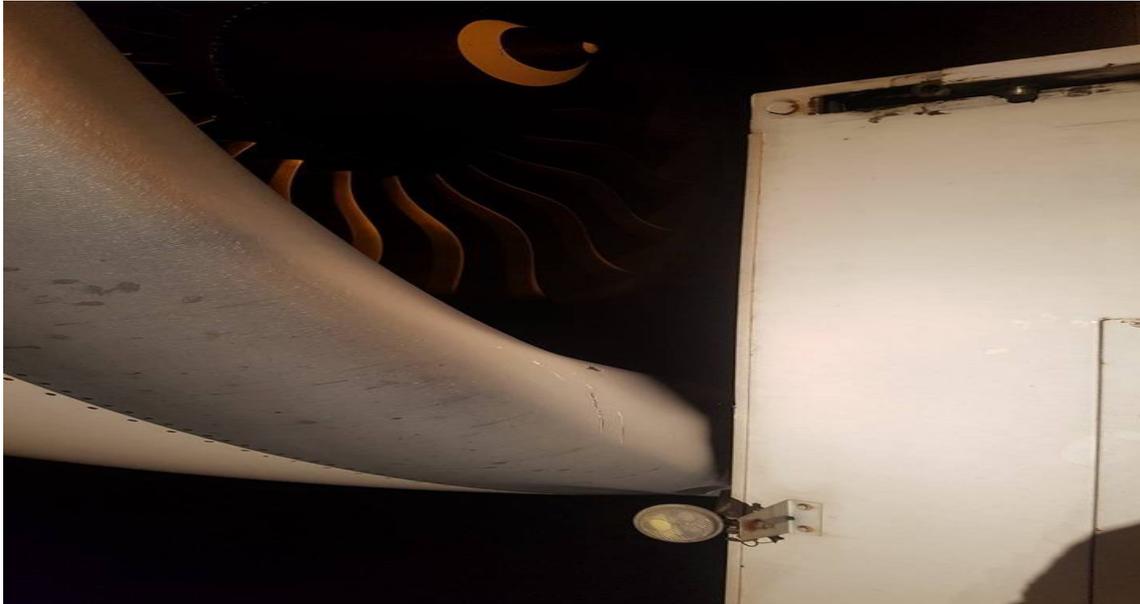
1.3.1. The aircraft sustained minor damage due to ambulift collision with the air inlet cowl of Engine No. 2.

Figure 2 Ambulift in Contact with Engine No. 2 Cowling

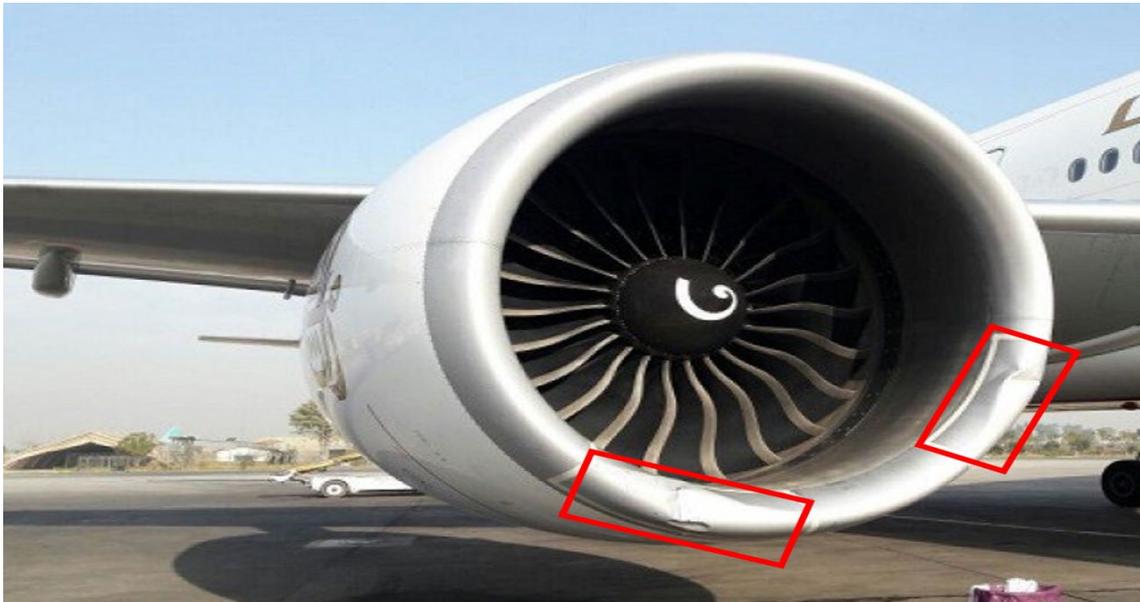
Figure 3 Damaged Air Inlet Cowl of Engine No. 2 (Front View)

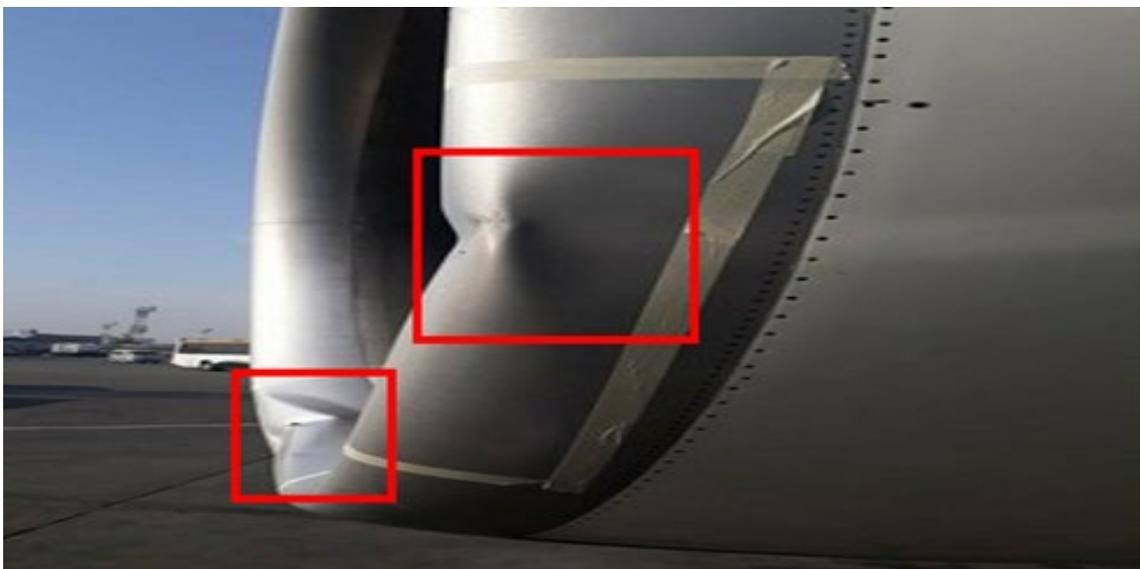
Figure 4 Damaged Air Inlet Cowl of Engine No. 2 (Side View)

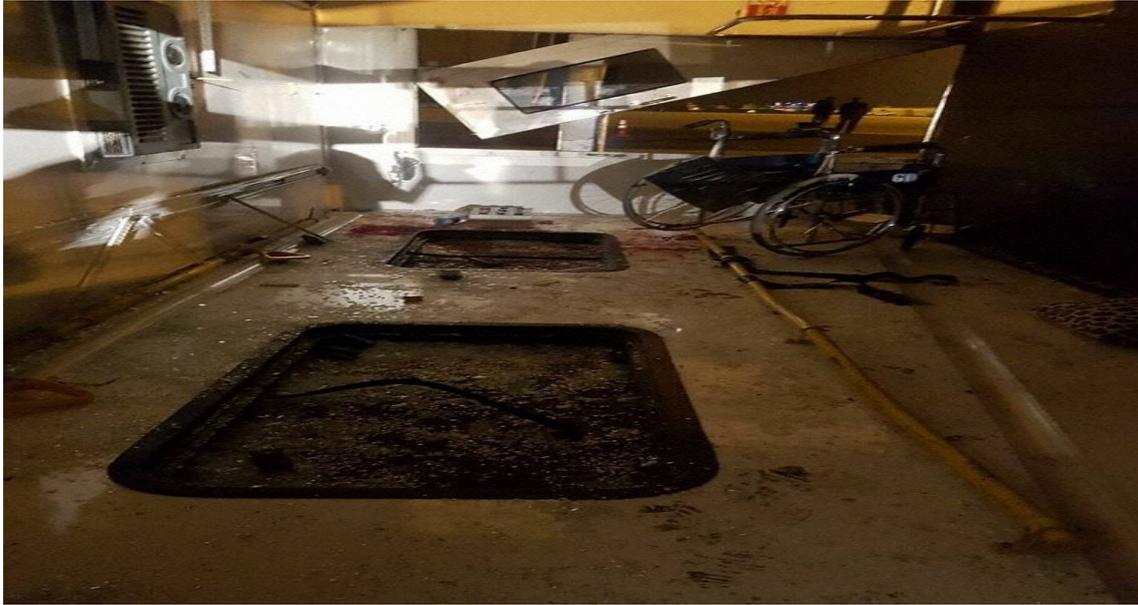
1.4.1. The ambulift sustained damages due to toppling and impact on ground.

Figure 5 Inside View of Van Box after the serious incident

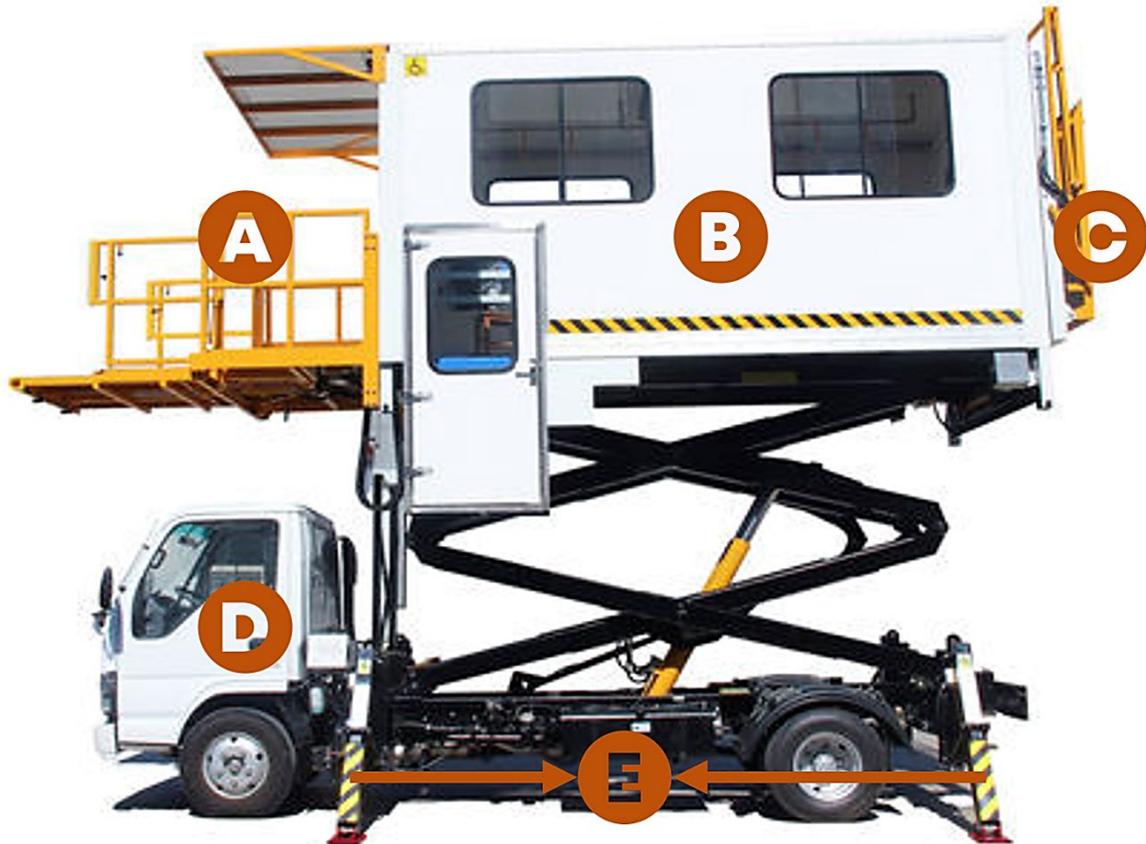
Figure 6 Main Parts of Ambulift

2.2.3.3. The operator lifted the van box of ambulift to the height of aircraft door without extending arm-braces, so ambulift was parked on wheels only.

2.2.4.3. Van box operation was checked and it was noticed that cabin could be lifted without extending the arm-braces. It was found that the design safeties provided to restrict operation of the van box without extension of arm-braces were not functional. Large number of relay switches were re-wired which bypassed the designed safeties in the system.

3.2.2. The operator lifted the van box of ambulift to the height of aircraft door without extending arm-braces, which caused ambulift to become unbalanced and toppled.

- 4.1.1. GHA may take appropriate measures to ensure the design safeties of Ramp Handling Equipment are operational.
- 4.1.2. GHA may take appropriate measures to ensure compliance of inspections of Ramp Handling Equipment as per the Checklist.
- 4.1.3. GHA may take appropriate measures to ensure availability of Marshaller for Ramp Handling Equipment (as applicable).
- 4.1.4. GHA may take appropriate measures to ensure deployment of authorized operator and Ramp Handling Equipment.
- 4.1.5. PCAA may take appropriate measures for effective oversight of GHA.
