FINAL INVESTIGATION REPORT

**ACCIDENT OF PIAC AIRCRAFT ATR 72-212A REG NO
AP-BKW AT JIAP KARACHI DURING GROUND RUN-UP
PERFORMANCE CHECKS ON 24 NOVEMBER 2018**

FINAL REPORT

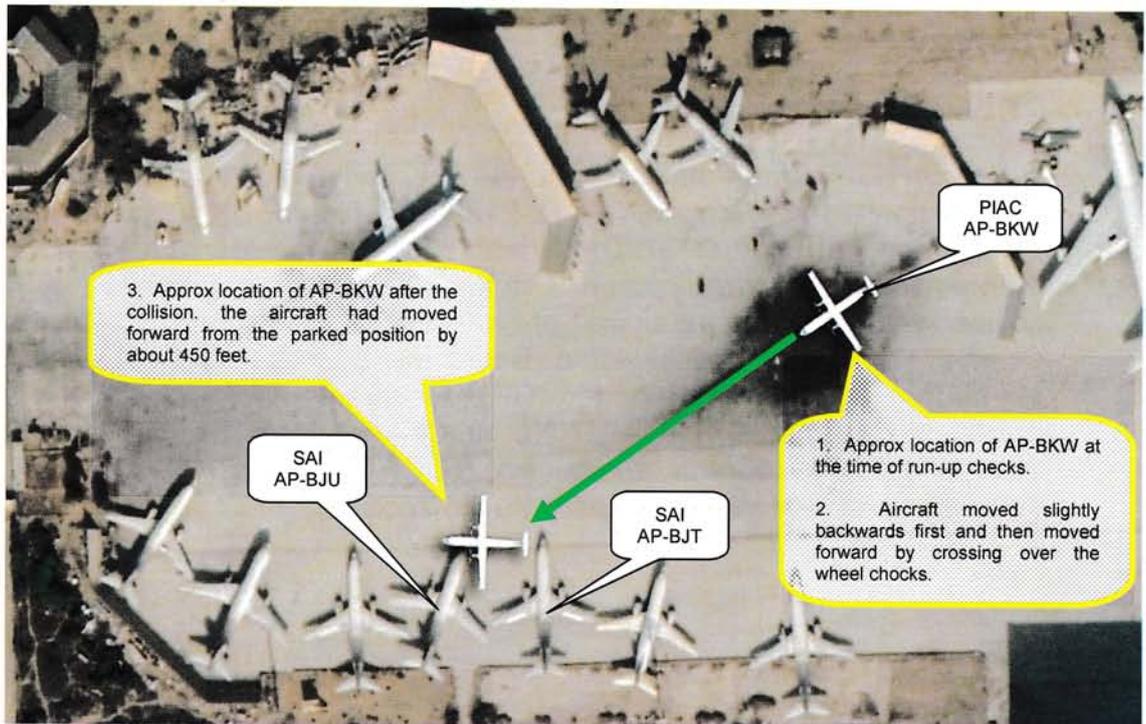
1.1.1. An overview of the accident site has been marked in the picture below:-

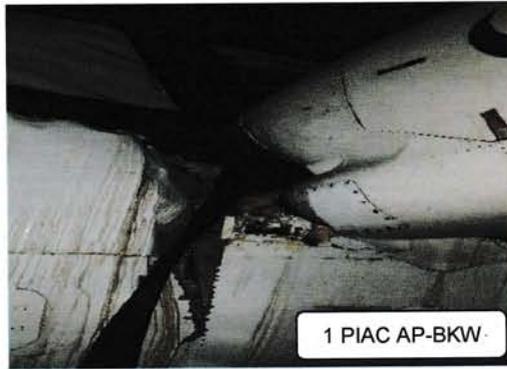
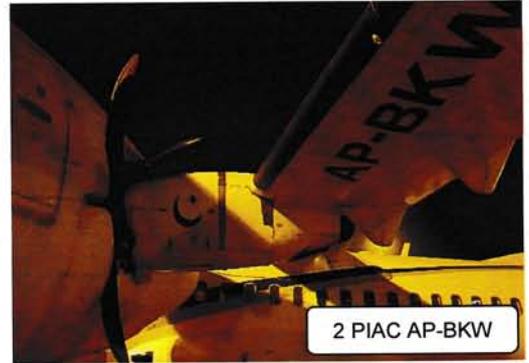
S No	Description of pictures given above
1 & 2	AP-BKW propeller No 1 embedded into fuselage of dormant AP-BJU
3	Inner ply of AP-BKW cockpit LHS # 3 window got shattered
4	Rubbing marks observed on fuselage of AP-BKW left hand side from captain aft windshield up to cabin window # 11
5	Left wing tip of AP-BKW which made first contact with AP-BJT
6	All 06 blades of AP-BKW propeller No 1 damaged
7	Damaged nose radome of AP-BJU after separating from AP-BKW
8	Marks of first contact of AP-BKW left wing tip on AP-BJT

- 2.18 It continued to move and collided another dormant SAI aircraft B-737 Reg No AP-BJU at it's nose radome. Due to momentum AP-BKW continued rubbing its the fuselage forward section with dormant AP-BJU nose radome, and it stopped with its No 1 Engine propeller getting stuck / embedded into right forward portion of fuselage.

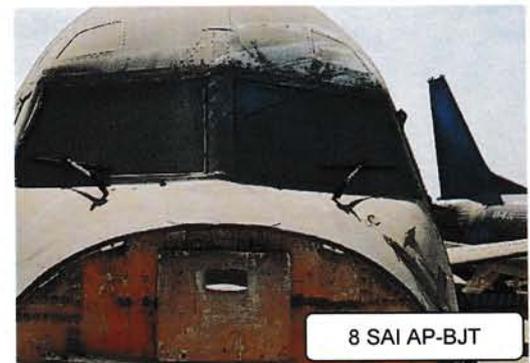
8 SAI AP-BJT

- 2.17 Aircraft did not stop with parking brakes ON as well as with the application of pedal brakes and it's left wing tip first made contact with a dormant SAI aircraft B737 Reg No AP-BJT.

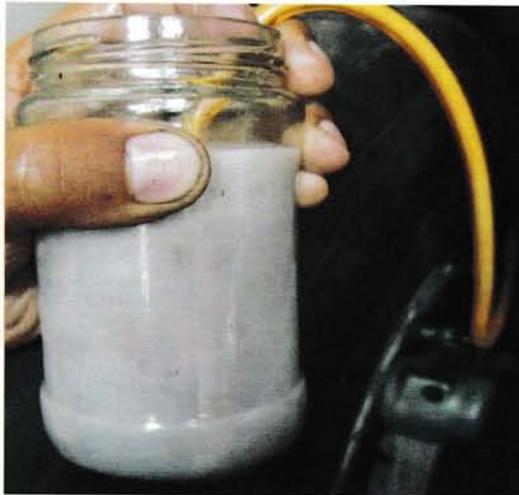
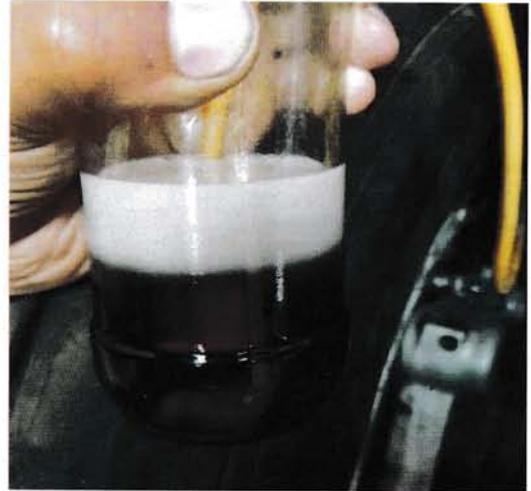
- 2.5 FDR was downloaded. The brake pressure throughout engine performance run-up was recorded between 39-45 psi, whereas it was required to be 3000 psi this supports the fact that there was no or very little hydraulic in brake system thus resulting in its in-effectiveness (for both normal and emergency operation). FDR data screen snapshot is as shown below: -

- 4.1.7 The brake pressure throughout engine performance run-up was recorded between 39-45 psi whereas it was required to be 3000 psi.
- 4.1.8 Nose wheel steering was not made available.

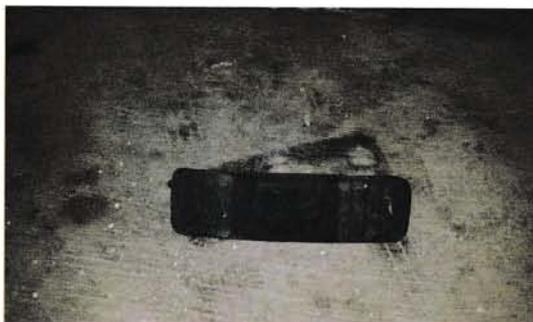
- 2.11 Non-standard / incompatible wheel chocks Part No W-88 (Dimensions: Height 5.5 inch, Width: 7 inch, Length: 24 inch) were placed only in front of left and right main wheels. For the nose wheel, one small rubber chock (Dimensions: Height: 7 inch, Width: 6.5 inch, Length: 12 inch) was placed in front and one wooden chock at it's back (dimensions: Height: 4 inch, Width: 5.5 inch, Length: 12 inch). It is worth mentioning here that both the chocks used for the nose wheel were meant to be used for GPU and not for the aircraft.

W-88 wheel chock placed in front of main wheels

- 2.13 The wheel chocks used during the ground run-up checks were smaller than the recommended ones, were used only in front of the wheels and not at the back side of the wheels, and were and therefore did not serve the purpose.

- 5.2 M/s PIAC is required to ensure an immediate procurement of the OEM recommended chocks in adequate quantity at all applicable stations for the ATR aircraft.

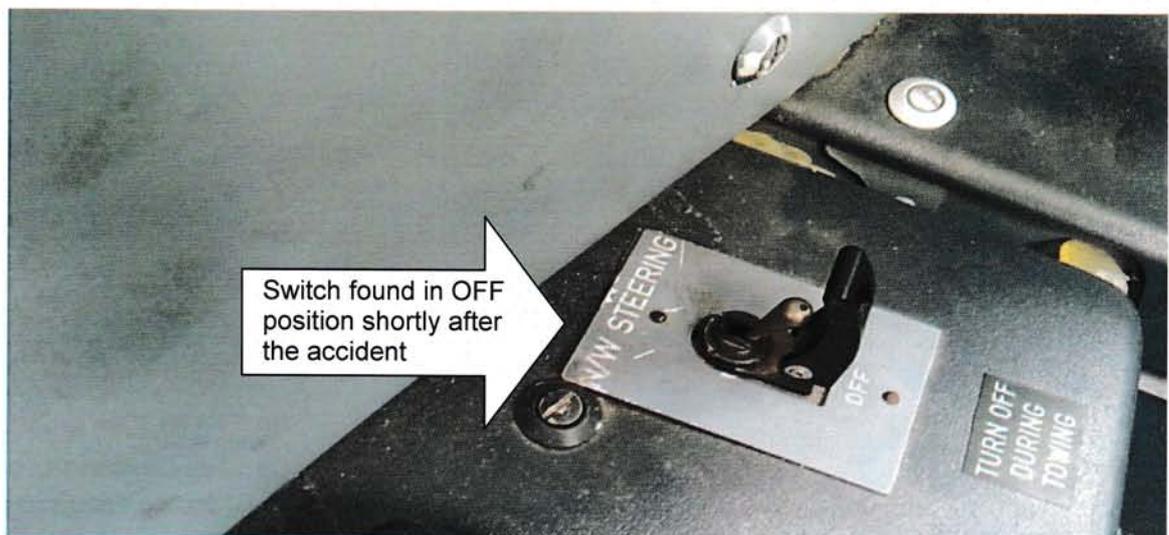
- 2.19 After collision of the aircraft at this time, both engines' Condition Levers (CL) were selected to Fuel Shut off position.
- 2.20 During cockpit inspection at the time of occurrence it was observed that Nose Wheel Steering (NWS) switch was OFF instead of ON position. Therefore the nose wheel steering was not available during the forward movement of the aircraft.

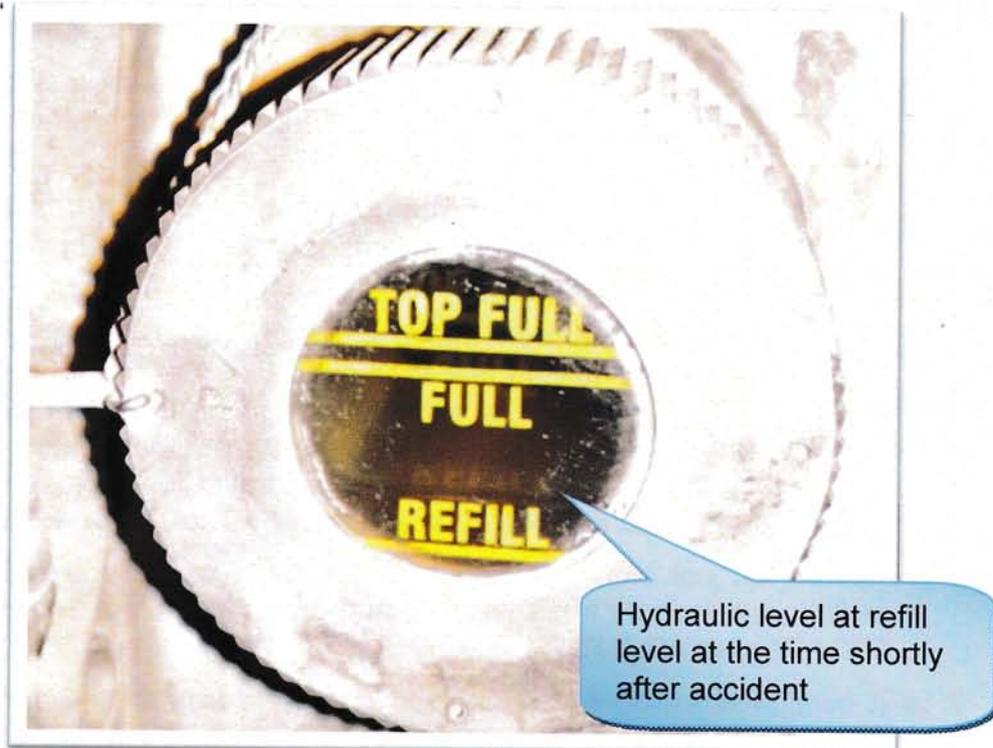
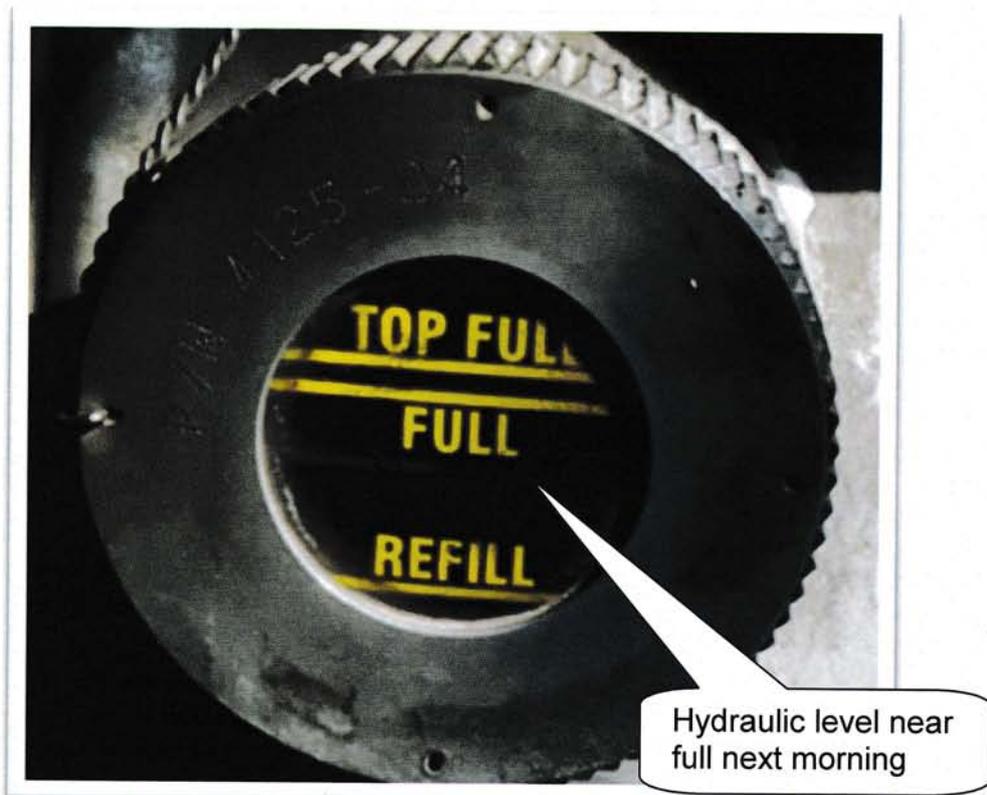
- 2.21 After the accident, aircraft brake system was inspected. The hydraulic reservoir quantity was found at refill level. Additionally upon opening of hydraulic reservoir

filler cap, there was no strainer. Next morning it was found filled up and a strainer was placed inside with its locking clip.

- 4.1.12 The evidence of low hydraulic level in the reservoir was found alleviated next morning. A strainer in the filling neck of hydraulic reservoir, which was missing after the accident, was found to be in place next morning.

- 5.4 All currently licensed ground run-up operator's of PIAC may be re-assessed by including practical evaluations on the aircraft.
- 5.5 M/s PIAC is required to ensure that in the event of any serious incident / accident, the evidence is adequately preserved and secured.
