FINAL INVESTIGATION REPORT

SERIOUS INCIDENT OF TCAS – RA REPORTED BY EMIRATES FLIGHT UAE 637, BOEING 777-31H(ER) AIRCRAFT, REG. NO. A6-ENO, ON 19-09-2019

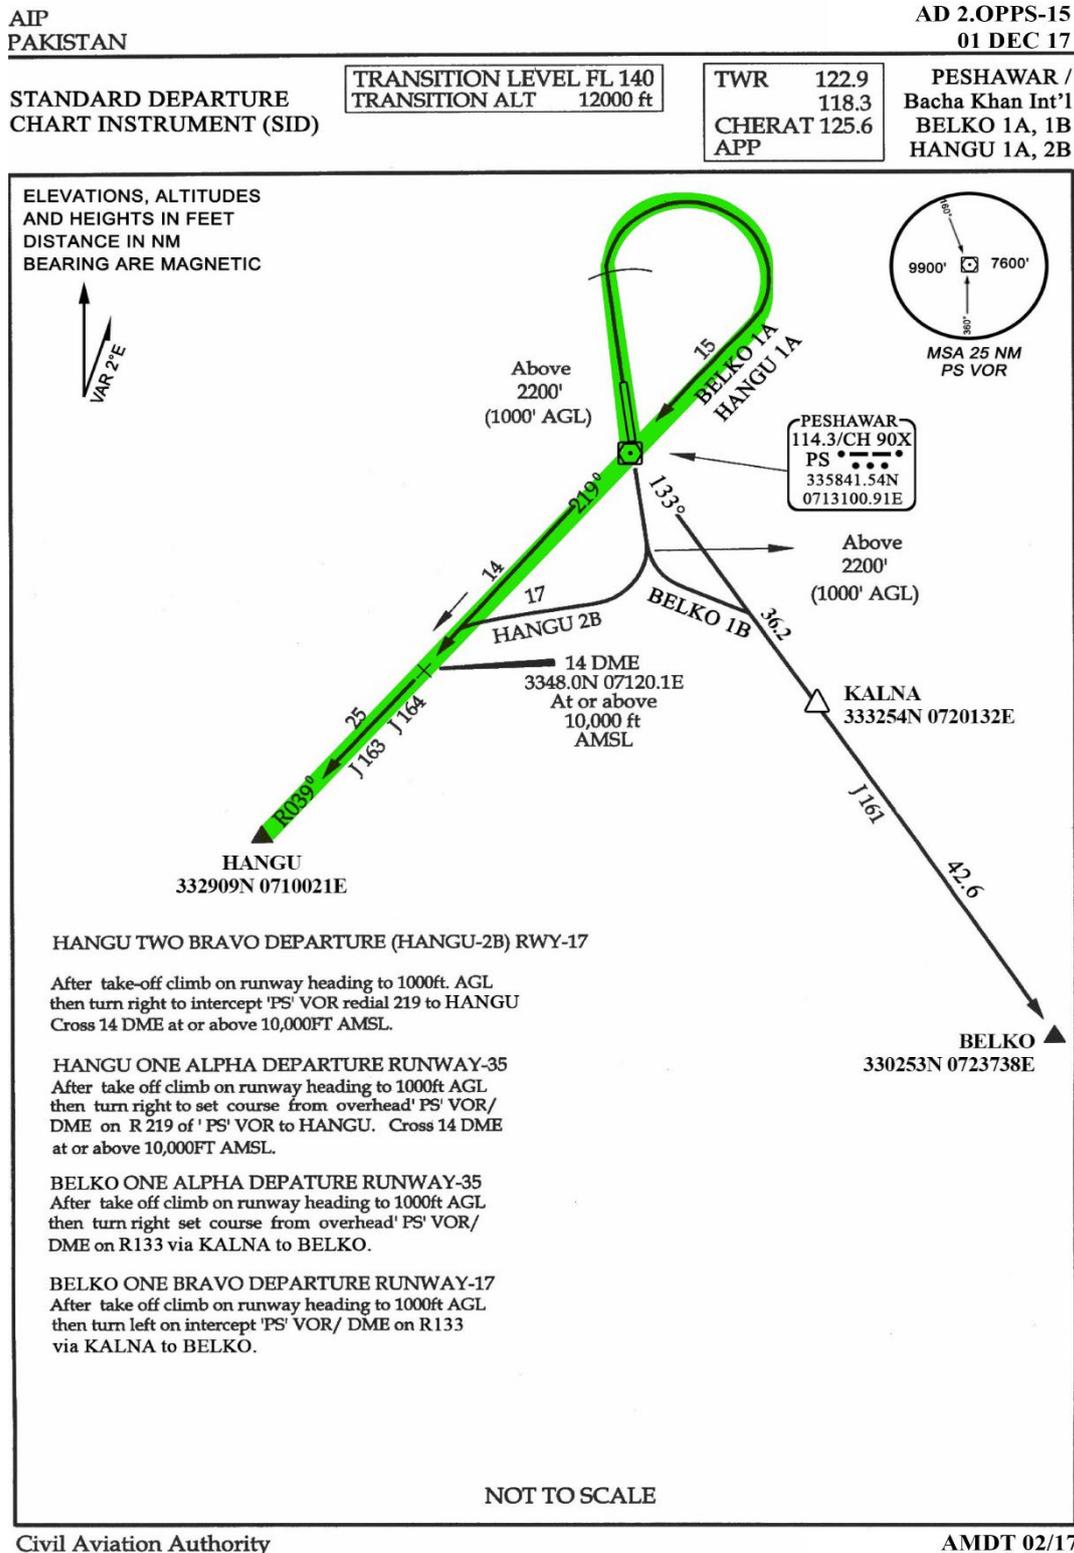
Figure 1 Standard Instrument Departure (SID) Chart

1.1.4. UAE 637 was restricted, to maintain R/W35 heading until passing 3,500 ft due PAF Helicopter, before turning right to join SID HG 1A DEP climbing 10,000 ft in coordination with PAF ATC.

1.1.5. UAE 637, while turning right towards overhead Peshawar passing 4,000 ft, reported TCAS – RA due to an F-7 PG, Military fighter aircraft crossing 400 ft below.

- 3.1.11. The Military controller failed to coordinate with Civil Controller regarding Essential Local Traffic of Fighter formation coming for Initials R/W17 at 3,500 ft which was reciprocal to the Take-off path of departing Civil Traffic (UAE 637) from R/W35 climbing 3,500 ft on R/W heading due to helicopter holding in circuit North East of the airfield at 2,500 ft.
