FINAL INVESTIGATION REPORT

SERIOUS INCIDENT (TCAS – RA) BETWEEN AERO NOMAD AIRLINE FLIGHT ANK4506, AIRBUS 320-233 AIRCRAFT, REG. NO. EX-32009 (OPIS – UCFM) & BRITISH AIRWAYS FLIGHT BAW2261, BOEING 777-236ER AIRCRAFT, REG. NO. GYMMD, (EGLL – OPIS) ON 05-06-2022

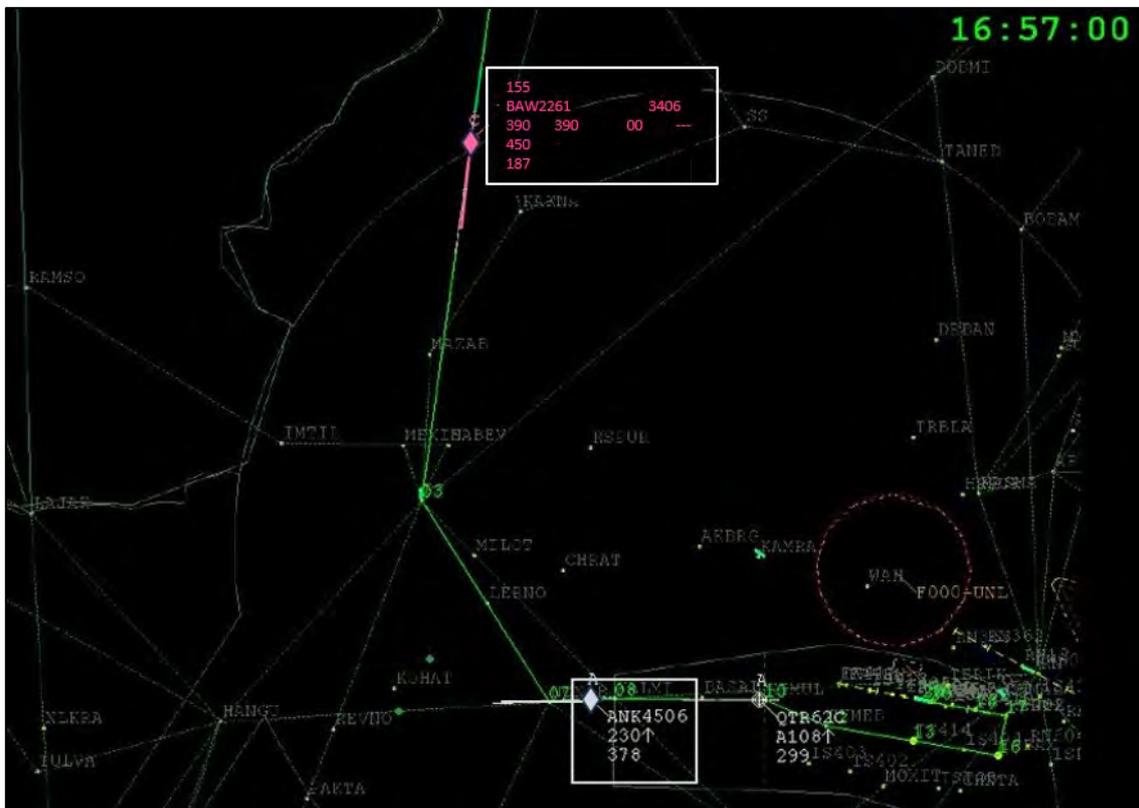
Figure 7 ANK came in contact with Islamabad ACC

2.1.4. At 16:57 h, ANK4506 came in contact with Islamabad ACC and was instructed to continue climb to FL320.

2.1.5. At the same time, BAW2261 was given descent to FL330.

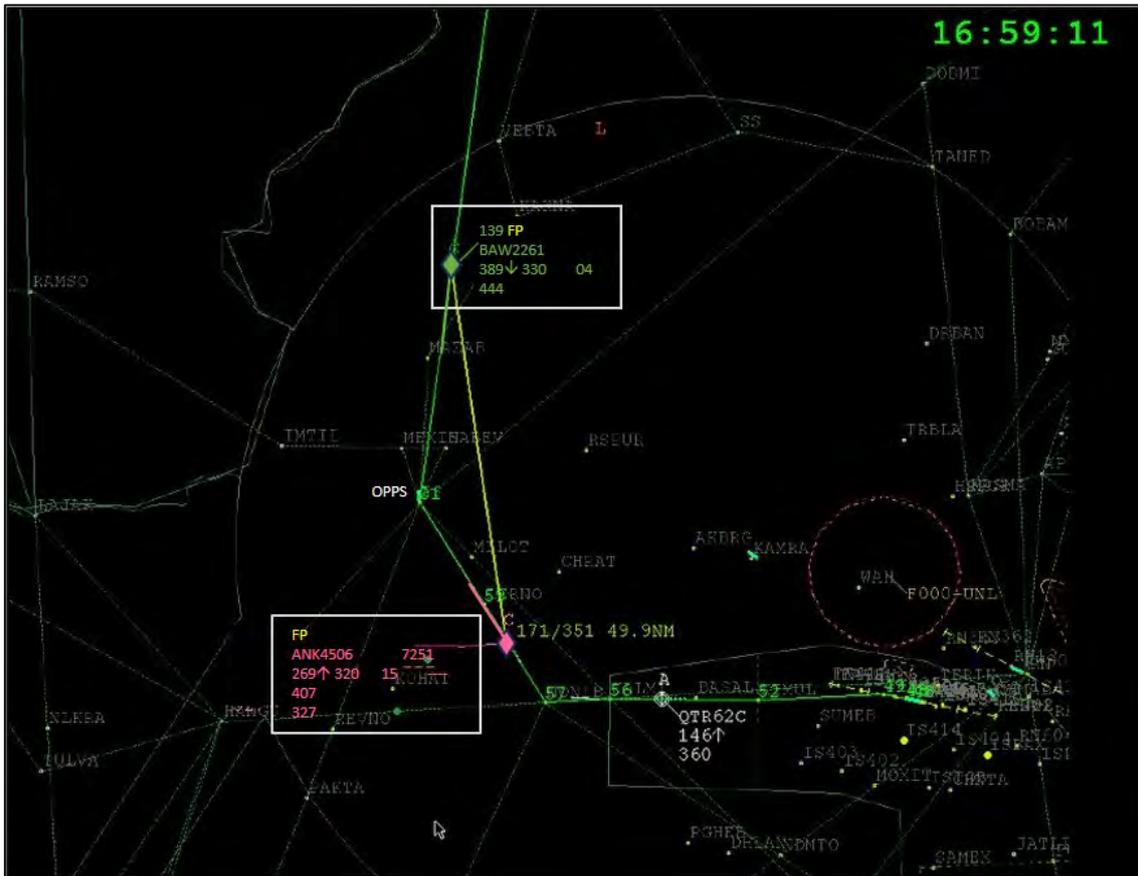
Figure 8 Traffic Information passed to BAW2261

2.1.6. At time 16:59 h, Islamabad ACC passed information of reciprocal traffic (ANK4506) to BAW2261.

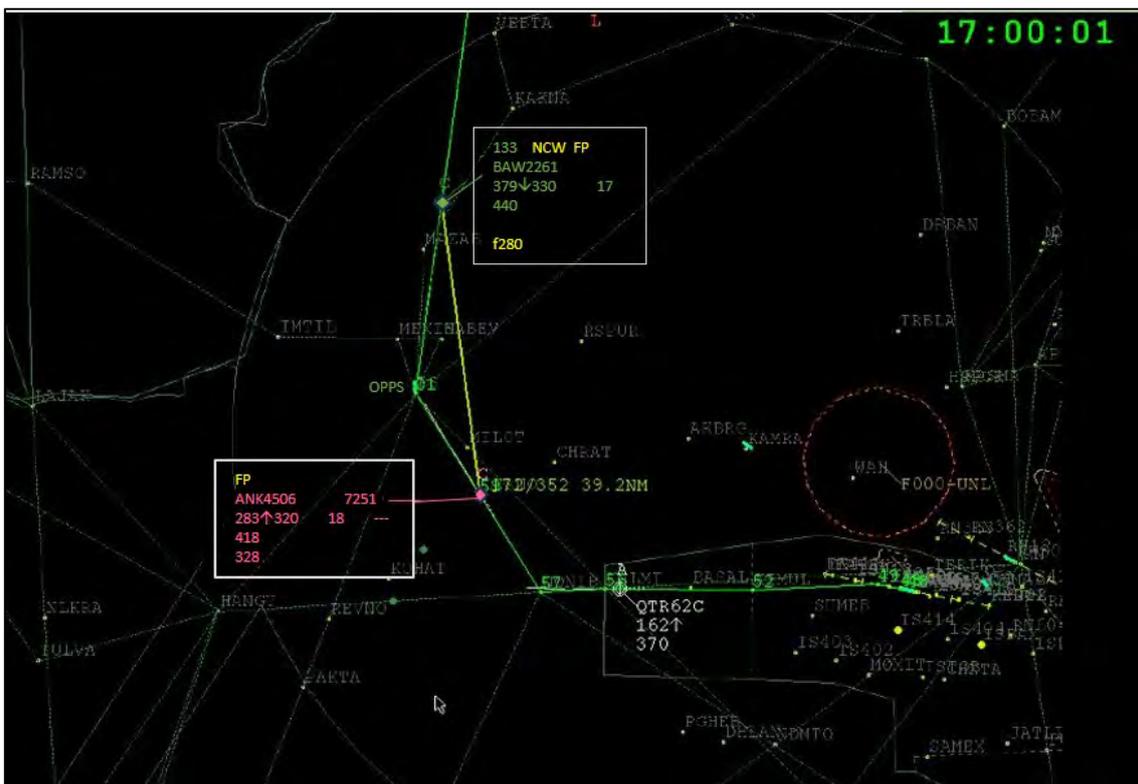
Figure 9 Traffic Information passed to ANK4506

2.1.7. At time 17:00 h, Islamabad ACC passed traffic information of BAW2261 to ANK4506 upon which ANK4506 reported that they have traffic in sight.

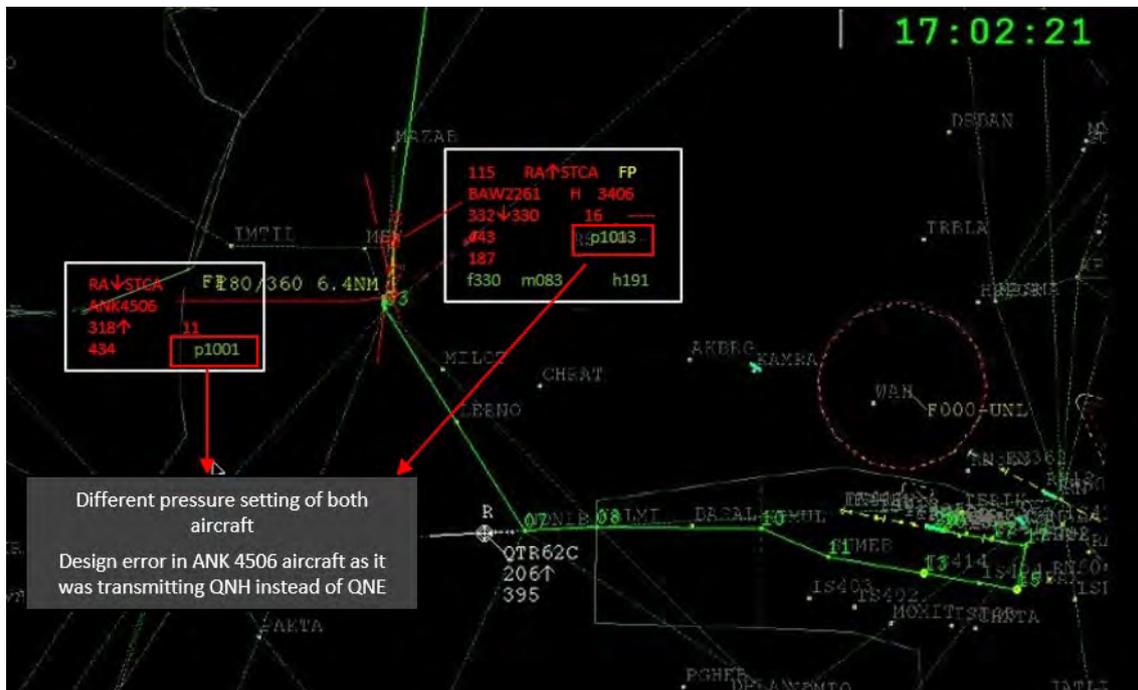
Figure 10 Activation of RA

2.1.9. When ANK4506 was 05 NM North of position PS VOR climbing out of FL318 for FL320 with ROC 1,100 ft/min, it encountered TCAS–RA with reciprocal traffic BAW2261 which was descending from FL390 to FL330 passing FL332 with ROD 1,600 ft/min at the time of incident.

2.1.10. ANK4506 descended from FL318 to FL315 on TCAS-RA. Meanwhile, BAW2261 did not report TCAS-RA however, it followed TCAS-RA command to level off at FL330⁹.

2.1.11. BAW2261 was maintaining high ROD Approx 2,200 ft / min just before RA which was contrary to ICAO Doc 8168 Vol-III¹⁰, which states: -

2.1.12. It was observed on Radar Display that the ROD of BAW2261 was fluctuating before the RA.

2.1.14. At the time of incident, 1,400 ft vertical separation and 05 NM horizontal separation existed between the two aircraft. Standard separation was not infringed.

3.2.1.1. Activation of TCAS – RA (**MAC – Mid Air Collision**) due high Rate of Descend by BAW2261.

4.1.1. CAA United Kingdom and Kyrgyz Republic as well as Pakistan Airport Authority are to advise all aircrew to adhere to standard ROCs / RODs as per ICAO Doc 8168, Vol-III, Section 4 Chapter 3 para 3.3.
