FINAL INVESTIGATION REPORT

SERIOUS INCIDENT (TCAS – RA) BETWEEN AIRBLUE FLIGHT ABQ611, AIRBUS 321-211 AIRCRAFT, REG. NO. AP-BMW (DUBAI – PESHAWAR) AND MILITARY AIRCRAFT ON 13-12-2021

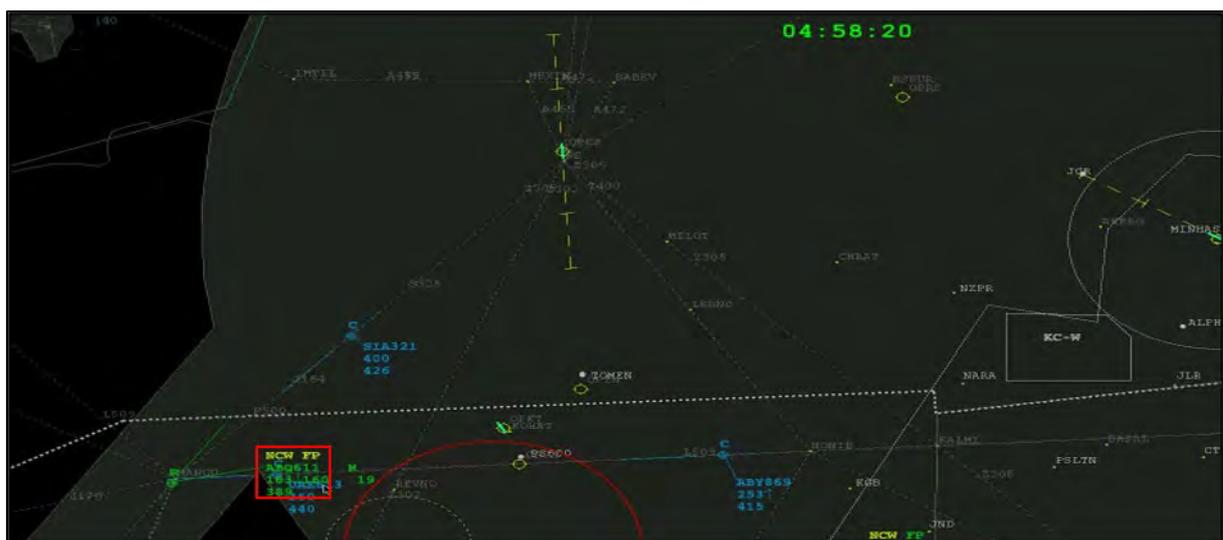
Figure 8 ABQ611 came in contact with Tower Controller

2.1.3. At 04:58:20 h, ABQ611 came in contact with Peshawar Tower while it was maintaining FL160 following Standard Instrument Arrival Route (STAR) HANGU 1C.

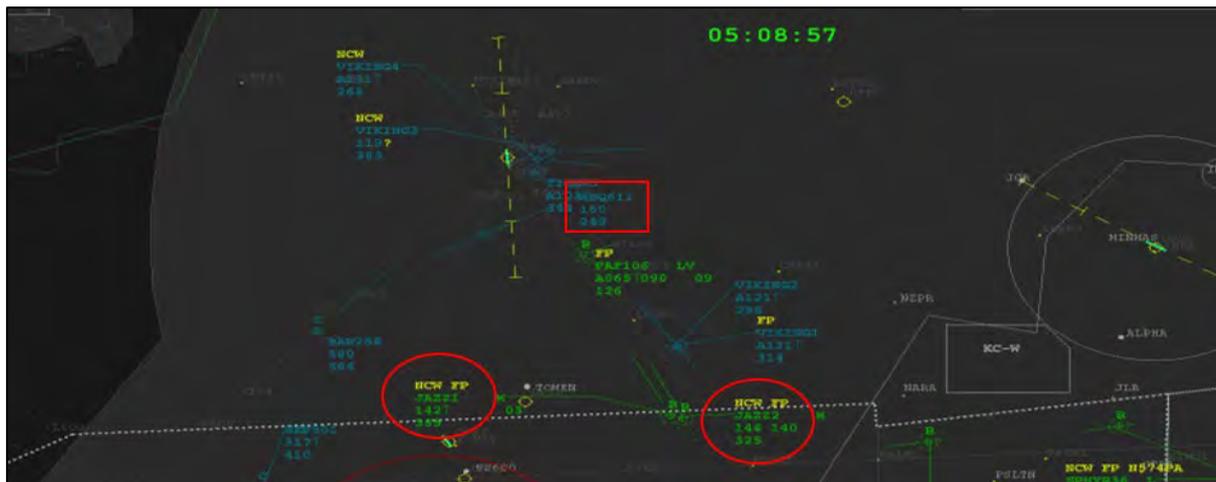
Figure 9 Fighters given climb from FL140 to FL160

2.1.7. At 05:08:57, JAZZ formation 2 x JF-17 were cleared from FL140 to FL160 by Military Aerodrome Controller.

2.1.9. At the time of occurrence, ABQ611 was maintaining FL160 and 02 x JF-17 Military aircraft were operating at FL159 as a single formation, which was revealed after the analysis of available Radar Video recording. (Refer Figure 9).

3.1.5. JAZZ Formation was given clearance by Military Controller to climb from FL140 to FL160 and further to FL180 without coordination / information with Military Supervisor as well as Civil Controller, which triggered TCAS-RA and multiple TAs of ABQ 611.

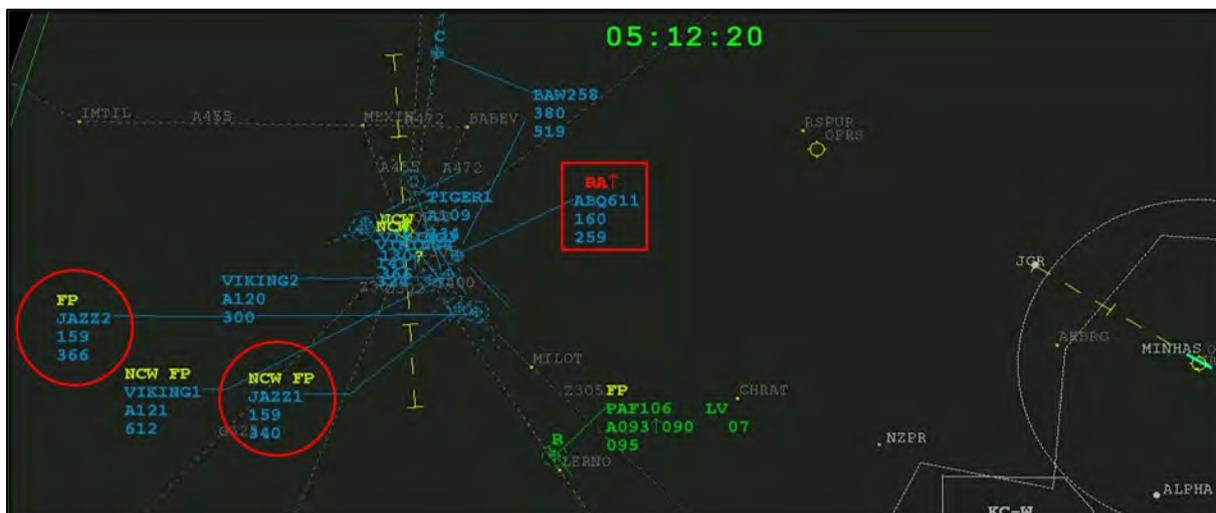
Figure 10 Activation of TCAS - RA

2.1.8. At 05:12:20 h, ABQ611, while in the hold over Peshawar VOR, reported TCAS – RA.

3.2.1.1. Lack of coordination by the Military Aerodrome Controller, who changed the altitude of the fighter aircraft without communicating with Military Supervisor and Civil Controller, resulting in the activation of TCAS-RA.

4.1.1. Air Headquarters should ensure regular briefings for all PAF aircrew as well as military ATCOs on the operation and limitations of TCAS-RA in civil aircraft (particularly regarding speed variations and rates of climb and descent) to maintain proper separation and spacing between the traffic.

4.1.2. PCAA / PAA and Air Headquarters should establish proper coordination between civil and military controllers through formal letters of agreement (LOAs) to promote safe air operations practices.
