FINAL INVESTIGATION REPORT

SERIOUS INCIDENT (TCAS – RA) – KUWAIT AIRWAYS FLIGHT KAC920, BOEING 777-369(ER) AIRCRAFT, REG. NO. 9K-AOE (SECTOR GUANGZHOU TO KUWAIT) AND MILITARY AIRCRAFT ON 01-12-2021

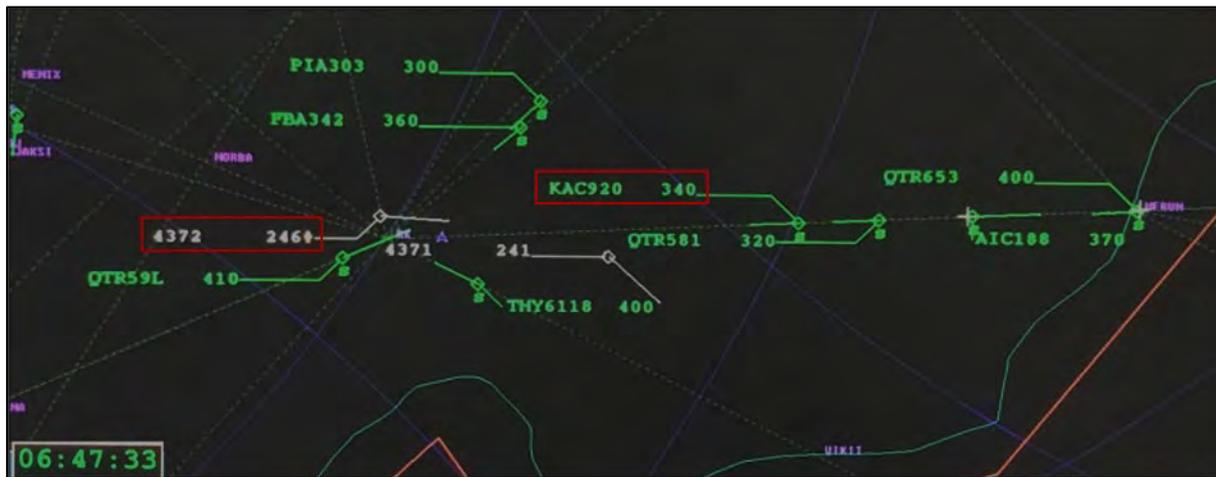
Figure 5 Military aircraft observed approx 03 NM North of RK

2.1.6. At time 06:47:33 h, one of the military aircraft, squawking A4372, was observed 3 NM north of 'RK' at FL246 in a climbing phase and subsequently disappeared from the radar.

3.1.3. 02 x F-16 military aircraft from PAF Base Shahbaz, Jacobabad, were operating east of 'RK' at coordinated levels between FL260 and FL200. One of the Military aircraft, squawking A4372, was observed 03 NM north of 'RK' at FL245 in climbing phase before disappearing from the radar.

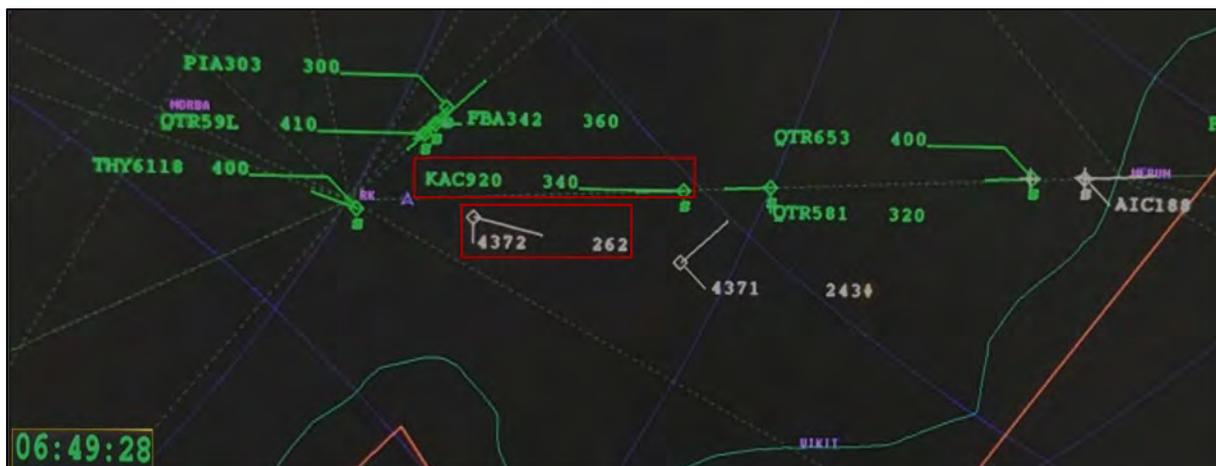
Figure 6 Military aircraft climbing FL262

2.1.7. At time 06:49:28 h, military aircraft squawking A4372 reappeared on radar display, climbing out of FL262 at a position 18 NM east of 'RK' and 20 NM on a reciprocal heading to KAC920.

2.1.9. At this time, the military aircraft was maintaining high ROC of approximately 6,000 ft / min as per controller's statement⁶.

3.1.5. Military aircraft squawking A4372 reappeared on radar, climbing out of FL264, at position 18 NM east of 'RK' and 20 NM on a reciprocal path to KAC920, with a high ROC (approximately 6,000 ft / min, as stated by Area Radar Controller).

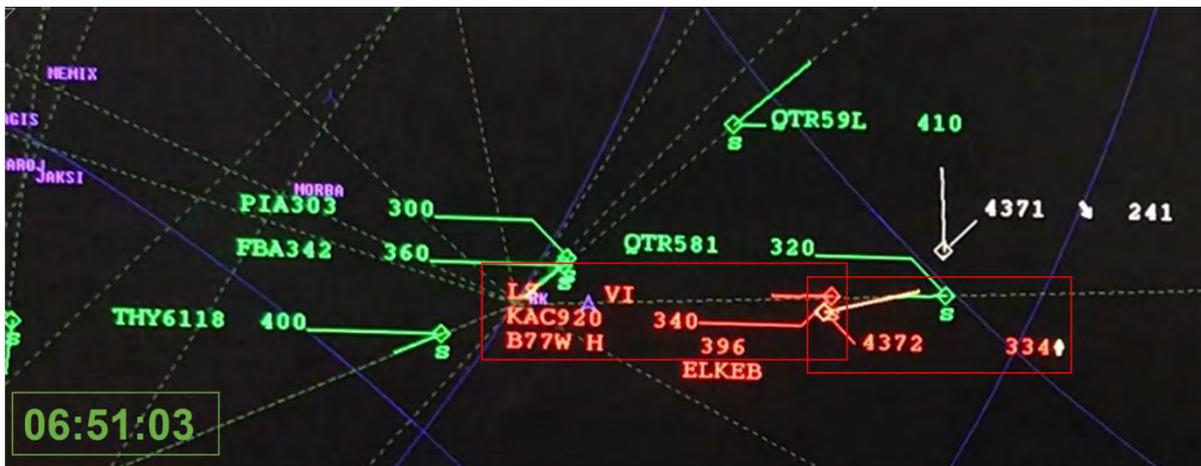
Figure 7 Military aircraft climbed FL334

2.1.11. At 06:51:03 h, ACC Lahore South again instructed KAC920 to proceed directly to POPOT and provided traffic information regarding an uncontrolled aircraft at its 9 o'clock position, range 02 NM away at FL334.

2.1.12. At 06:51:05 h, KAC920 reported TCAS – RA and initiated a climb to FL348 in response to the RA activation (Figure 7).

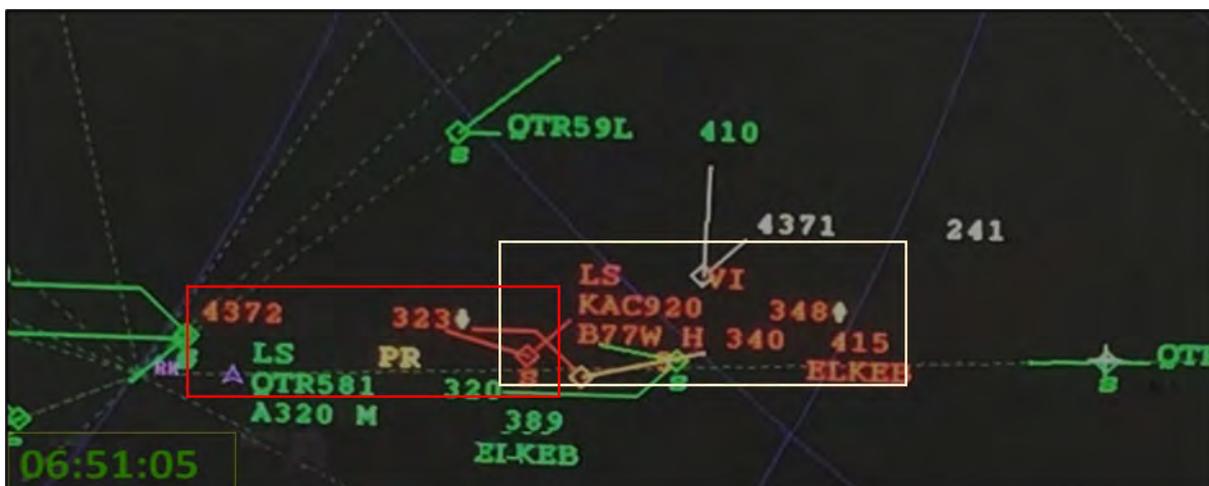
Figure 8 TCAS-RA activation

2.1.13. The military aircraft crossed KAC920 at its 9 o'clock position, approximately 02 NM away at FL334, which triggered the activation of TCAS – RA.

2.1.17. Vertical Separation of approximately 600 ft and lateral separation of 02 NM existed between military aircraft and KAC920 at the time of RA.

3.2.2. Activation of TCAS – RA (**MAC – Mid Air Collision**) due to an abrupt change in the altitude of a military aircraft.

3.2.3.1. There was a **lack of coordination** and information sharing between military ATC and SOC South with civil ATC Controller.

3.2.3.2. SOC **allotted levels** above the coordinated height band (FL260 - FL200) to fighters, **without intimation and coordination** with ACC Lahore Controller.

3.2.3.3. Neither PAF Base Shahbaz Controller nor civil Controller took timely action by giving call on emergency frequency to fighters, which might have avoided the incident.

4.1.1. Aircraft separation must be maintained in accordance with SOPs. Air Headquarters (AHQ) and Pakistan Airports Authority (PAA) should issue directives to all controlling units to ensure compliance with these SOPs.

4.1.2. AHQ and PAA should conduct regular training sessions / lectures for all controllers regarding adherence to SOPs.

4.1.3. A proactive approach should be adopted by all controllers to ensure swift and smooth coordination and prevent reoccurrences of such incidents in future.

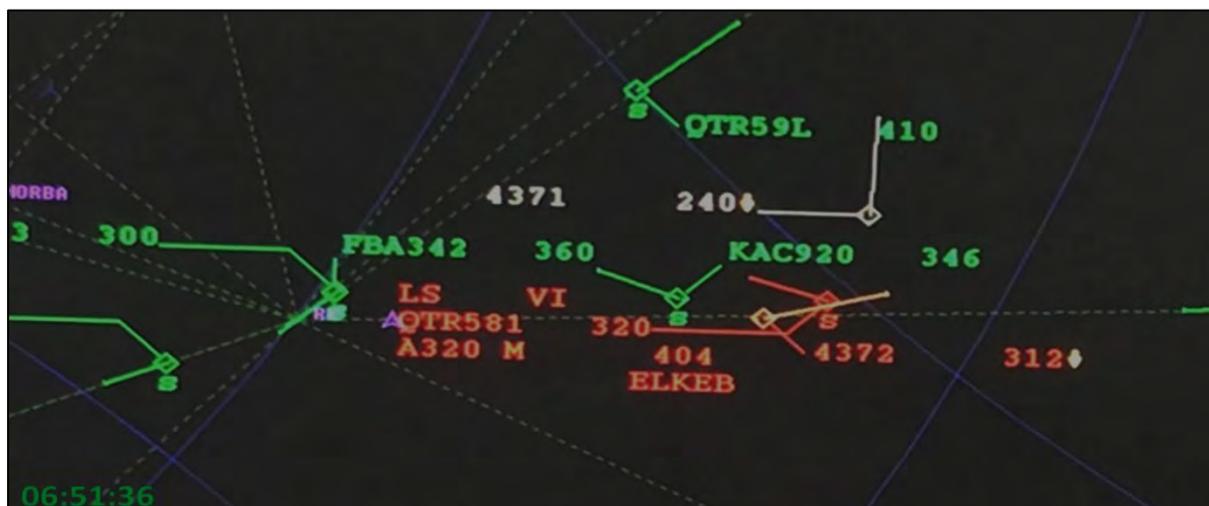
Figure 9 KAC920 reporting clear of conflict

2.1.14. At 06:51:36 h, KAC920 reported it was clear of traffic and descended back to FL340 from FL348 while the military aircraft was descending through FL312 (Figure 8). The other fighter aircraft remained within the coordinated block between FL260 and FL200 throughout the event.

3.1.7. After crossing the reciprocal military traffic, KAC920 reported clear of conflicting traffic and descended back to FL340.
