FINAL INVESTIGATION REPORT

SERIOUS INCIDENT (TCAS – RA) BETWEEN PIAC FLIGHT PIA303, A320-214 AIRCRAFT, REG. NO. AP-BOL (OPLA - OPKC) AND MILITARY AIRCRAFT ON 04-03-2022

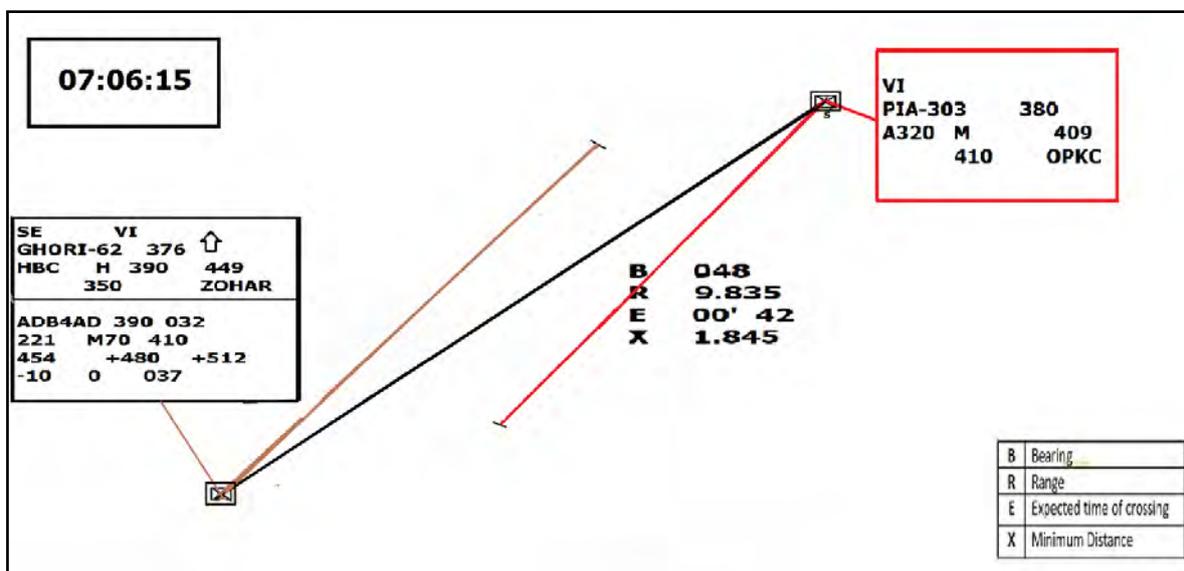
Figure 3 PIA303 Maintaining FL380

- 1.1.3. At 06:51:00 h, GHAURI-62 came in contact with Karachi ACC East passing FL235 for FL310.
- 1.1.4. At 06:52:00 h, GHAURI-62 was re-cleared to FL390 [by trainee in coordination with his On-the-Job Training Instructor (OJTI)]⁴.
- 1.1.5. At 06:56:00 h, PIA303 checked position ZOHAR maintaining FL380 and was cleared direct to position MAKLI.
- 1.1.6. At 07:05:32 h, PIA303 informed Karachi ACC East that they are receiving reciprocal traffic climbing through its level. At that time reciprocal traffic GHAURI-62 was 20 NM from PIA303 climbing out of FL373 for FL390.
- 1.1.7. At 07:06:15 h, East Procedure Controller passed traffic information to GHAURI-62 regarding reciprocal traffic PIA303 at 9 NM maintaining FL380. At that time GHAURI-62 was passing FL376 for FL390. On response GHAURI-62 reported turning.

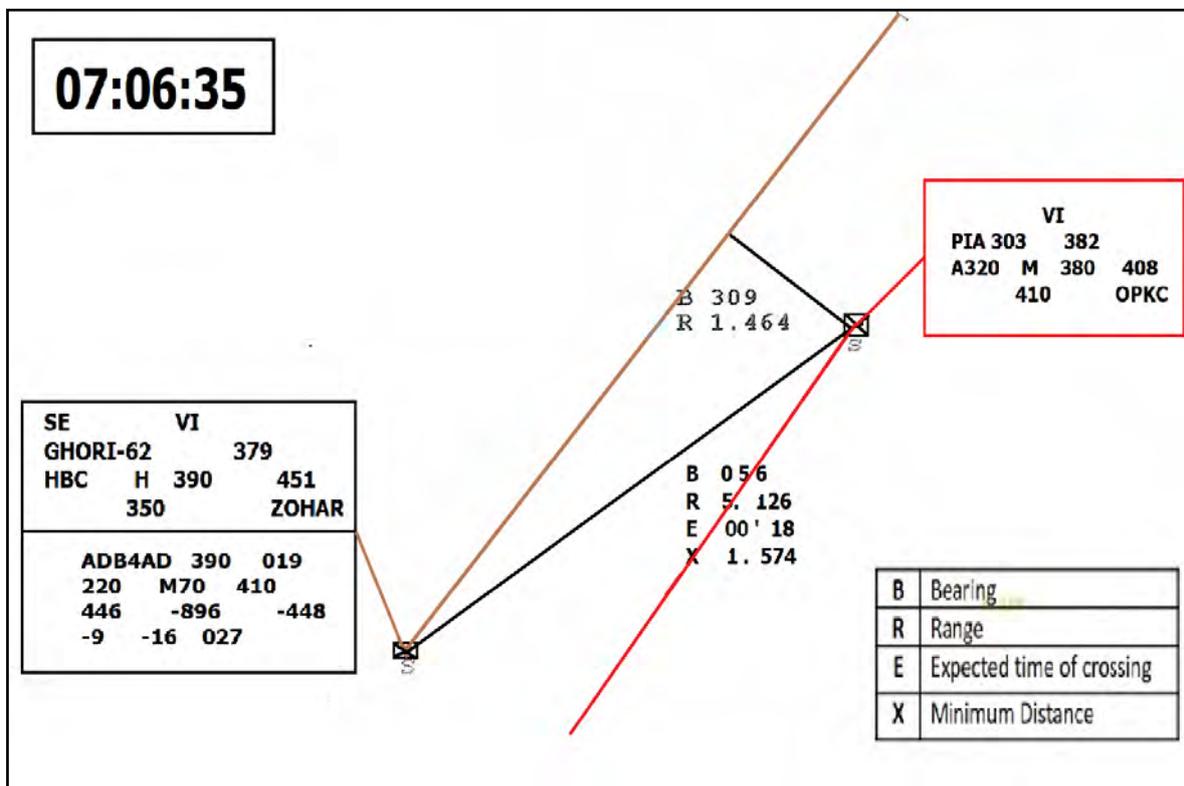
Figure 4 Aircraft initiated RA climb & descend

- 1.1.8. At 07:06:40 h, both aircraft reported TCAS-RA 30 NM North-East of Nawabshah. PIA303 initiated RA climb to FL385 whereas GHAURI-62 initiated RA descend to FL374 respectively.

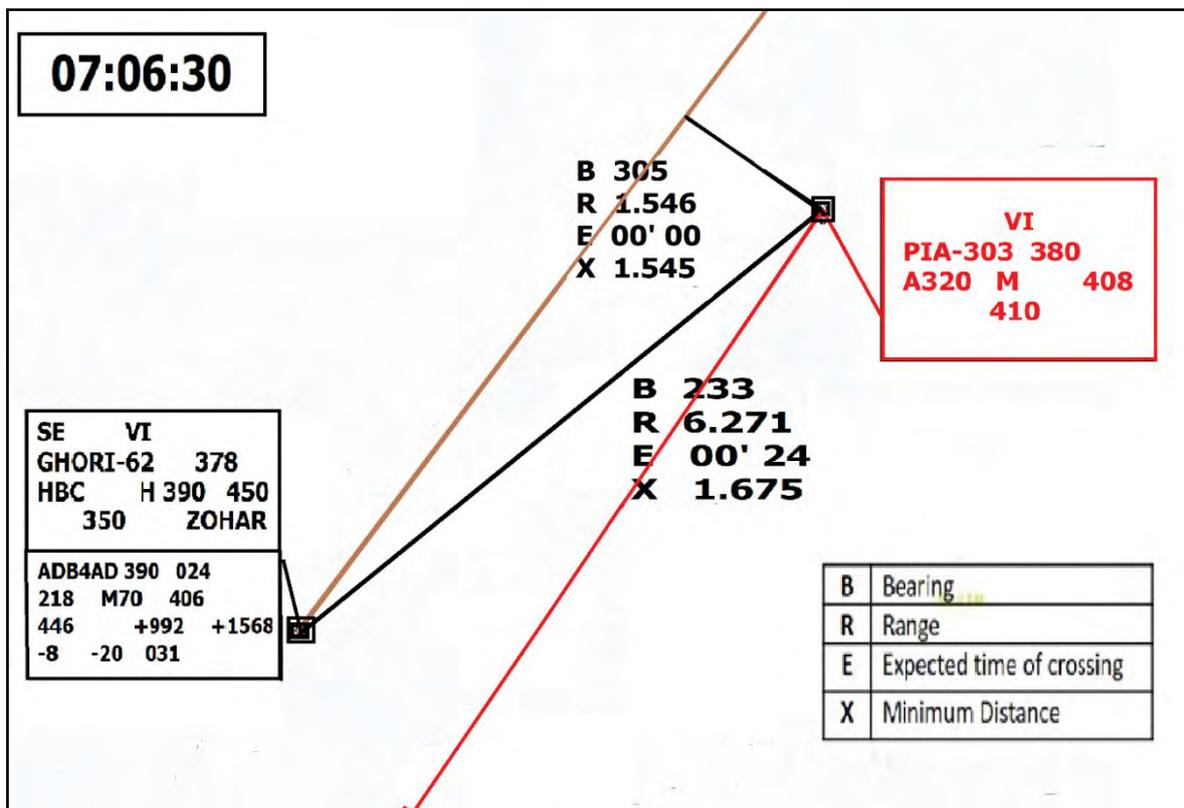
Figure 5 Vertical & Lateral separation

1.1.9. At the time of TCAS-RA, there was a vertical separation of 200 ft and a lateral separation of 6.2 nautical miles between both aircraft.

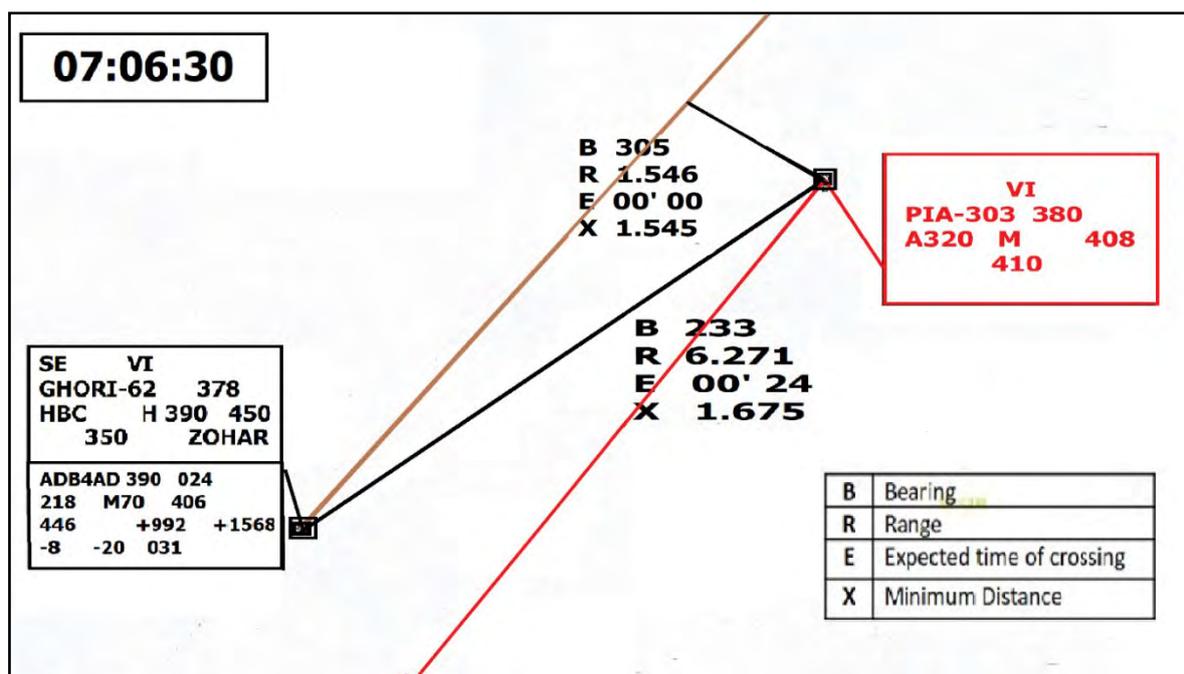
Figure 9 Vertical & Lateral Separation

2.1.10 At the time of TCAS-RA, there was a vertical separation of 200 ft and a lateral separation of 6.2 NM between both aircraft.

2.1.12 The ACC Radar Controller (East) could have handed over the radar control position to the available team leader for better traffic management, instead of leaving the seat and assuming that the procedure controller, who was already pre-occupied with coordination with other units regarding military exercise, would manage the radar traffic in his absence.

3.2.1.1. Absence of ACC Radar Controller East from his radar executive position considering that ACC Procedure Controller (East), being radar rated would manage the position during his absence.

3.2.1.2. Activation of TCAS – RA (**MAC – Mid Air Collision**) due to lack of situational awareness by the ACC Procedure Controller.

4.1.1. PAA to implement rigorous training for Procedure Controllers and OJTIs to handle simultaneous tasks effectively, especially during critical situations like military exercises or high traffic scenarios.

4.1.2. Ensure that all Radar Controllers positions are manned positively to avoid attention diversion and pre-occupation of other controllers. A dedicated controller may be deployed for coordination among units during high density traffic / Military exercises.

4.1.3. Effective involvement and supervision by Team Leaders / Supervisors may avoid such recurrences in future.
