FINAL INVESTIGATION REPORT

SERIOUS INCIDENT (TCAS – RA) BETWEEN EMIRATES FLIGHT UAE600, BOEING 777-31H(ER) AIRCRAFT, REG. NO. A6-ENK (SECTOR OMDB TO OPKC) AND MILITARY AIRCRAFT ON 13-07-2018

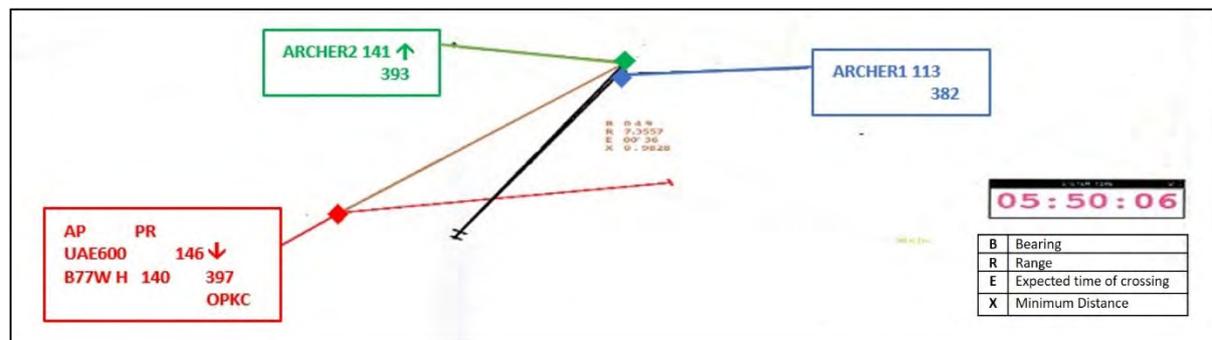
1.1.6. At 05:50:06 h, UAE600 reported traffic at 3 o'clock (which was actually 10 o'clock) just 200 ft below, upon which Approach Controller informed UAE600 about the Military traffic maintaining FL120, crossing from left to right.

Figure 2 Presence of military traffic in climbing phase out of FL141

2.1.5. At 05:50:06 h, UAE600 reported traffic at 3 o'clock (which was actually 10 o'clock) just 200 ft below, upon which Approach Controller informed UAE600 about the Military traffic maintaining FL120, crossing from left to right whereas Military traffic was passing through FL141 for higher although it was restricted to FL120.

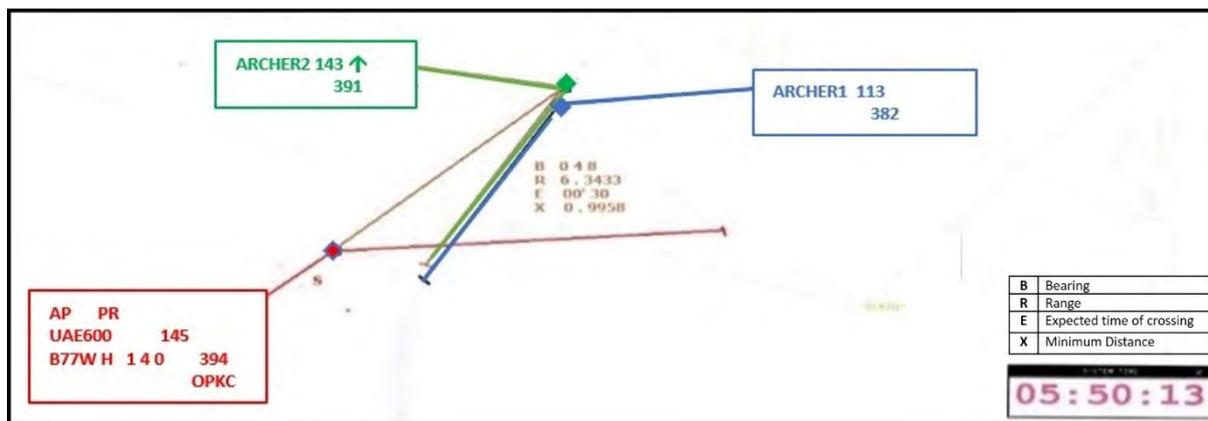
1.1.7. At 05:50:17 h, UAE600, reported and initiated TCAS – RA climb.

Figure 3 UAE600, reported TCAS – RA

1.1.11. At the time of incident, minimum vertical separation of 200 ft and lateral 6.3 NM existed between UAE600 and ARCHER-2 Military aircraft³.

³ Refer Figure 3

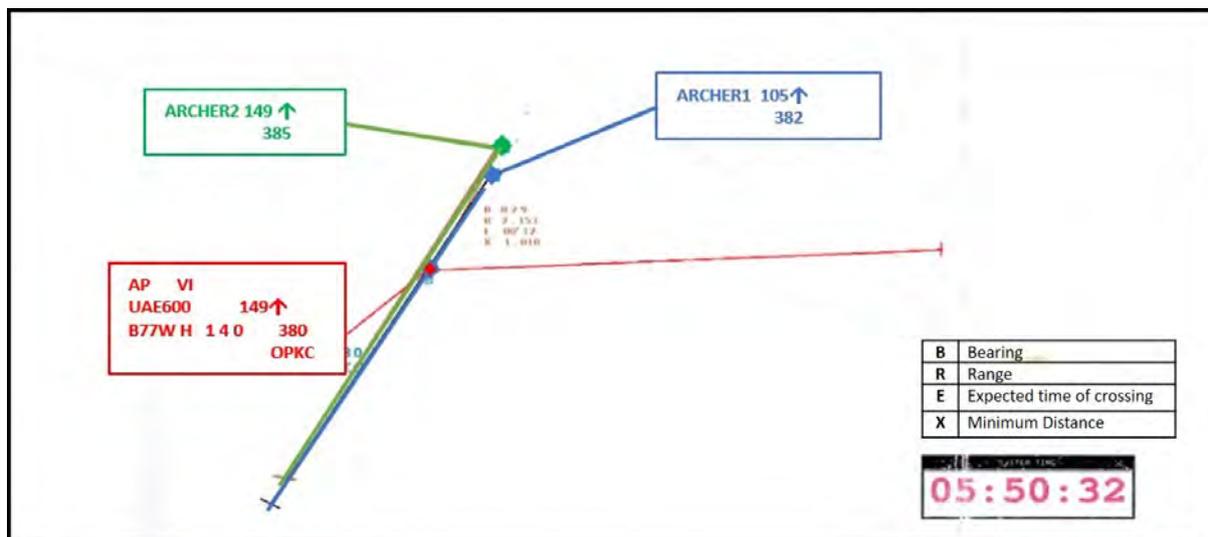
1.1.8. At 05:50:32 h, UAE600 informed “traffic insight and clear of conflict”.

Figure 4 Traffic insight and clear of conflict

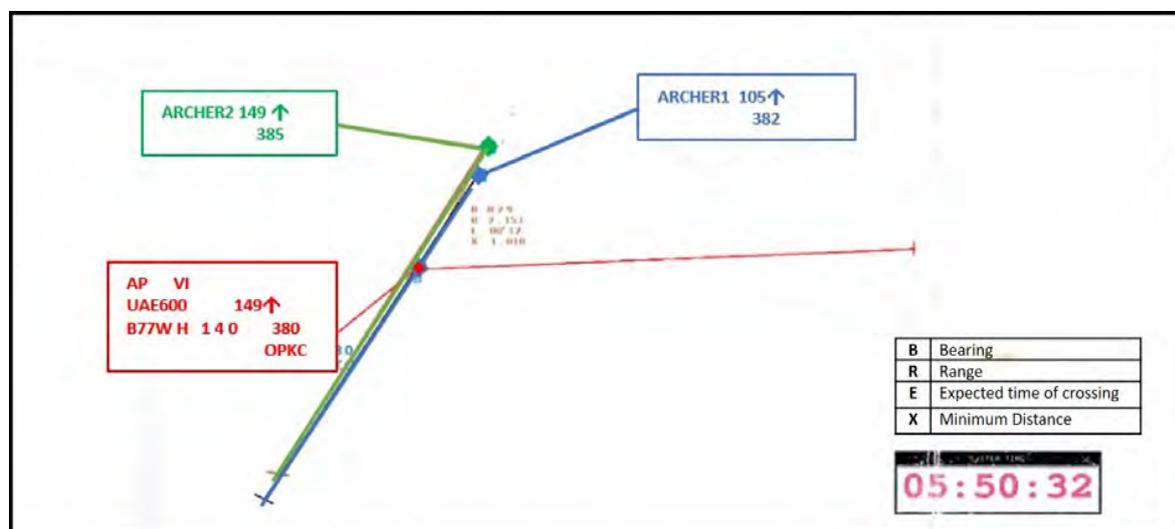
2.1.8. At the time of incident, minimum vertical separation of 200 ft and lateral 6.3 NM existed between UAE600 and ARCHER-2 Military aircraft.

2.1.9. As per the available record, ARCHER-2 climbed to FL149 from FL133 while approaching close to UAE600 on a crossing track. UAE600 was also crossing FL 149 while initiating RA climb to higher level, which may have resulted in activation of TCAS – RA.

Figure 8 Traffic insight and clear of conflict

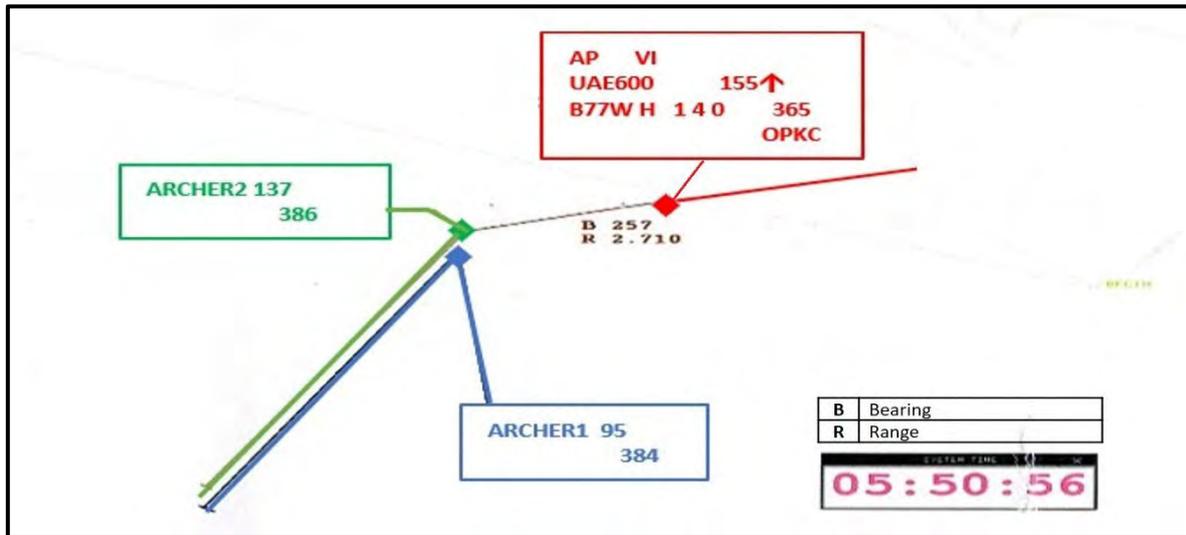
2.1.10. UAE600 climbed up to FL155 in response to TCAS – RA.

Figure 9 Climbed up to FL155 in response to TCAS – RA
