## FINAL INVESTIGATION REPORT

### **SERIOUS INCIDENT – AIR BLUE FLIGHT ABQ-613, AIRBUS 320 AIRCRAFT, REG NO AP-EDA, BACHA KHAN INTERNATIONAL AIRPORT, PESHAWAR ON 23-04-2019**

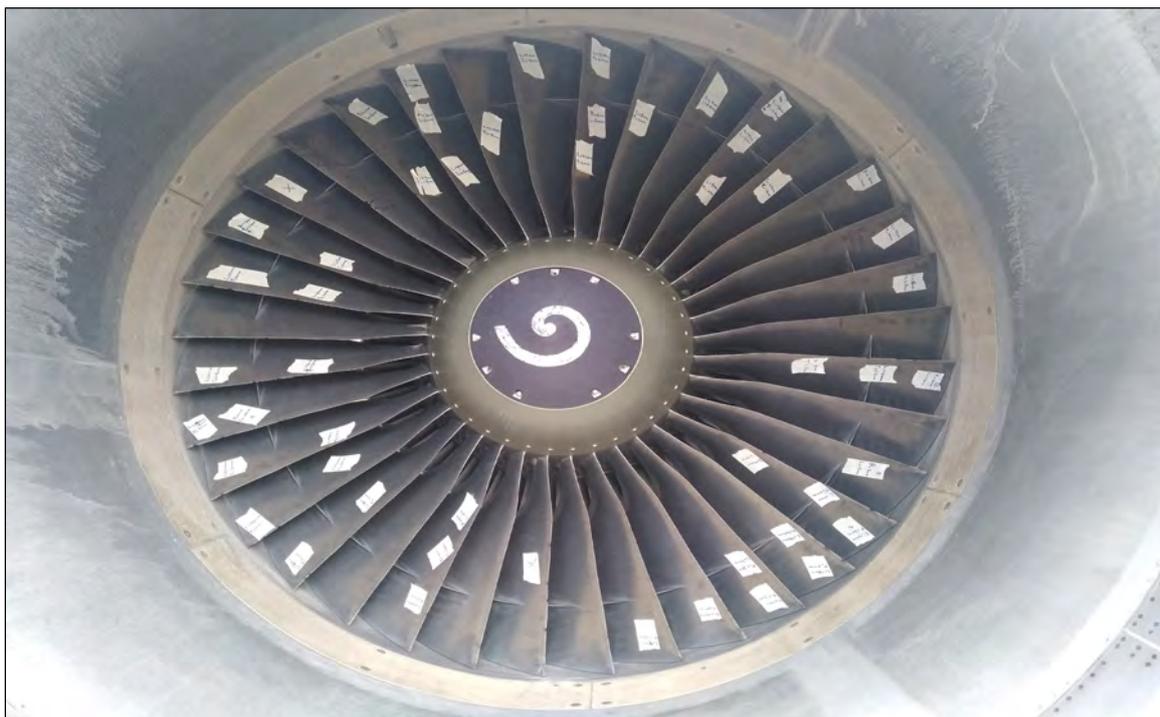
1.3.1. 14 Fan Blades of Engine No. 1 were found to be damaged beyond serviceable limits.

Figure 1 Damaged Engine Fan Blades

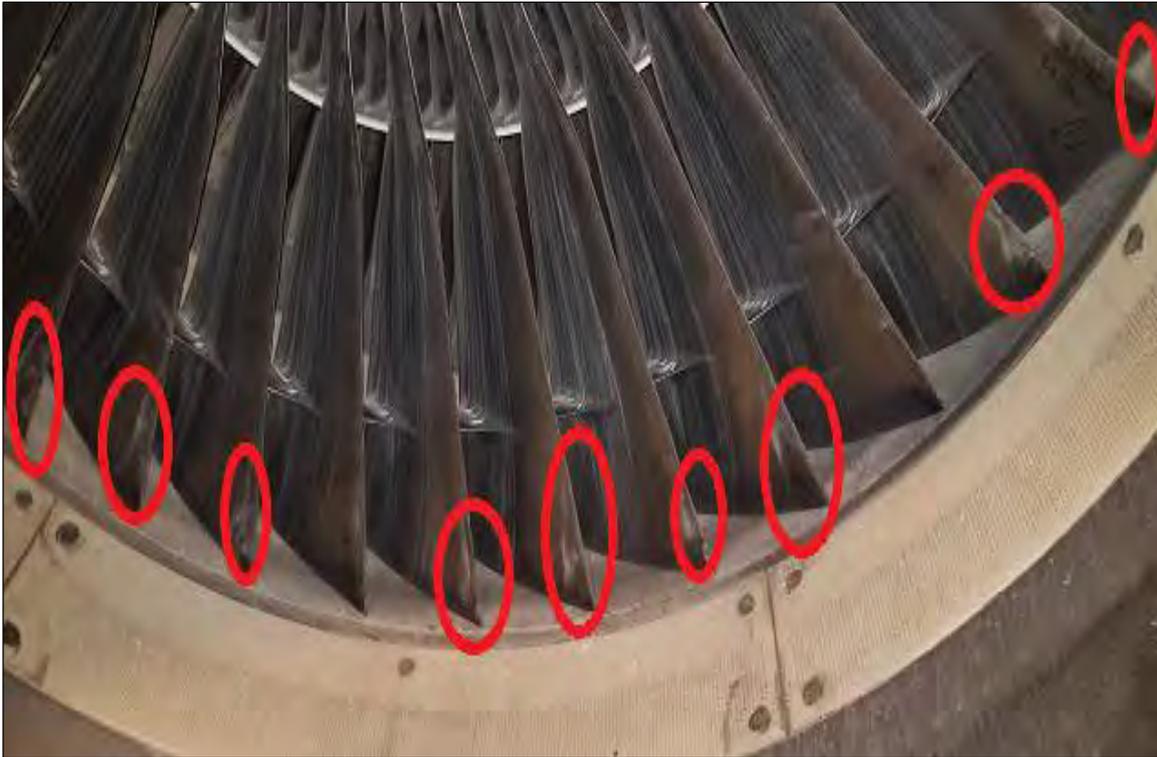
1.3.2. 02 Fan Blades of Engine No. 2 were found to be damaged beyond serviceable limits.

Figure 2 Damaged Engine Fan Blades

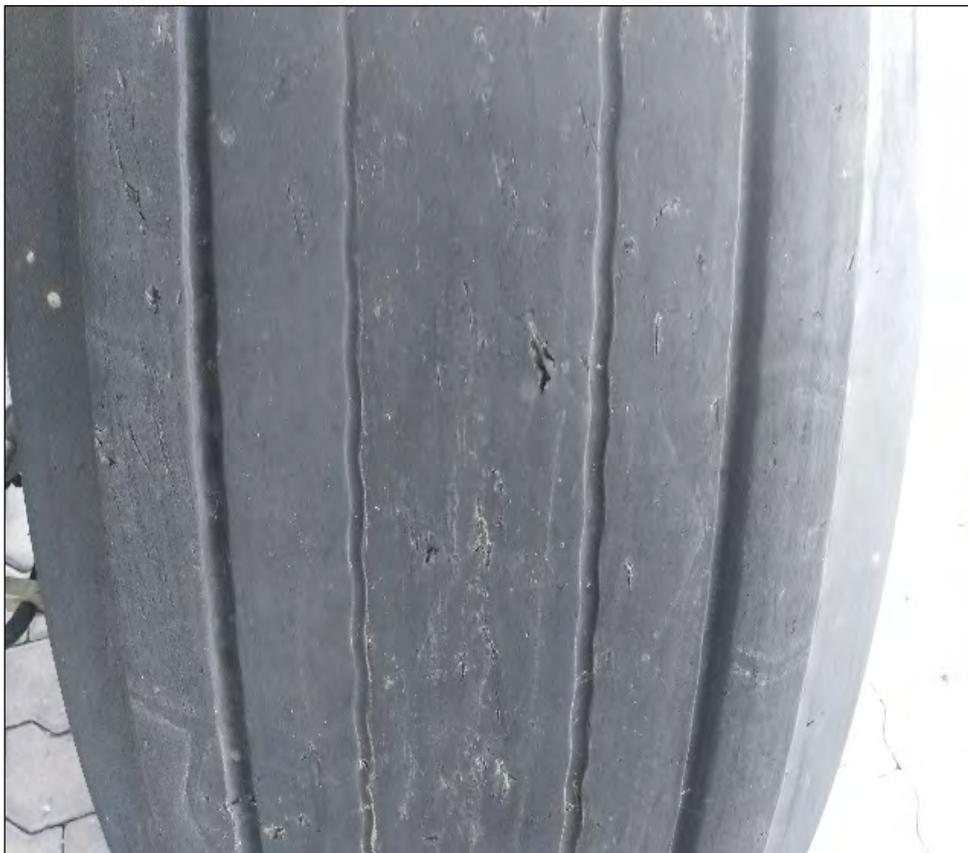
1.3.3. All wheels were to be replaced due crossing over barrier steel cable (for fighter aircraft) at the end of the runway.

Figure 3 Damaged Tyre

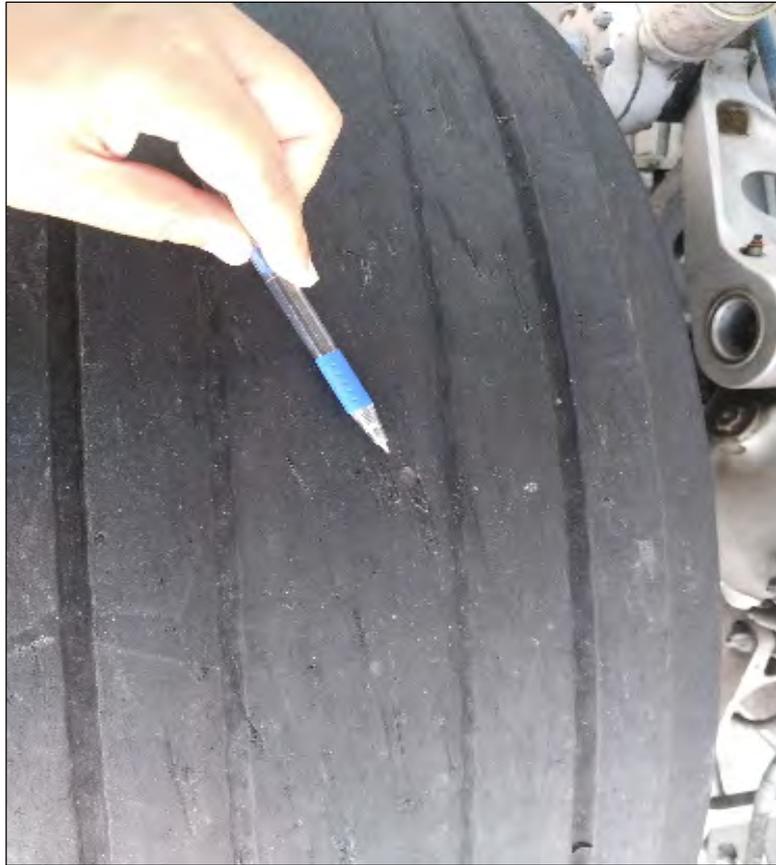
Figure 4 Damaged Tyre

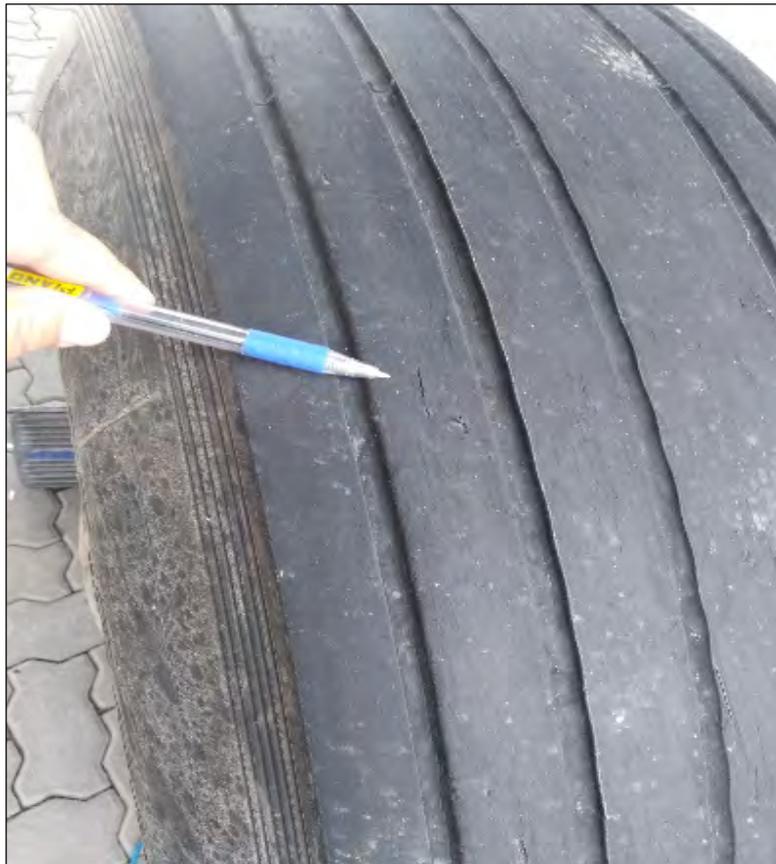
Figure 5 Damaged Tyre

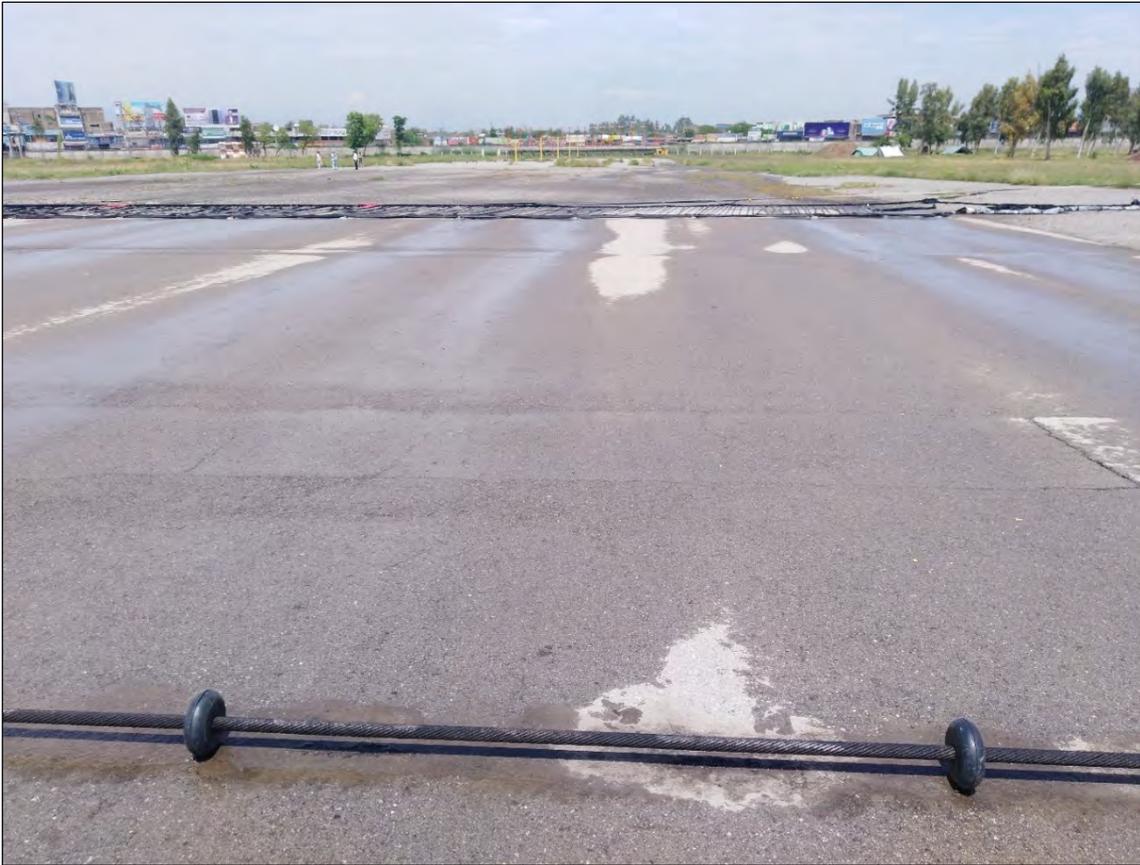
Figure 6 Fighter Aircraft Arrester Cable and Net

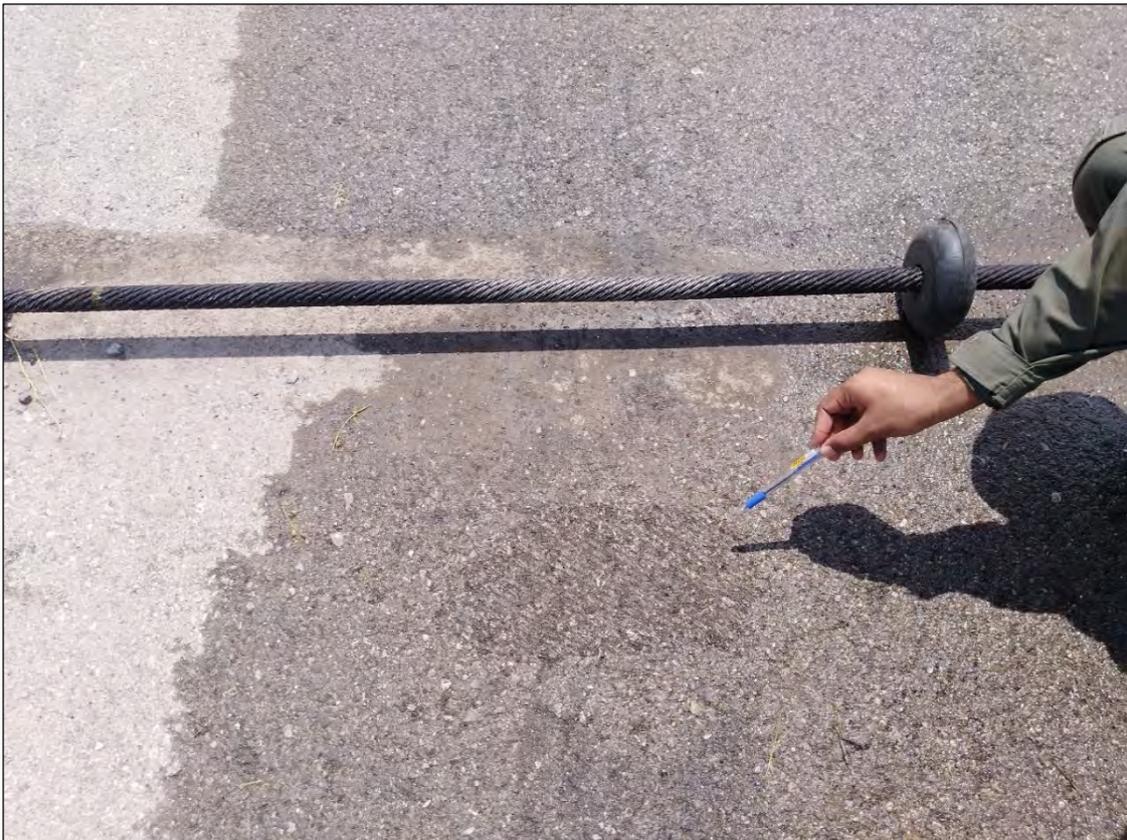
Figure 7 Tyre Marks Prior to Crossing Arrester Cable

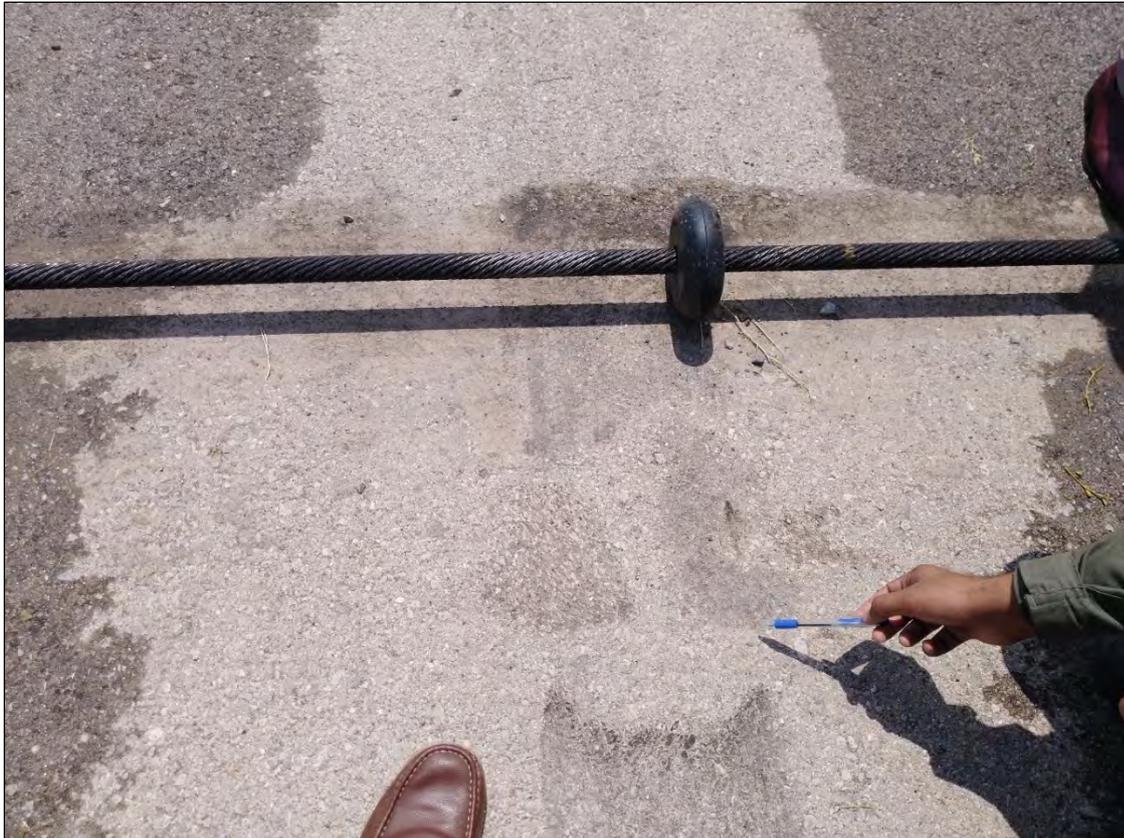
Figure 8 Tyre Marks Prior to Crossing Arrester Cable

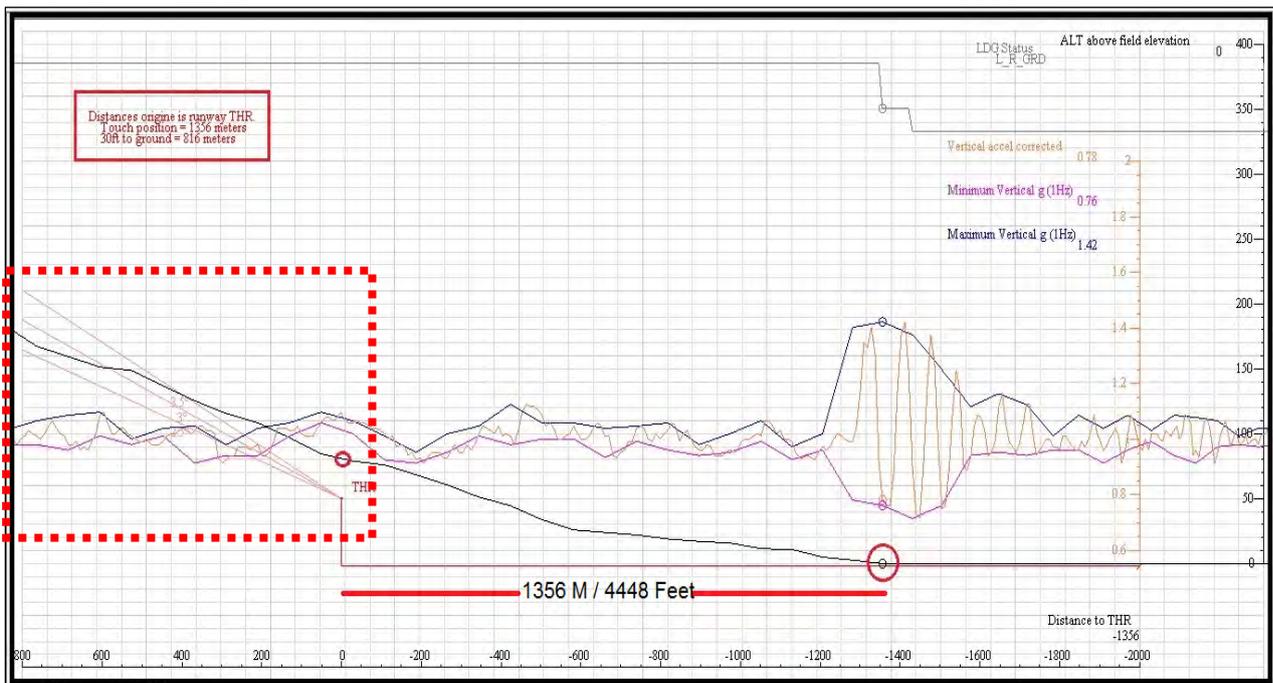
2.6.2. However, no effort was made by the PF to increase the Rate of Descent (ROD) by adjusting the pitch attitude. Instead of maintaining Glide Slope of 3°, the Captain maintained a shallower aircraft attitude and thus shallower glide slope, as a result of which the aircraft crossed the Runway threshold at 66 ft AGL.

Figure 14 Aircraft Glideslope

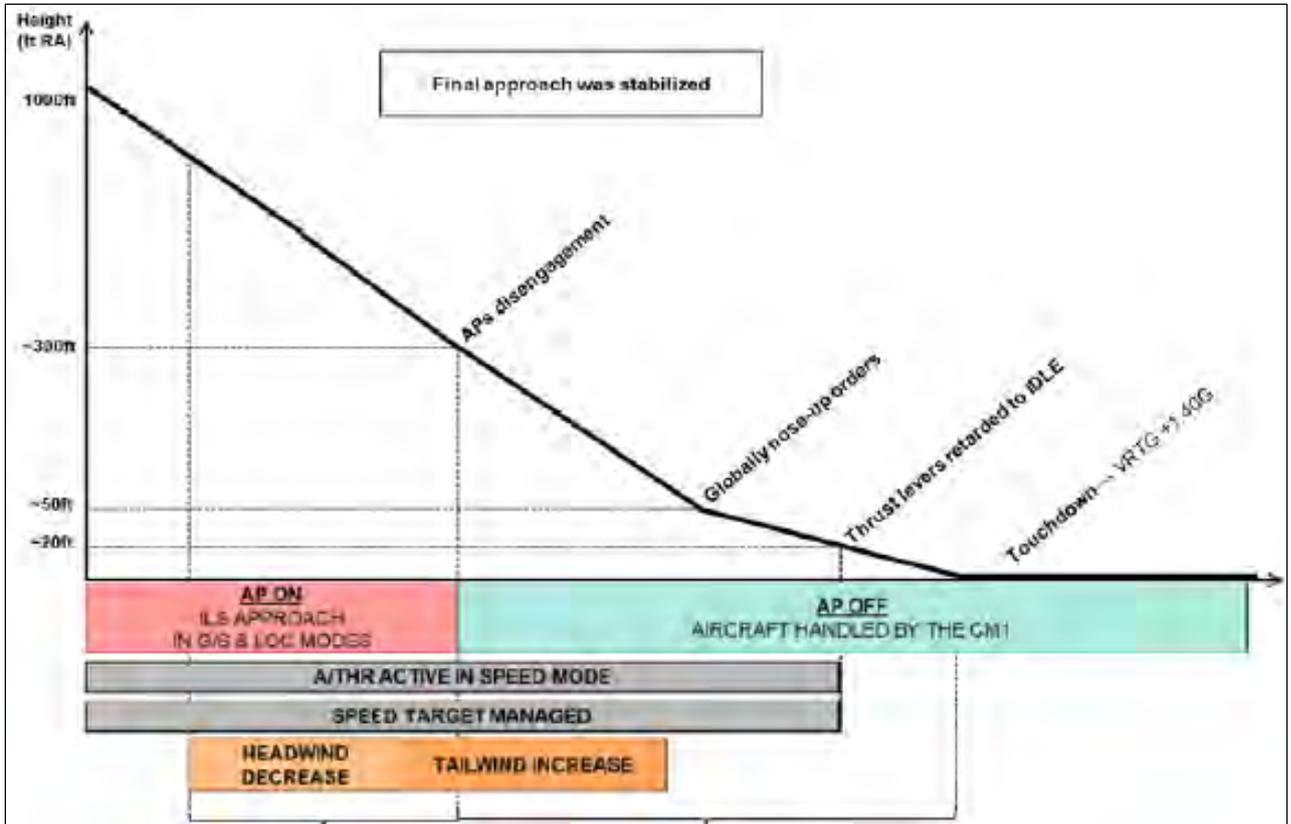
Figure 15 Aircraft Glideslope

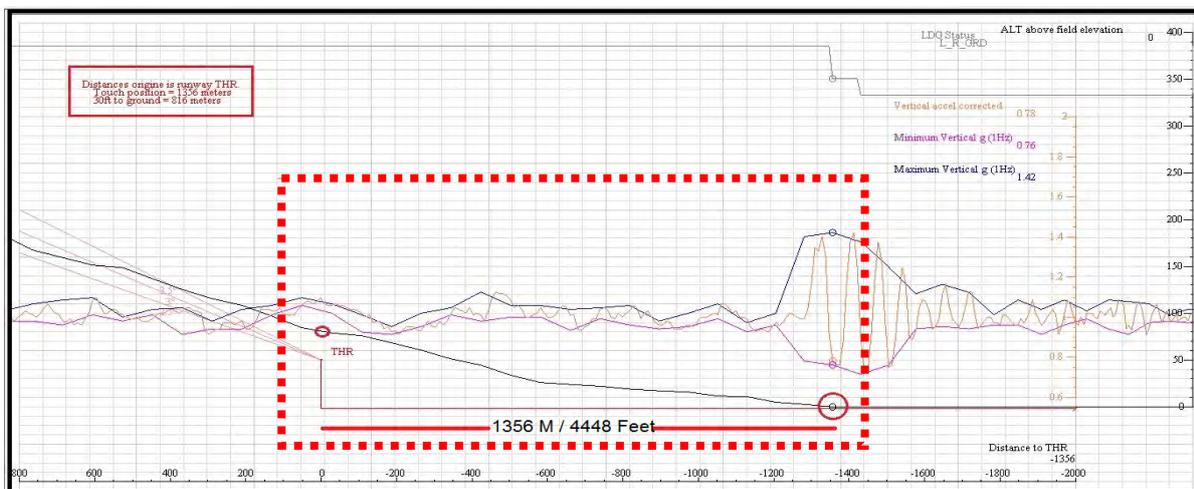
2.7.1. Approaching a height of 20 ft above the R/W surface, the pitch attitude of the aircraft further shallowed thus reducing the ROD. This reduced ROD coupled with the tail wind component served to increase the float distance of the aircraft.

Figure 16 Aircraft Flare out

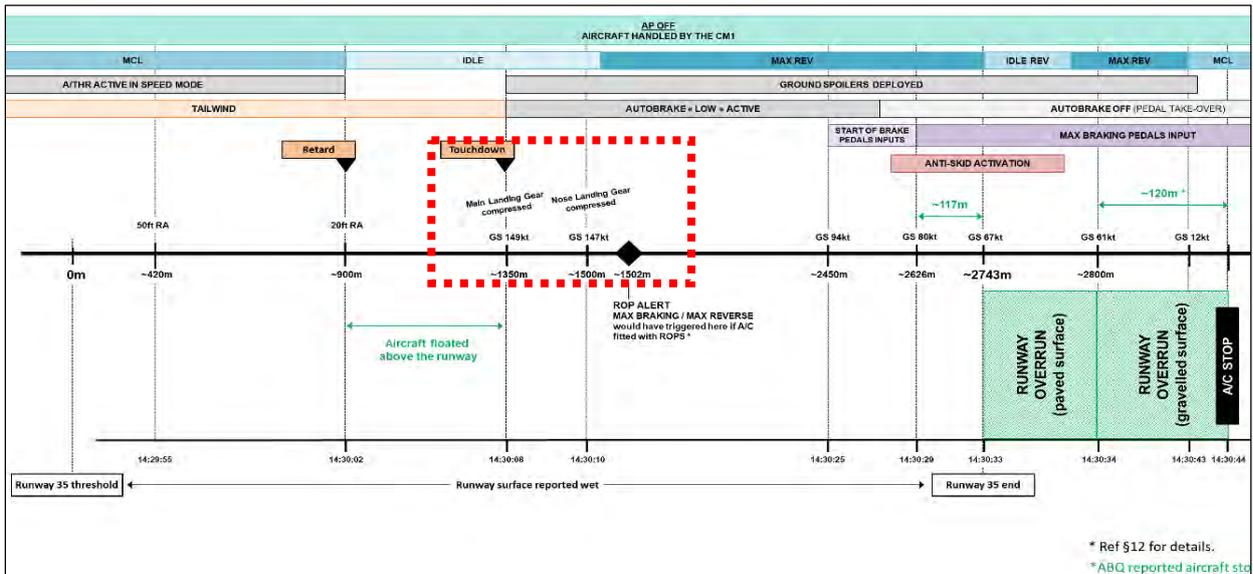
2.8.1. As a result of the long float, the aircraft landed at a distance of 4,448 ft from the threshold of R/W 35 (Main + Nose Landing Gears on runway surface).

Figure 17 Aircraft Touchdown

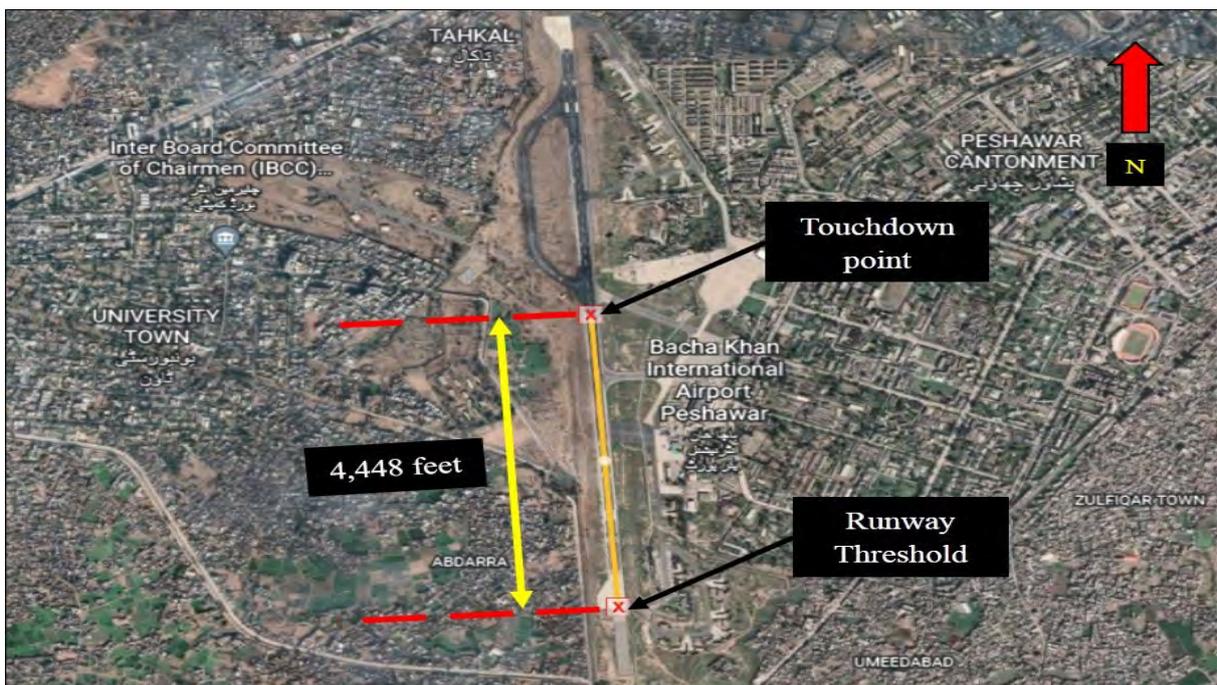
2.8.2. As the length of the R/W is 9,000 ft, so the aircraft touched down almost halfway down the R/W with only 4,552 ft of R/W length remaining in which to stop the aircraft. The Captain selected thrust reversal on touchdown which, coupled with spoilers that had already been armed, became effective two seconds after touchdown. The indicated speed on touchdown was 141 kt with Ground Speed (GS) being 147 kt.

Figure 18 Landing Distance

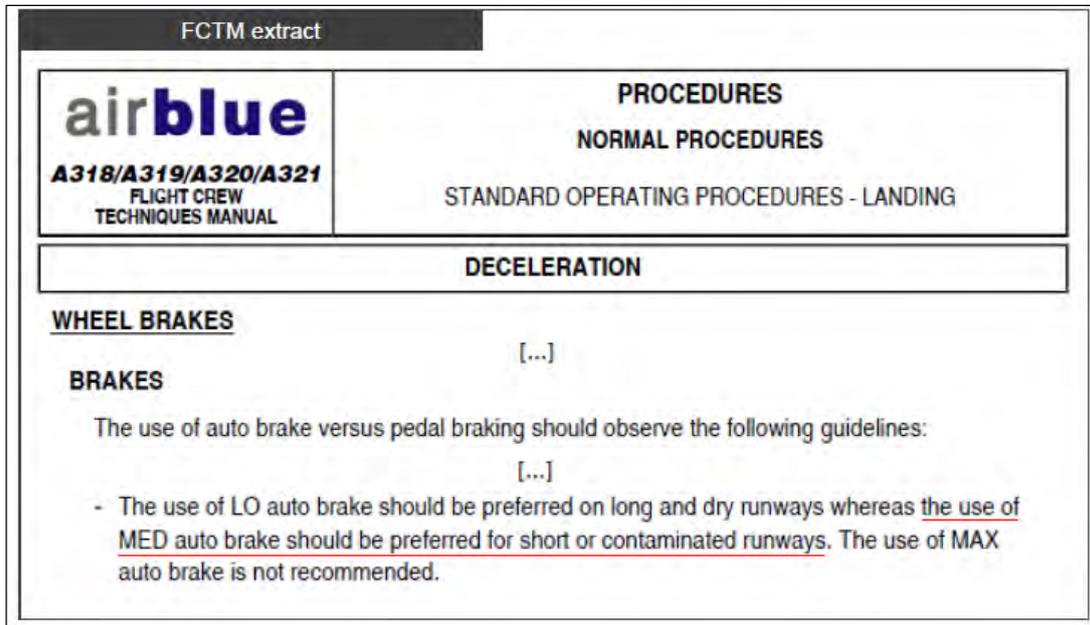
2.9.1. As the aircraft was on finals during ILS pattern, the auto braking was armed and selected to “LOW”; however, as per the Cockpit crew Training Manual (FCTM), the use of Autobrake mode MEDIUM should be preferred for contaminated runways.

Figure 19 Deceleration on Brakes

4.1.1.6. Selection of Auto braking to MEDIUM may be made as standard for inclement weather landing.

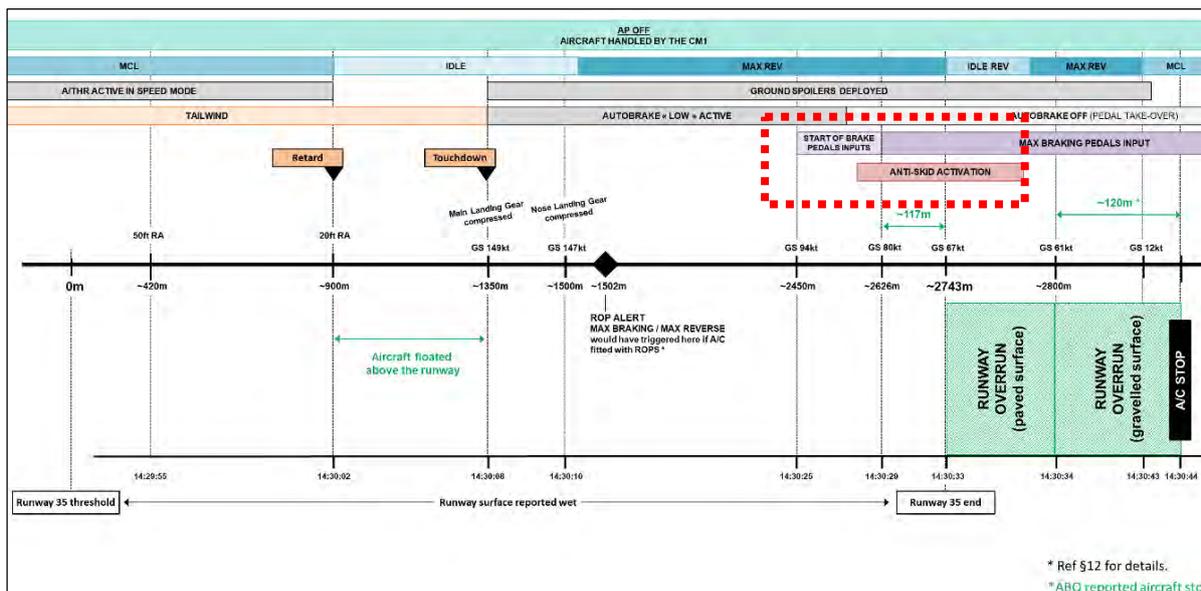
2.9.2. In conjunction with thrust reversers and spoilers, deceleration was initiated as soon as brakes were activated after touchdown; however, owing to late touchdown, wet runway surface and LOW autobraking selection, the deceleration proved to be insufficient. At a distance of 8,036 ft down the R/W (Speed 94 kt), the Captain initiated manual braking with maximum brake input coming in at 8,614 ft down the R/W at which time the anti-skid activated to prevent wheel jamming.

Figure 20 Manual Braking

2.9.3 The wheel rotation for all wheels was uniform with no wheel jamming or hydroplaning on the wet R/W surface. This action of manual braking, however, also proved to be insufficient to stop the aircraft on the R/W as it was applied too late.

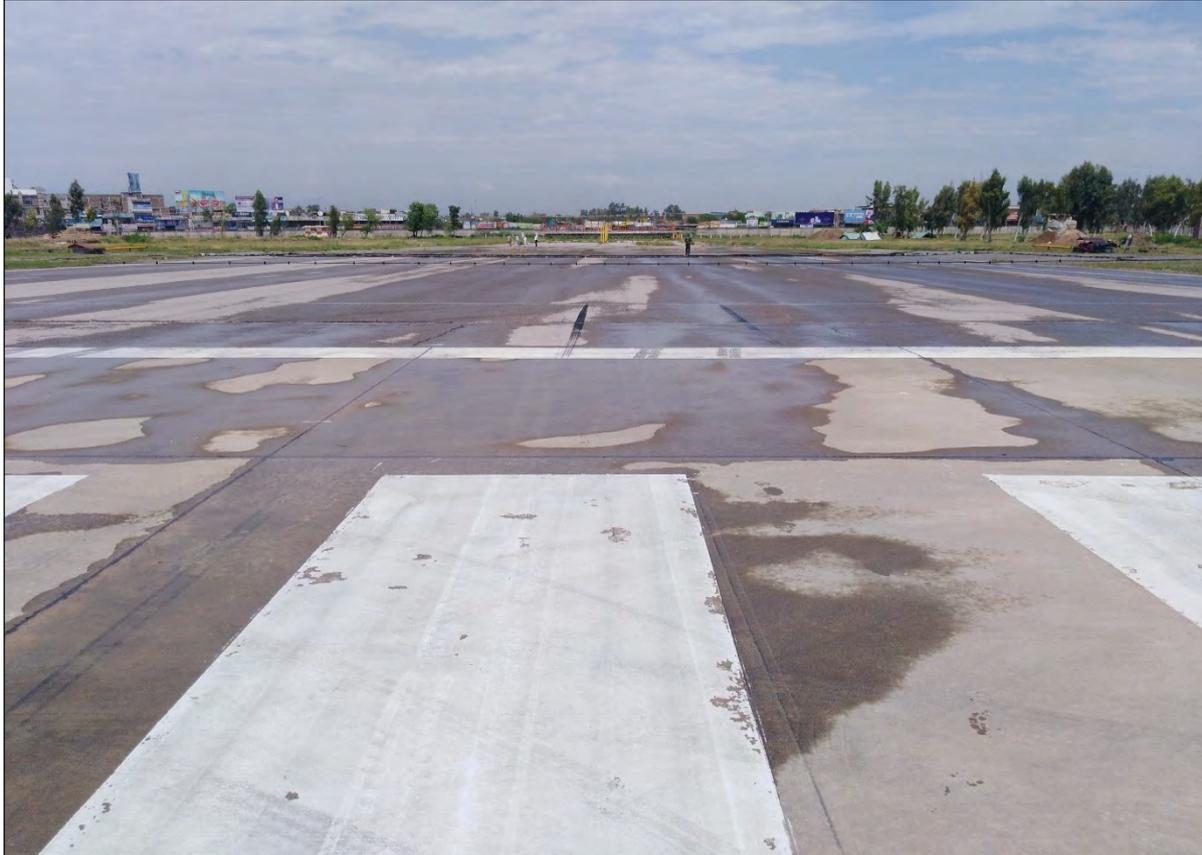
2.10.1. The aircraft being unable to stop on the R/W initially entered the paved surface and, after crossing over the barrier cables, came to rest 425 ft after the R/W threshold.

Figure 21 Aircraft Tyre Marks Approaching End of Runway

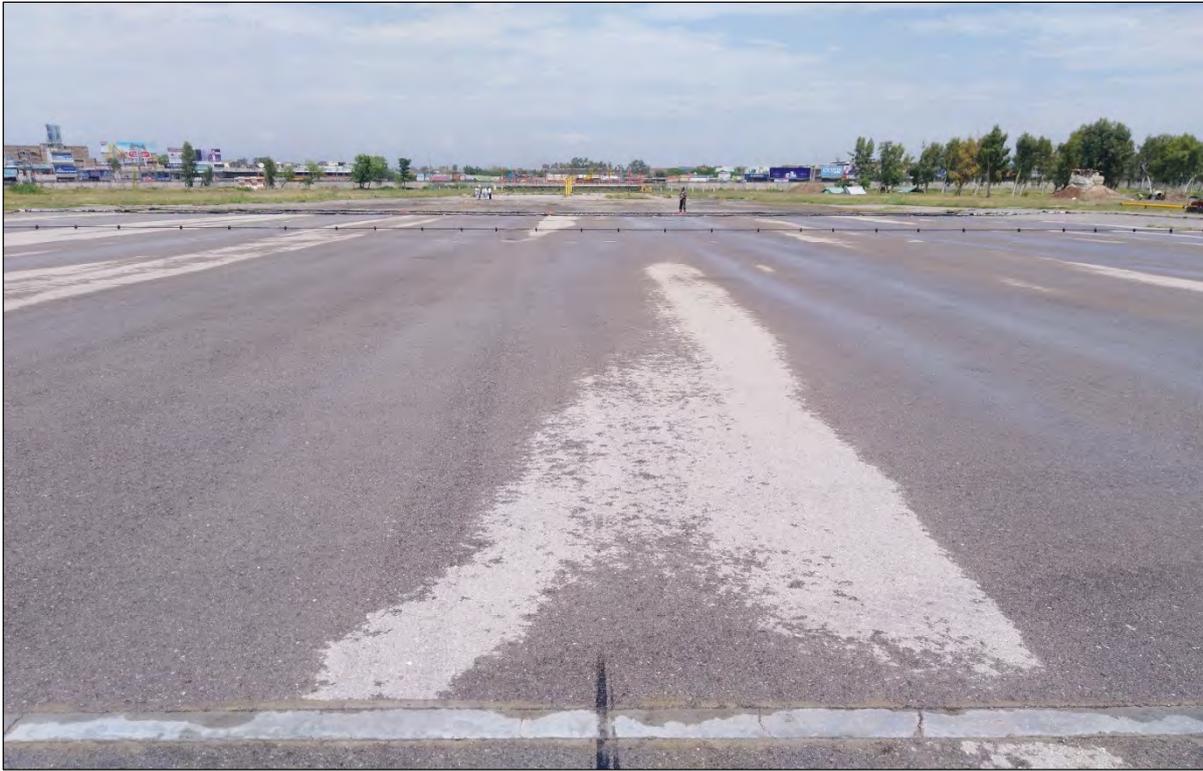
Figure 22 Aircraft Tyre Marks Approaching End of Runway

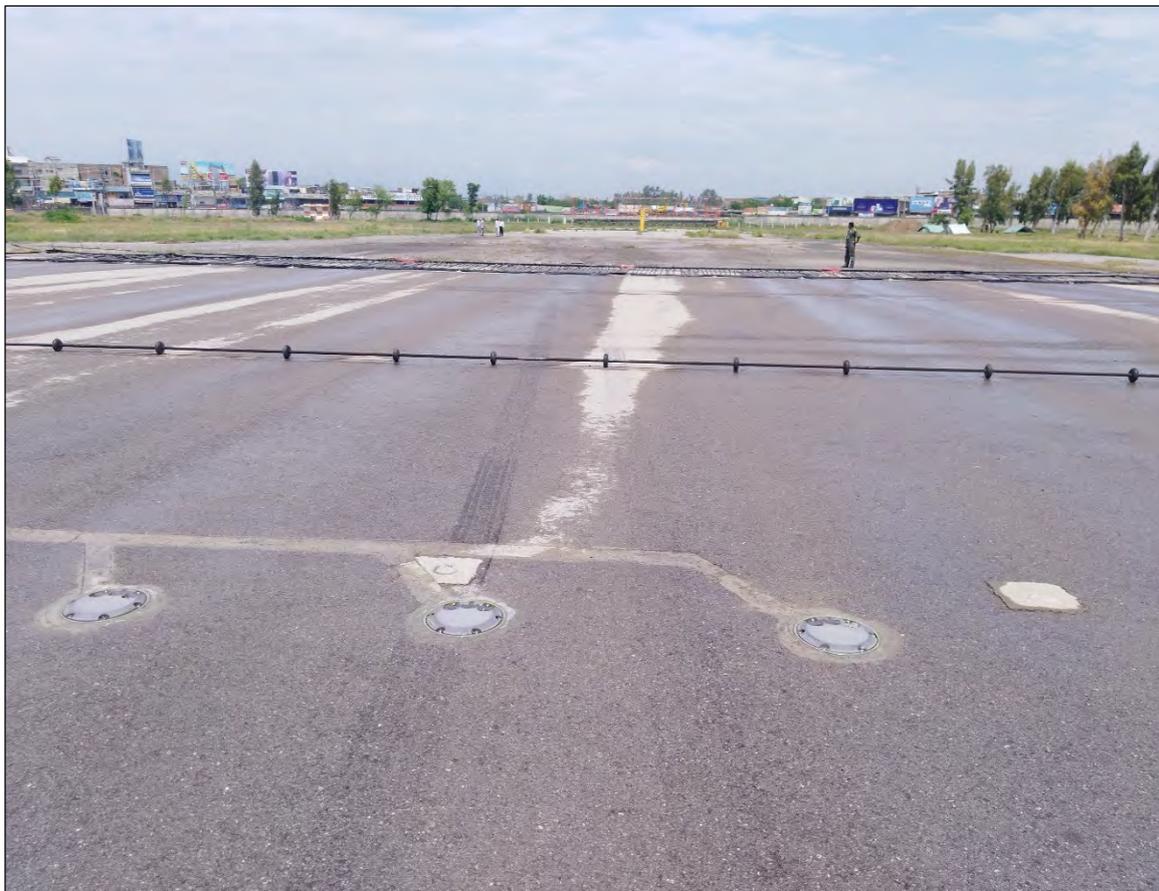
Figure 23 Aircraft Tyre Marks Approaching Arrester Cable

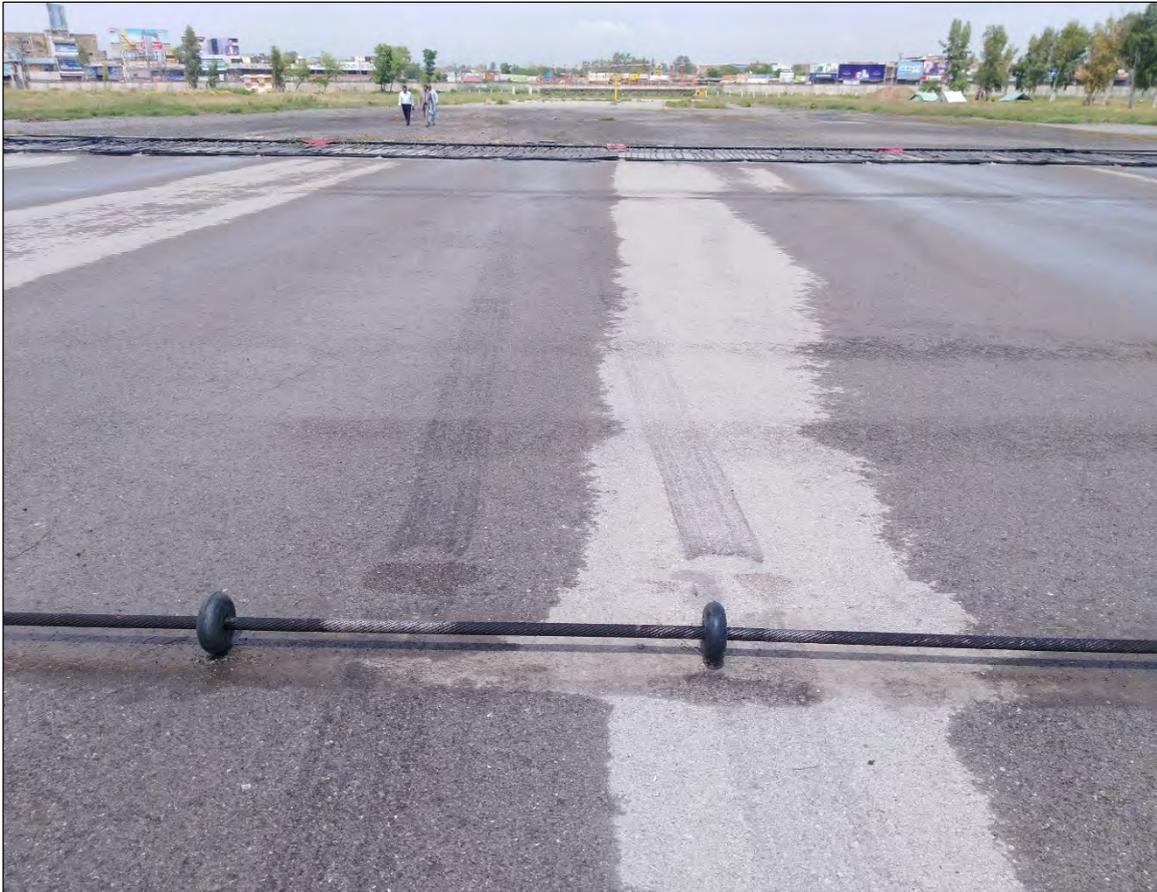
Figure 24 Aircraft Tyre Marks Crossing End of Runway
