FINAL INVESTIGATION REPORT

SERIOUS INCIDENT OF GULF AIR FLIGHT GFA 770 BOEING 787-9 AIRCRAFT REG. NO. A9C-FF AT ISLAMABAD ON 02-06-2021

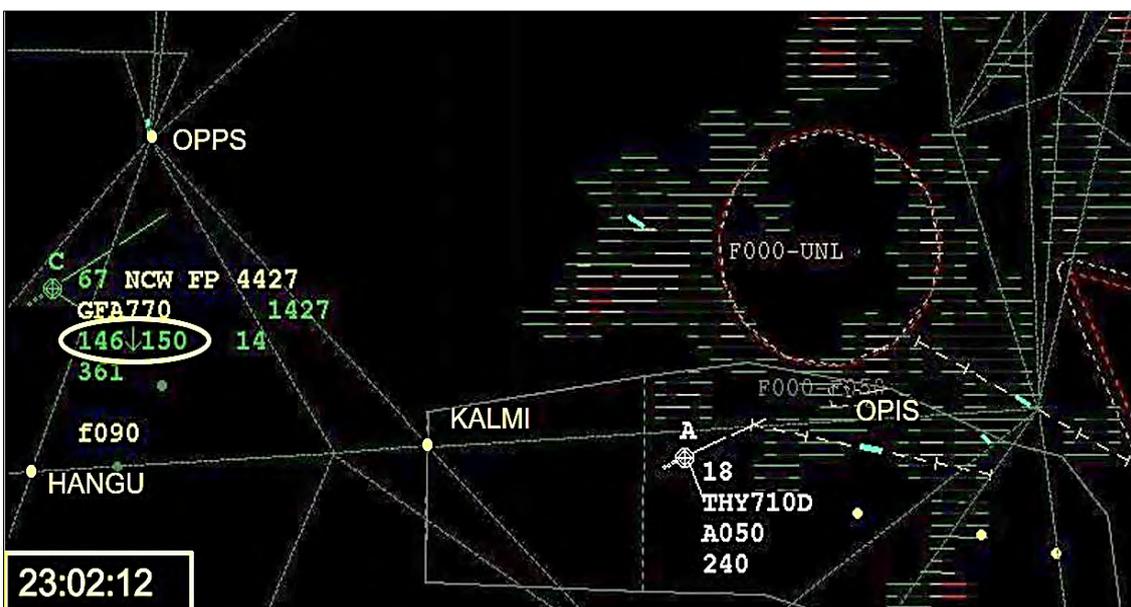
1.1.8. At 23:02:12 h, GFA 770 came in contact with Approach Control Islamabad crossing FL144 descending 9,000 ft on heading 050°. Approach Control Islamabad inquired whether the aircraft was turning right upon which GFA 770 informed that they would be turning right if given descent otherwise will be entering bad weather. Approach Control Islamabad advised GFA 770 to descend 10,000 ft, to which GFA 770 informed that they had been cleared to 9,000 ft. Approach Control Islamabad cleared GFA 770 to descend to 9,000 ft. The descent given by Area Control Islamabad (9,000 ft) was not updated electronically as it showed FL150 as cleared level.

Figure 4 GFA 770 cleared 9,000 ft but not updated electronically

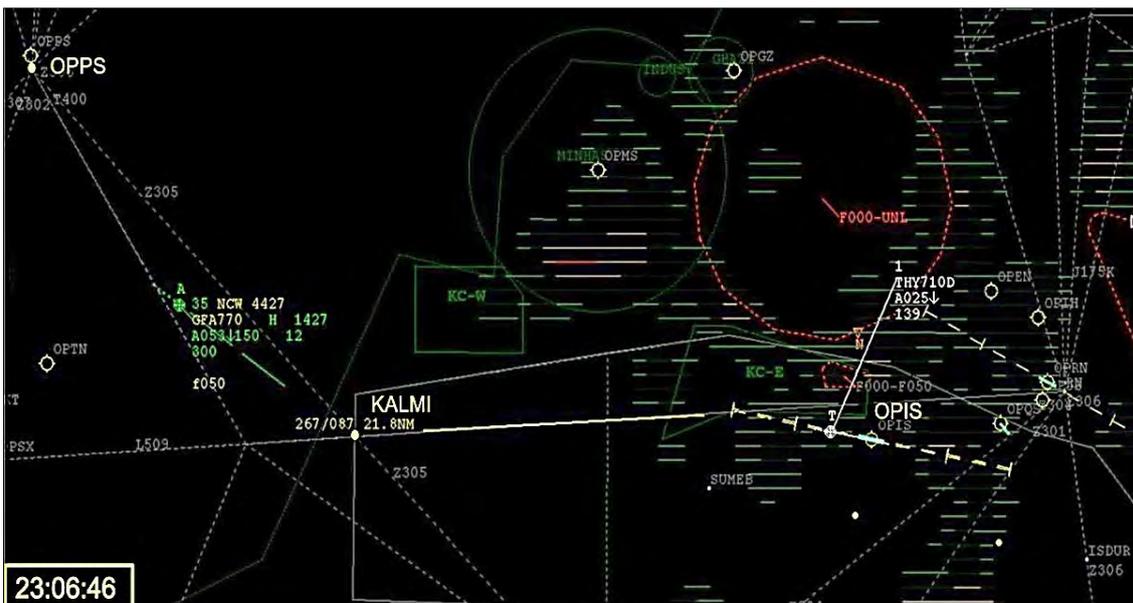
1.1.14. At 23:06:46 h, passing 5,300 ft, GFA 770 informed Approach Control Islamabad that “GFA 770 climbing Terrain React”.

Figure 7 GFA 770 Climbing Terrain React

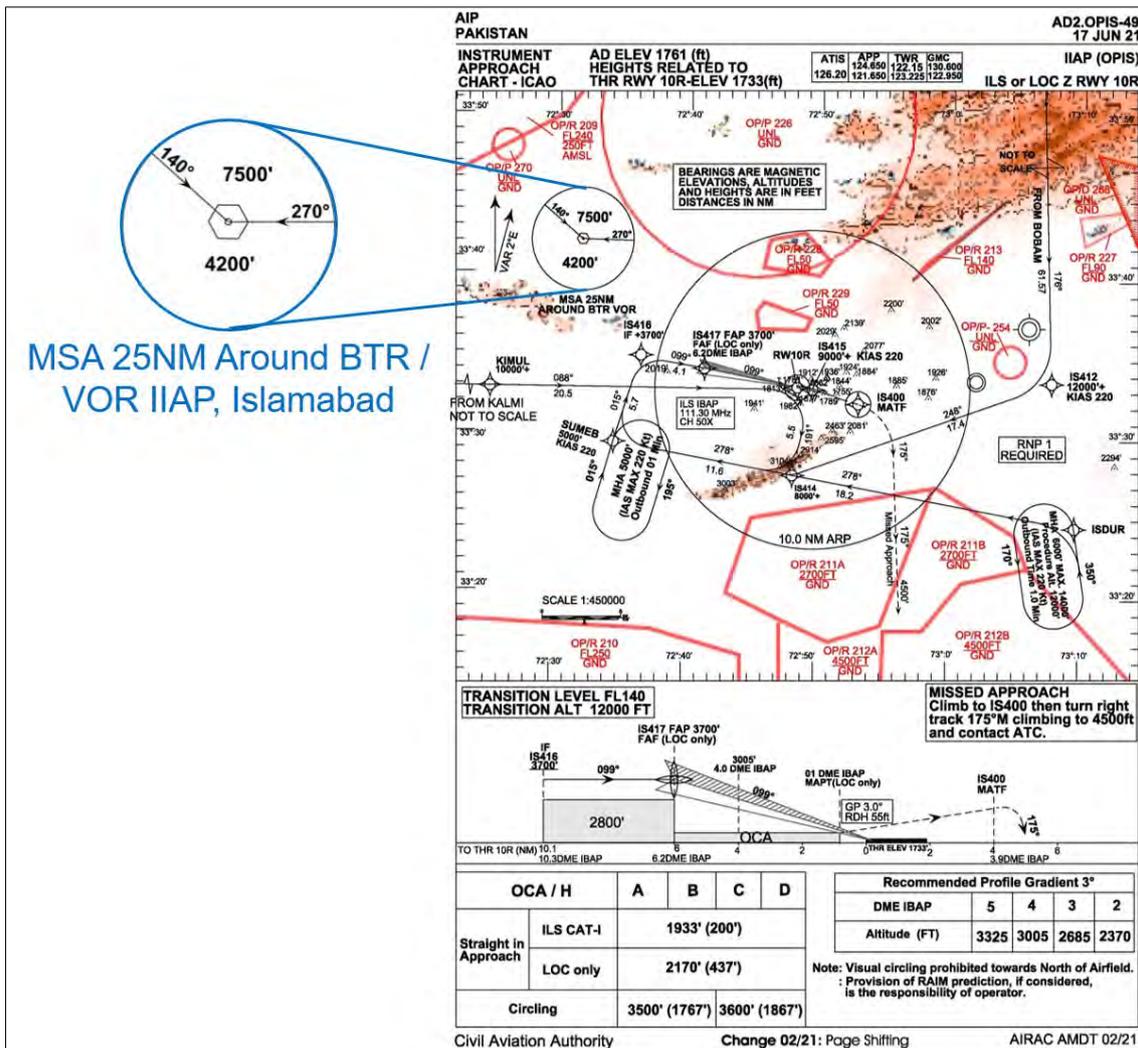
(e) Additionally, although the flight crew were familiar with GRID MORA, they did not consult it while deviating away from the planned route. On the contrary, they obtained the Minimum Sector Altitude (MSA) from the Approach Chart which specified 4,200 ft in the South West Sector within 25 NM from BTR (IIAP VOR), whereas aircraft was approximately 56 NM North West of IIAP, Islamabad (bearing 280° from IIAP, Islamabad), thus incorrectly identifying the MSA for the area.

Figure 15 MSA 25 NM around BTR / VOR IIAP, Islamabad

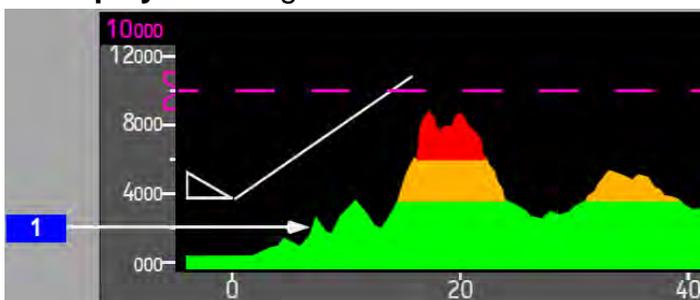
(g) **Aircraft Vertical Situation Display** – Boeing 787 has a Vertical Situation Display (VSD) where terrain is depicted along the projected aircraft vertical path, however; this only works in managed navigation mode (LNAV) on specified routes. Since the aircraft was off route due weather avoidance, therefore the VSD did not display any terrain.

Figure 17 Aircraft Vertical Situation Display
Copyright © Boeing, Reprinted with the permission of The Boeing Company

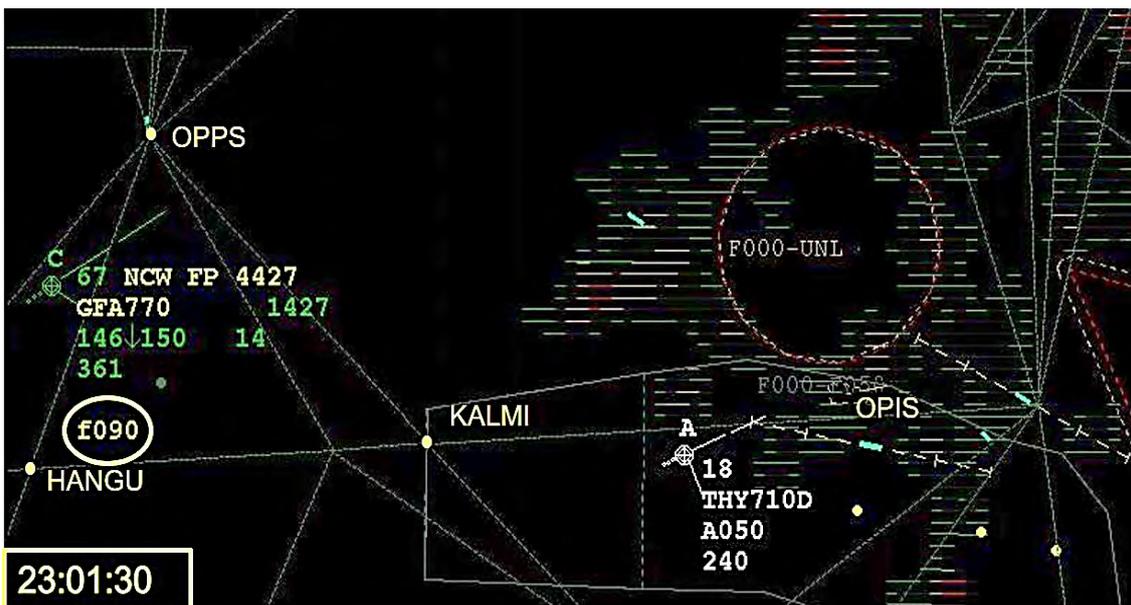
(e) At 23:01:30 h, GFA 770 was given descent 9,000 ft on its request by Area Control Islamabad in AOR of Cherat Approach North contrary to Area Minimum Altitude (AMA) of 10,300 ft.

Figure 19 GFA 770 descending 9,000 ft in Cherat Approach North

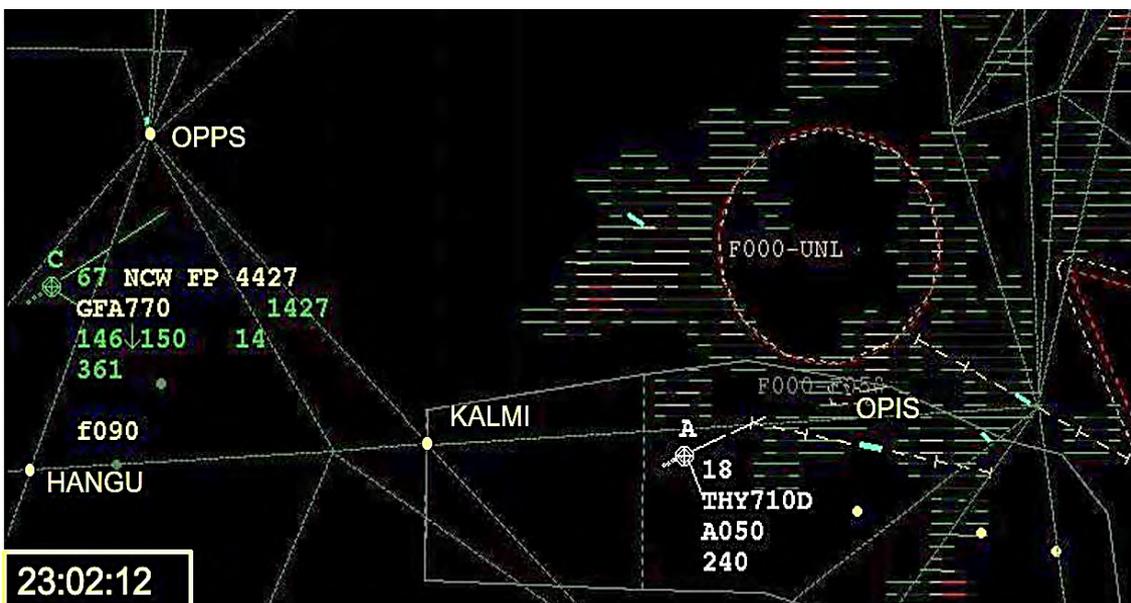
(a) At 23:02:12 h, GFA 770 came in contact with Approach Control Islamabad crossing FL144 descending 9,000 ft on heading 050°. Approach Control Islamabad inquired whether the aircraft was turning right upon which GFA 770 informed that they would be turning right if given descent otherwise they will be entering into bad weather. Approach Control Islamabad gave descent to 10,000 ft to which GFA 770 replied that they are descending 9,000 ft as cleared by Area Control Islamabad. Approach Control Islamabad cleared GFA 770 to descent to 9,000 ft contrary to AMA of 10,300 ft.

Figure 23 GFA 770 contact with Approach Control Islamabad crossing FL144

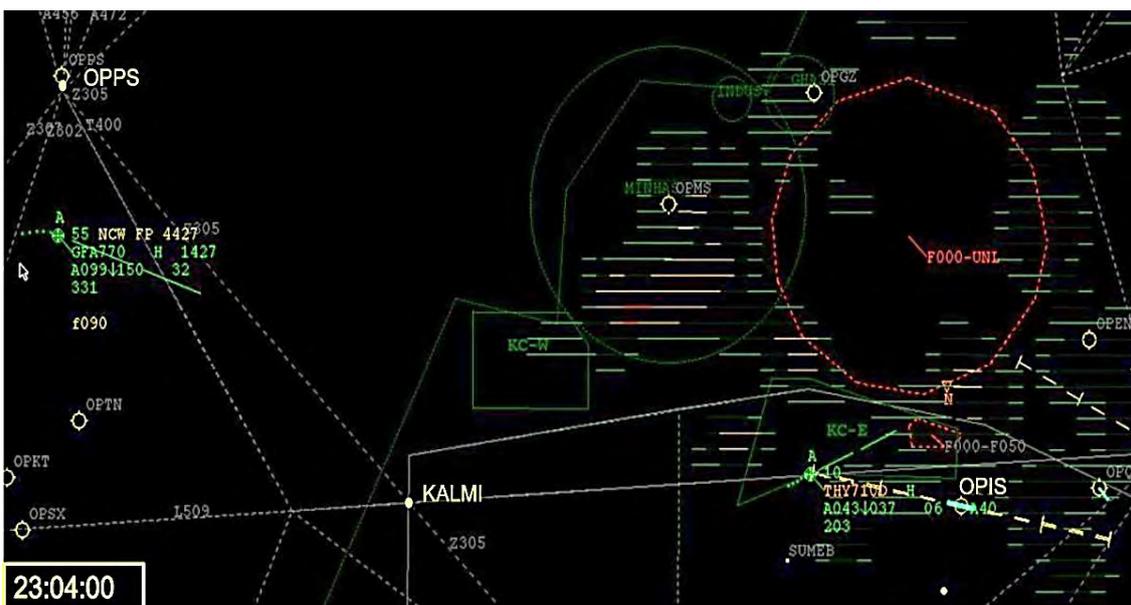
(e) Approaching KALMI, at 23:04:00 h, GFA 770 requested for descent twice in response to which the Approach Control Islamabad cleared GFA 770 to descend to 5,000 ft contrary to AMA of 10,300 ft and advised GFA 770 to expect further descent 25 NM short of Islamabad (KALMI). GFA 770 was at this time approximately 15 NM North West of KALMI.

Figure 27 Descend to 5,000 ft Contrary to AMA of 10,300 ft

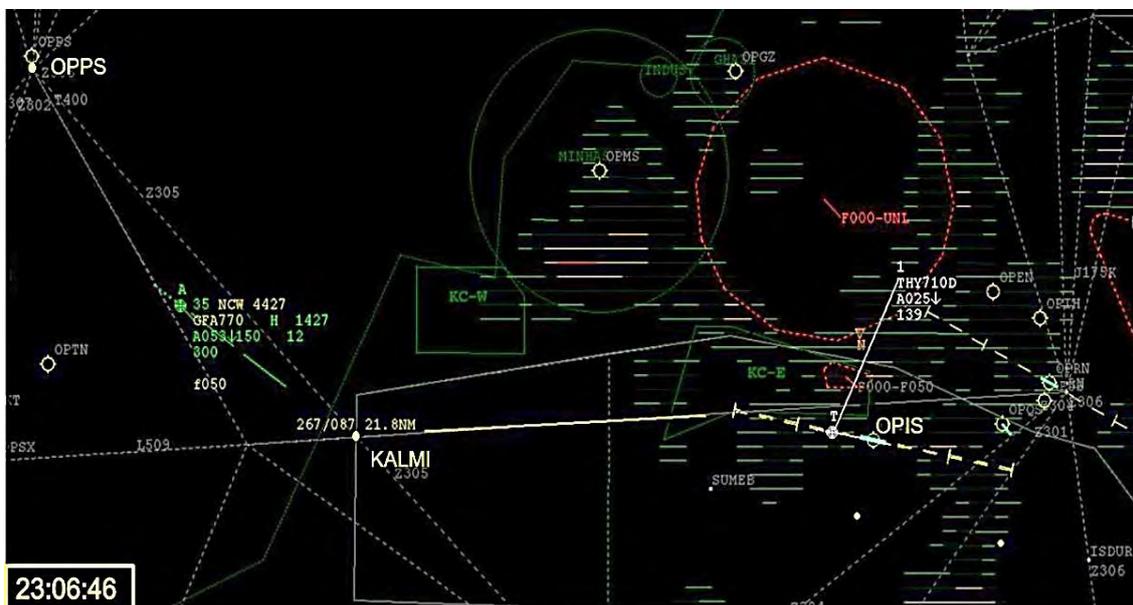
Figure 29 descending through 5,300 ft, GFA 770 received the Terrain react
