FINAL INVESTIGATION REPORT

SERIOUS INCIDENT OF TCAS – RA REPORTED BY AIRBLUE FLIGHT ABQ 211 AIRBUS 320 AIRCRAFT REG. NO. VN-A650 (ON WET LEASE) AT ISLAMABAD ON 03-04-2018

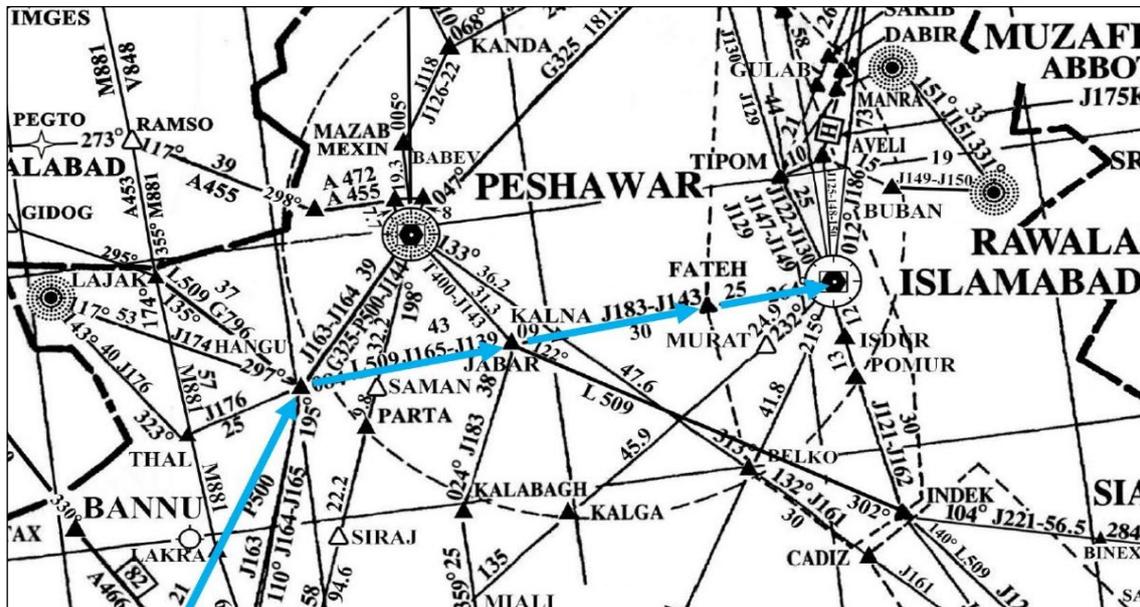
Figure 1 ABQ 211 Route plan

1.1.1. On 3rd April 2018, Airblue flight ABQ 211, Airbus 320 aircraft, Reg. No. VN-A650 was operating from Dubai International Airport, Dubai to BBIAP, Islamabad on route PG – G325 – HANGU – J139 – FATEH – OPRN.

2.1.1. On 3rd April 2018, Airblue Flight No. ABQ 211 was a scheduled passenger flight operating from Dubai International Airport, Dubai to BBIAP, Islamabad on route PG – G325 – HANGU – J139 – FATEH – OPRN.

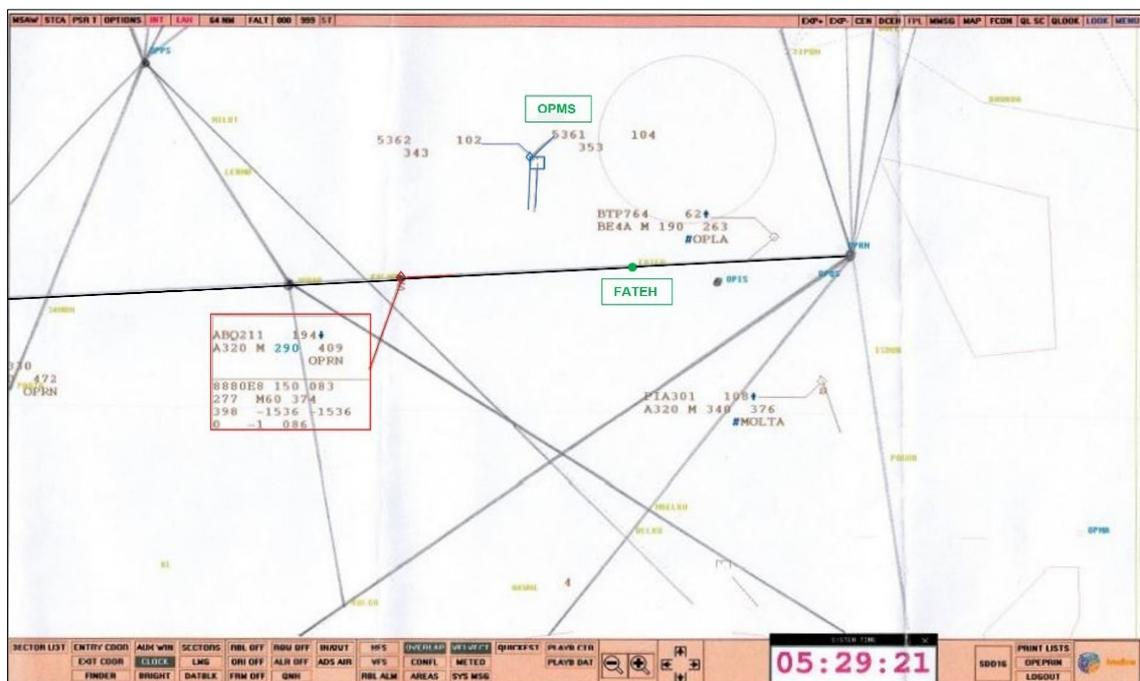
Figure 2 Military Traffic crossing Route J139 from North to South

1.1.3. Military traffic, a formation of 02 x Fighters from PAF Base Minhas to Pindi Gheb was crossing ATS route J139 from North to South at FL140.

2.1.4. Military traffic, a formation of 02 x Fighter aircraft from PAF Base Minhas to Pindi Gheb was crossing ATS route J139 from North to South at FL140 for their routine mission.

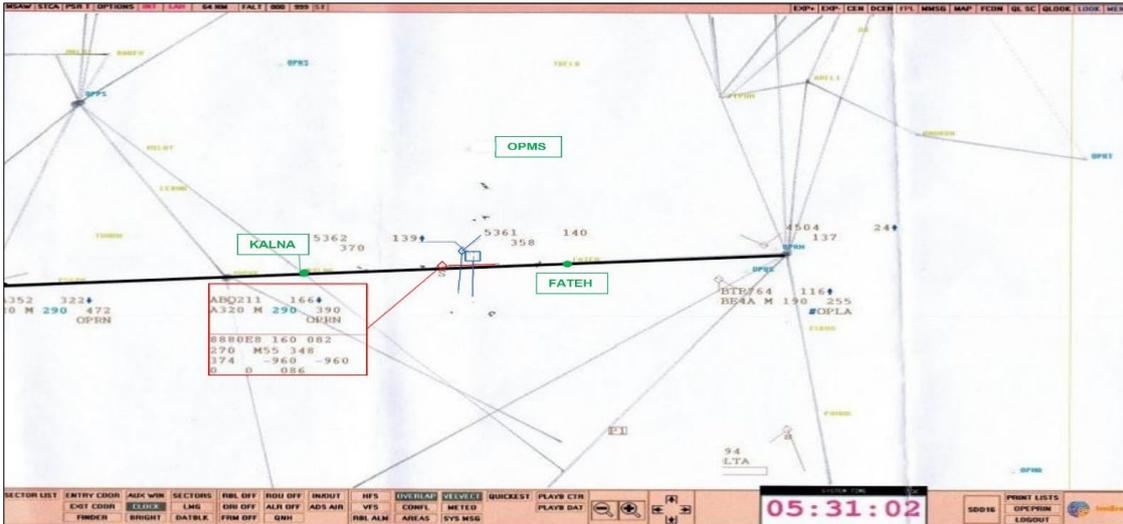
Figure 3 Activation of TCAS – RA of ABQ 211

1.1.5. At 05:31:02 h, while ABQ 211 was 30 NM West of position FATEH descending through FL166, it reported TCAS – RA due traffic.

2.1.6. At 05:31:02 h, while ABQ 211 was 30 NM West of position FATEH descending out of FL166, it reported TCAS – RA due Military traffic, crossing ATS route J139 from North to South.

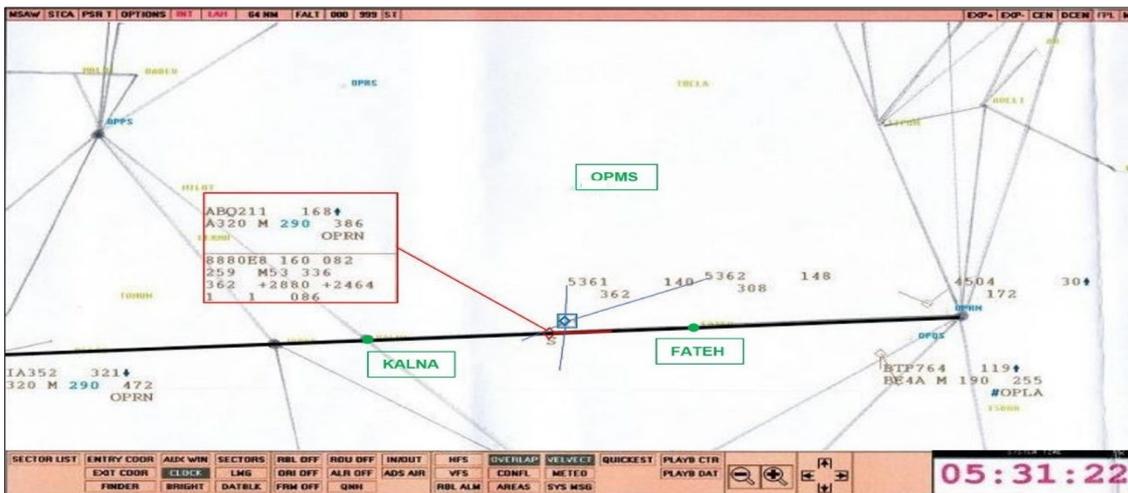
Figure 4 ABQ 211 initiated climb

1.1.6. At 05:31:22 h, Mode C of Fighter aircraft No 2 showed a climb up to FL148. At this time, ABQ 211 also initiated climb as a result of RA activation.

2.1.7. However, at 05:31:22 h, Mode C of Fighter aircraft No 2 showed a climb up to FL148, which was 800 ft above the cleared level. At this time, ABQ 211 initiated climb as a result of RA activation.

2.1.10. Abrupt climb of Military aircraft may have triggered the TCAS – RA of ABQ 211.

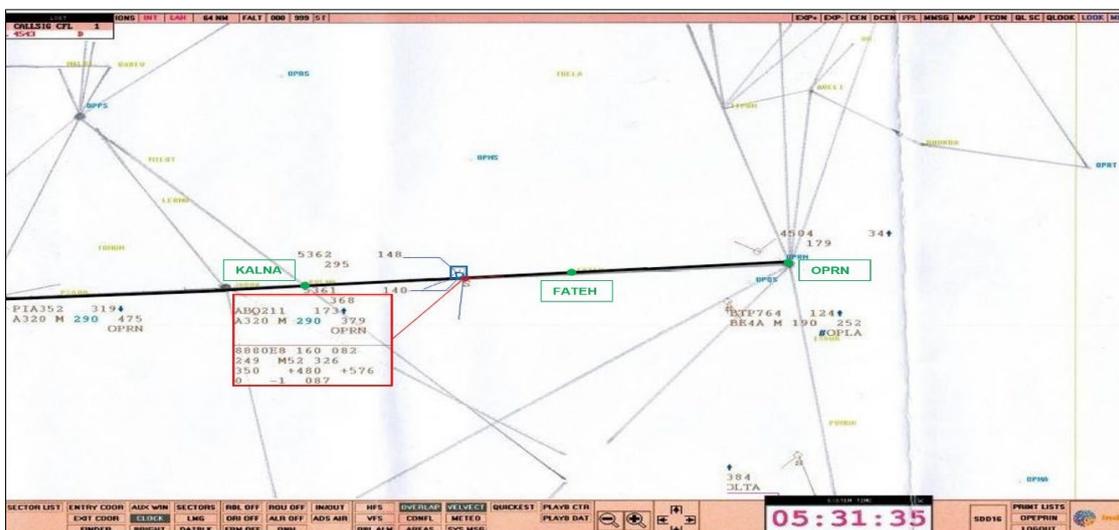
Figure 5 Vertical Separation of 1,800 ft between ABQ 211 & Military Traffic

1.1.7. Vertical Separation of approximately 1,800 ft existed between both the aircraft at the time of RA.

2.1.8. Vertical Separation of approximately 1,800 ft existed between both the aircraft at the time of RA.

2.1.9. Standard separation as mentioned in ICAO Doc 4444 (PANS – ATM) is to be implemented between civil aircraft. However, due to significant performance difference between civil and fighter aircraft, vertical separation of 2,000 ft or more is ensured between civil and military traffic.

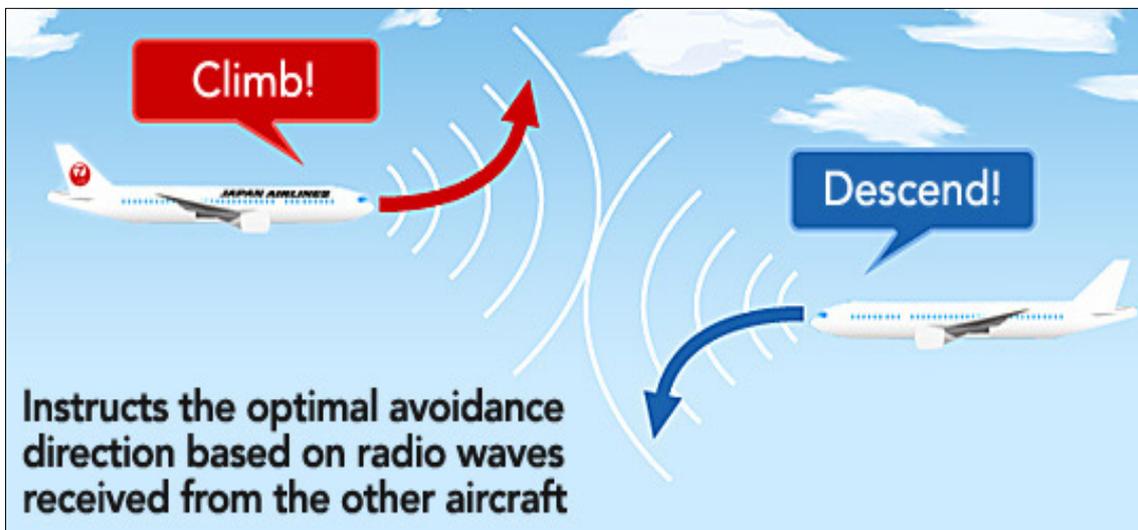
Figure 7 TCAS (TA) alert

1.18.1. **TCAS Working Principle** – TCAS stands for Traffic Collision Avoidance System, and its purpose is to minimize the risk of mid-air collisions between aircraft. Working independently from Air Traffic Control, TCAS uses nearby aircraft’s transponder signals to alert pilots to the danger of mid-air collisions. It does so by constructing a three-dimensional map of airspace through which the aircraft is travelling. In detecting the other aircraft’s transponder signals, it can foresee the potential collisions based on speeds and altitude of planes passing through the airspace in question. If TCAS detects a potential collision, it will automatically notify each of the affected aircraft. In this instance, it will automatically initiate a mutual avoidance manoeuvre. This involves the system informing the crews of the aircraft in question both audibly and visibly to either climb or descend in a manner that ensures that, when their paths cross, they do not meet.

1.18.2.3. **Traffic Advisories (TAs)** - TAs alert the flight crew to potential RAs and may indicate the range, range rate, altitude, altitude rate and bearing of the intruding aircraft relative to own aircraft. TAs without altitude information may also be provided on Mode 'C' or Mode 'S' equipped aircraft that have temporarily lost their automatic altitude-reporting capability. The information conveyed in TAs is intended to assist the flight crew in sighting nearby traffic.

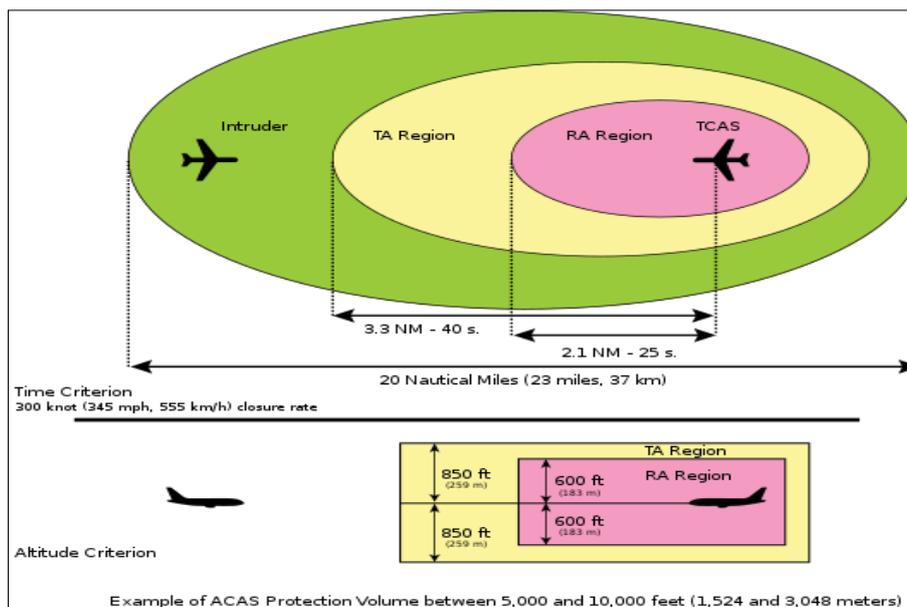
Figure 8 TCAS TA & RA ranges

1.18.2.6. **Warning Times** - In any potential collision, ACAS generates an RA nominally 15 to 35 seconds (s) before the Closest Point of Approach (CPA) of the aircraft. The ACAS equipment may generate a TA up to 20 s in advance of an RA. Warning times depend on Sensitivity Levels (SLs) of RAs.

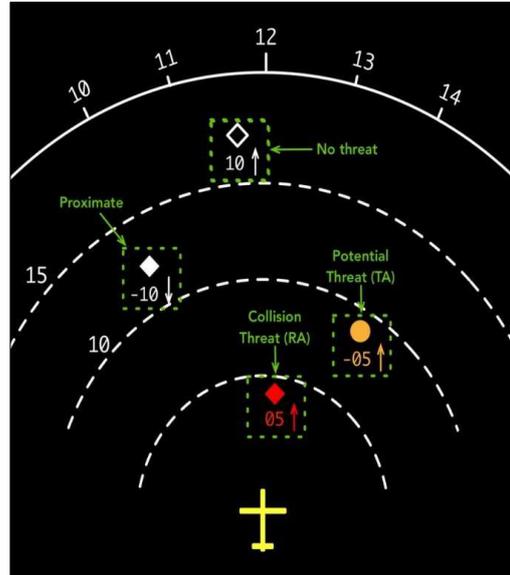
Figure 9 Traffic Display

1.18.3. **Traffic Display Symbology** – On the TCAS traffic display both colour and shape are used to assist the pilot in interpreting the displayed information.

1.18.3.1. Own-aircraft is depicted as a white or yellow aircraft-like symbol. Targets are displayed by different symbols, according to their threat status

1.18.3.2. Hollow white diamond – for other traffic. (No threat).

1.18.3.3. Solid white diamond – for proximate traffic.

1.18.3.4. Solid yellow or amber circle – for intruders (i.e. aircraft which trigger a TA).

1.18.3.5. Solid red square – for threats (i.e. aircraft which trigger an RA).
