FINAL INVESTIGATION REPORT

SERIOUS INCIDENT (TCAS – RA) – AIR ARABIA FLIGHT ABY531, AIRBUS 320 AIRCRAFT, REG NO. A6-ANS (KATMANDU – SHARJAH) & SPICEJET, FLIGHT SEJ711, BOEING 737 AIRCRAFT, REG NO. VT-MXK, (DUBAI – INDORE) ON 15-01-2022

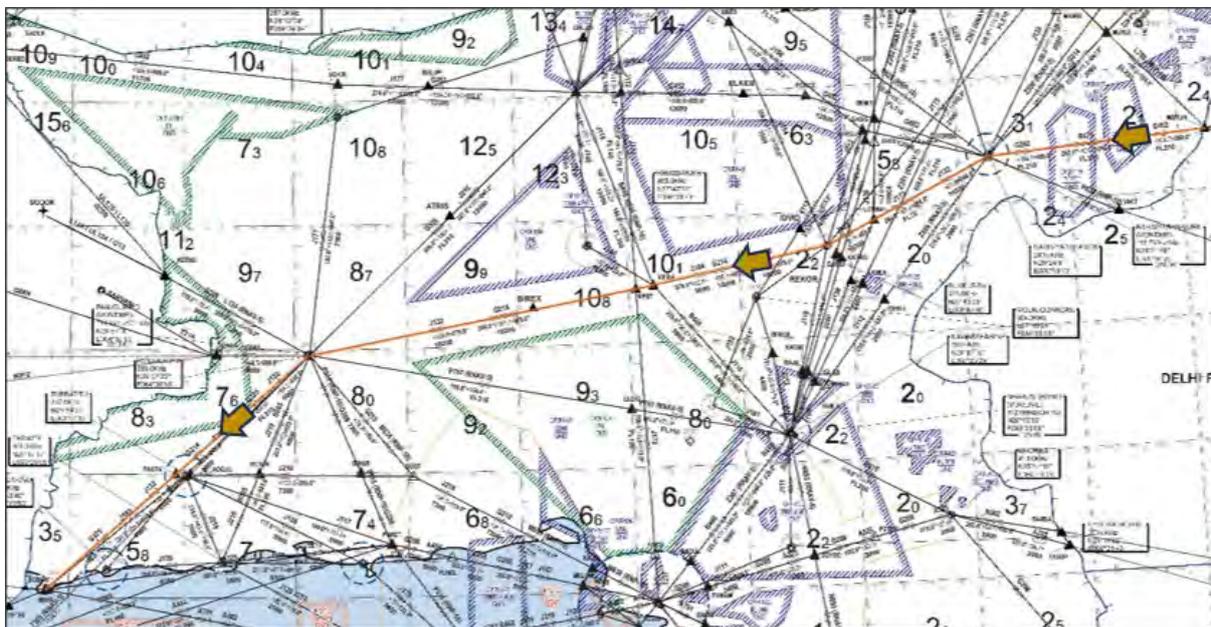
Figure 1 ABY531 Route

1.1.1. On 15th January, 2022, Air Arabia flight ABY531 was a commercial passenger flight which took off from VNKT, Kathmandu, Nepal for OMSJ, Sharjah, UAE on Air Traffic Services ATS route MERUN-RK-LUBNA-G214-OPSK-IDEBA-OPPG-G214-BIVIN.

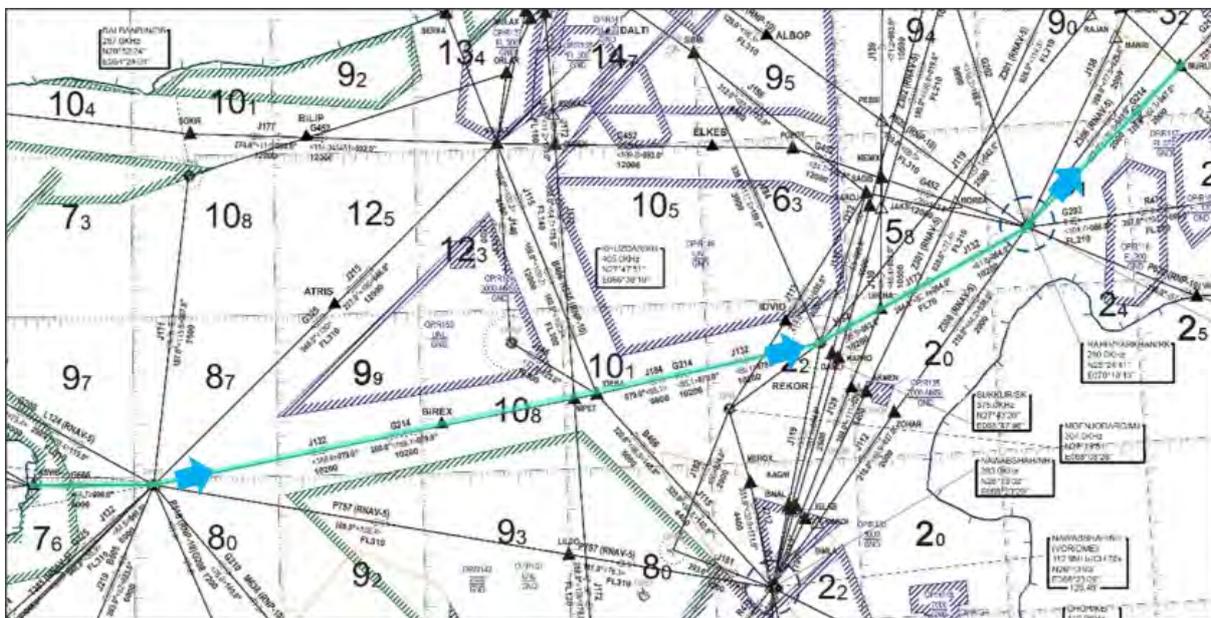
Figure 2 SEJ711 Route

1.1.2. SpiceJet flight SEJ711 was operating from OMDB, Dubai, UAE to VAID, Indore, India on route ASVIB-G665-PG-G214-MOLTA-G214-LA-A456-AAR.

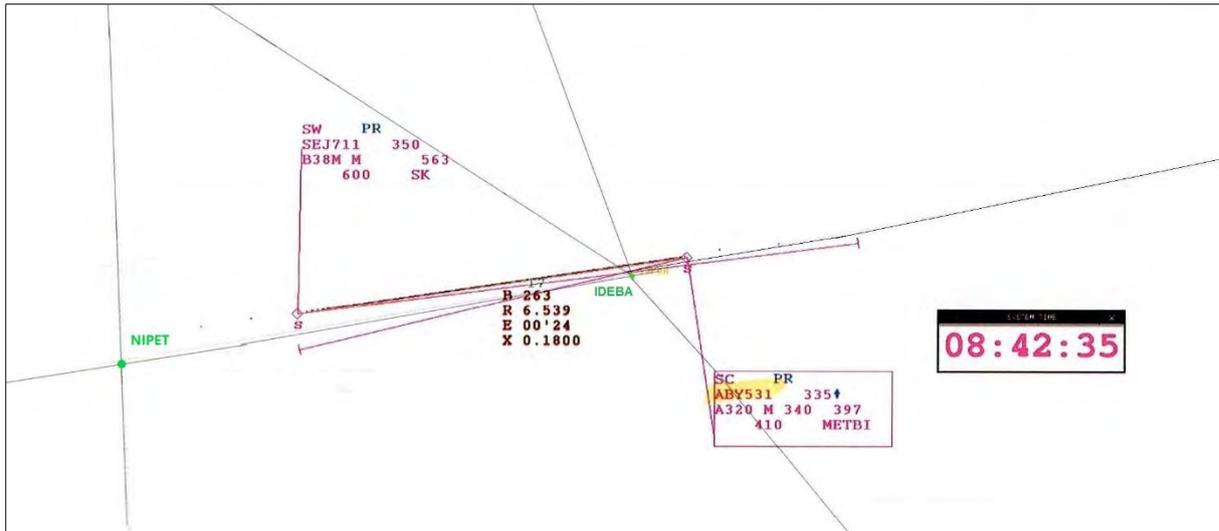
Figure 3 - ABY531 Approaching position IDEBA (6.5 NM reciprocal)

1.1.6. When ABY531 was overhead IDEBA passing FL335 for FL340, it reported TCAS – RA and stopped climb at FL335.

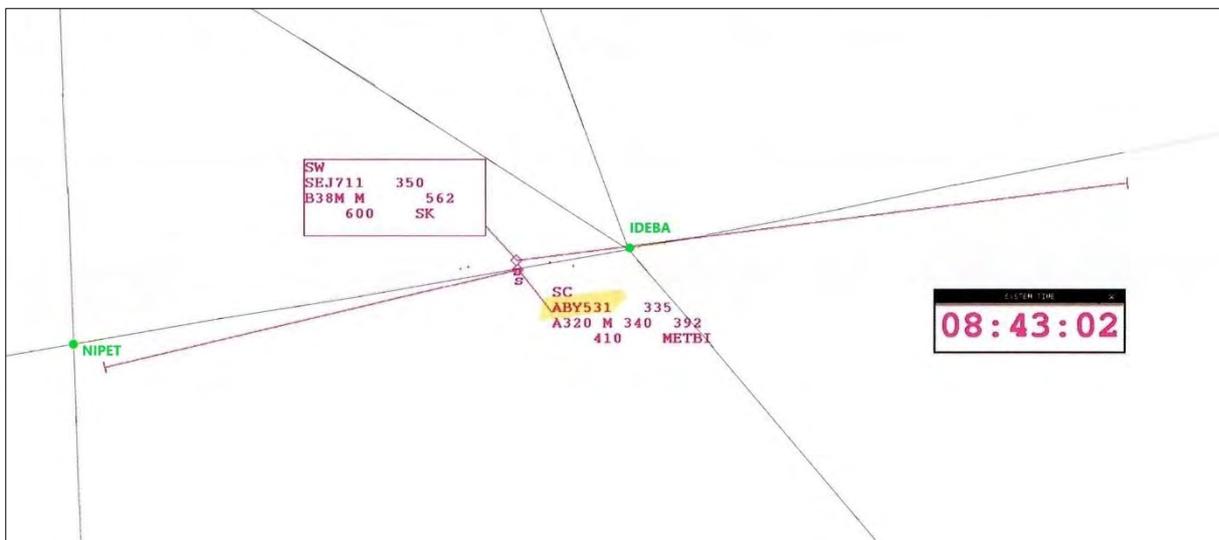
Figure 4 - ABY531 maintaining FL335 after crossing position IDEBA

1.1.7. At the time of RA, reciprocal traffic SEJ711 was 05 NM at FL350. On confirmation from SEJ711, pilot reported TCAS – TA only due high ROC of reciprocal traffic. ABY531 resumed its climb to FL340.

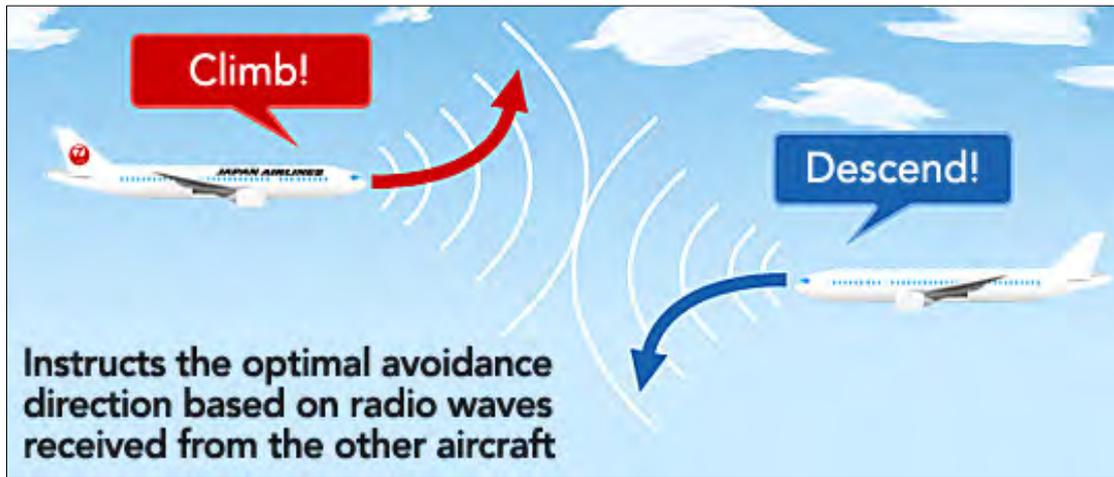
Figure 5 TCAS (TA) alert

1.18.1. **TCAS Working Principle** – TCAS stands for Traffic alert and Collision Avoidance System, and its purpose is to minimize the risk of mid-air collisions between aircraft. Working independently from Air Traffic Control, TCAS uses nearby aircraft's transponder signals to alert pilots to the danger of mid-air collisions. It does so by constructing a three-dimensional map of airspace through which the aircraft is travelling. In detecting the other aircraft's transponder signals, it can foresee the potential collisions based on speeds and altitude of planes passing through the airspace in question. If TCAS detects a potential collision, it will automatically notify each of the affected aircraft. In this instance, it will automatically initiate a mutual avoidance manoeuvre. This involves the system informing the crews of the aircraft in question both audibly and visibly to either climb or descend in a manner that ensures that, when their paths cross, they do not meet.

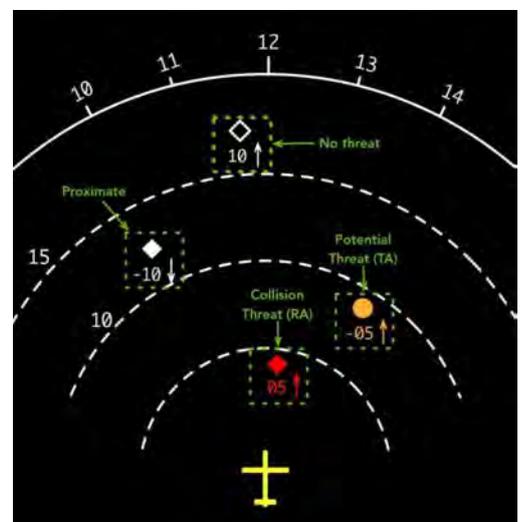
Figure 7 Traffic Display

1.18.2. **Traffic Display Symbology** – On the TCAS traffic display both colour and shape are used to assist the pilot in interpreting the displayed information.

1.18.2.1. Own-aircraft is depicted as a white or yellow aircraft-like symbol. Targets are displayed by different symbols, according to their threat status

1.18.2.2. Hollow white diamond – for other traffic. (No threat).

1.18.2.3. Solid white diamond – for proximate traffic.

1.18.2.4. Solid yellow or amber circle – for intruders (i.e. aircraft which trigger a TA).

1.18.2.5. Solid red square – for threats (i.e. aircraft which trigger an RA).

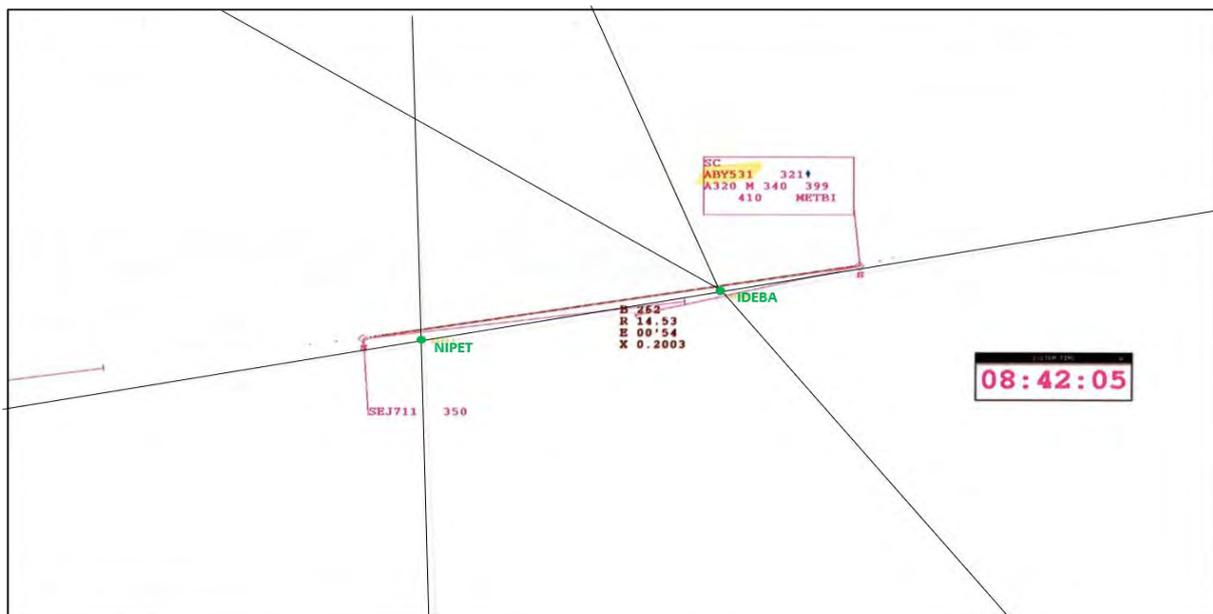
Figure 8 - ABY531 reporting TCAS - RA

2.1.10. At 08:42:00 h, when ABY531 was overhead IDEBA passing FL335 for FL340, it reported TCAS – RA and stopped climb at FL335.

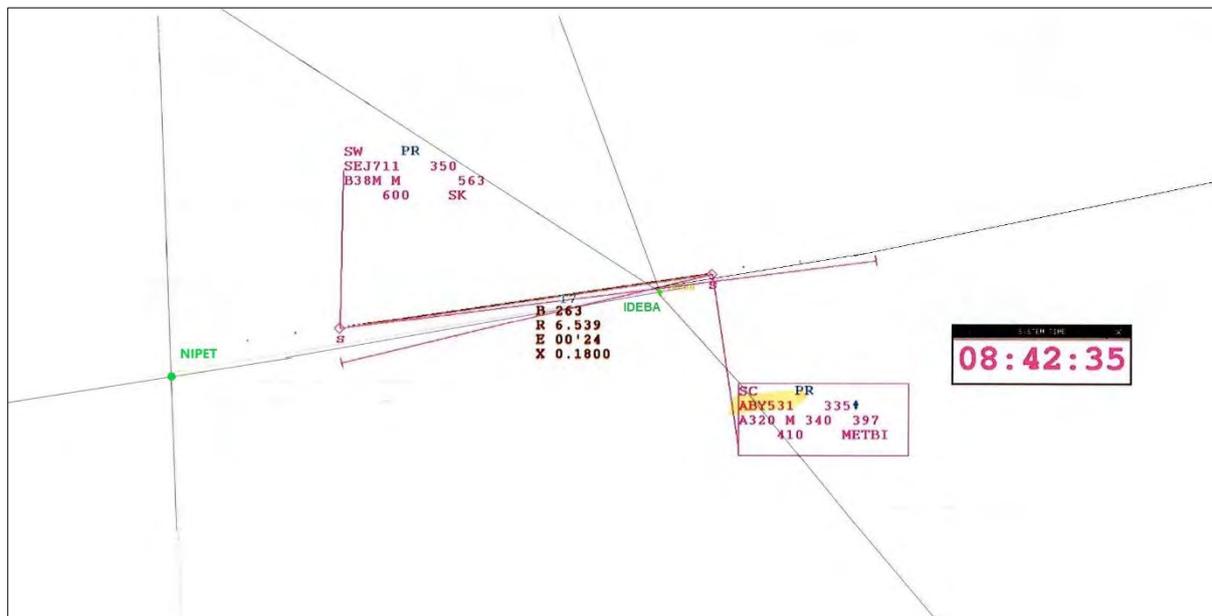
Figure 9 - ABY531 maintaining FL335

2.1.11. At the time of RA, reciprocal traffic SEJ711 was separated by 05 NM⁷ at FL350. Once inquired from SEJ711, pilot reported TCAS –TA only, due to high ROC of reciprocal traffic. On confirmation from SEJ711, ABY531 resumed its climb to FL340.

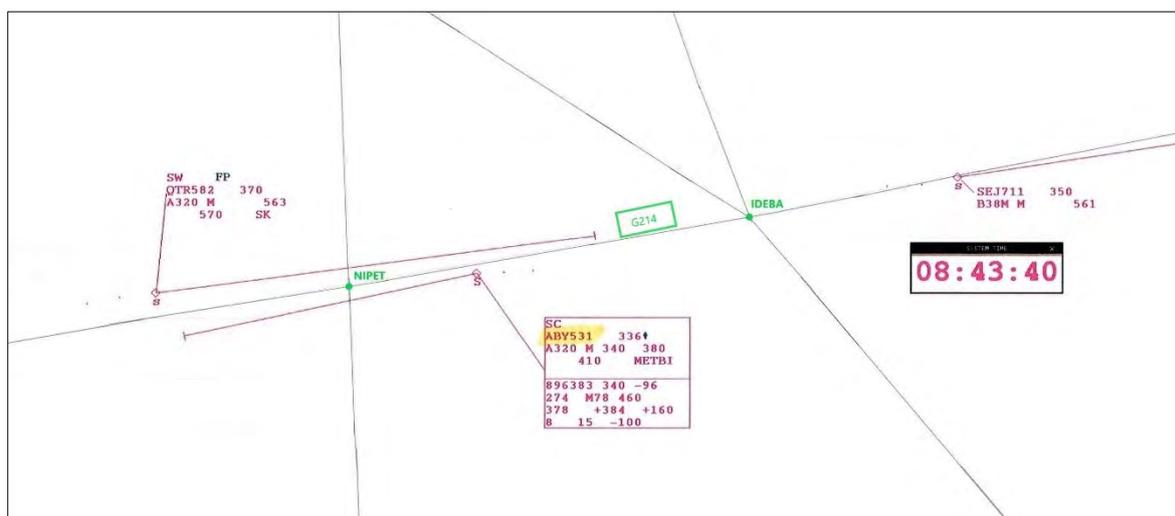
Figure 10 - ABY531 reporting clear of conflict

2.1.14. At time 08:44:34 h, ABY531 reported clear of conflict and maintaining FL340.

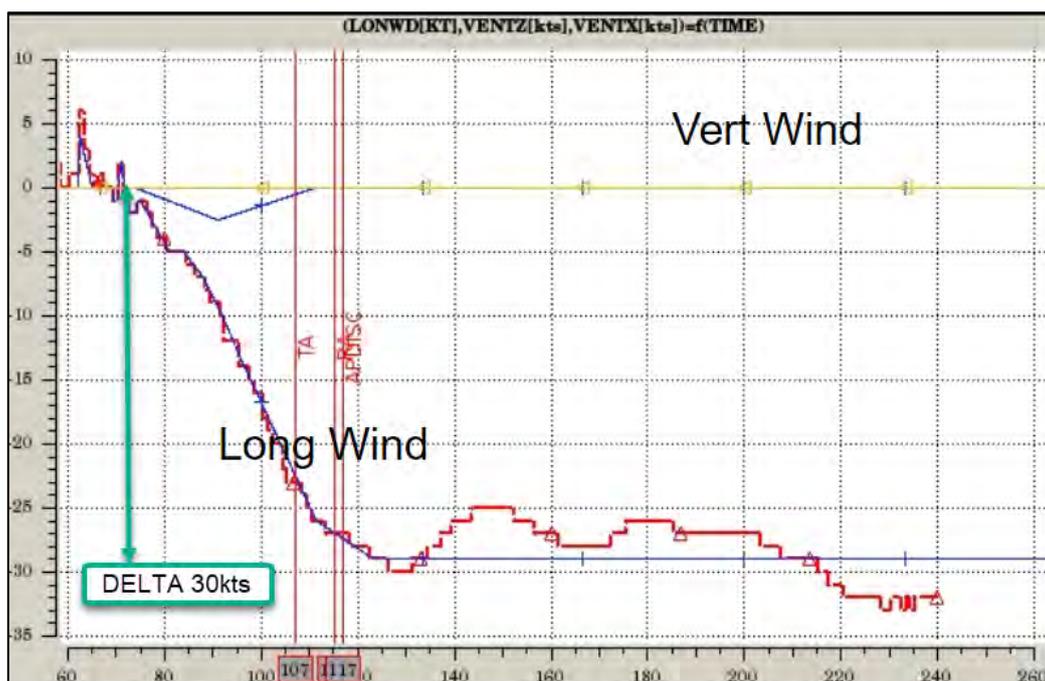
Figure 11 – Head Wind Data

2.1.18. **Meteorological Factors:** As the aircraft climbed from FL320 to FL340, the head wind increased from 50 kt to 80 kt. The contribution of this increase in wind to the vertical speed of climb is as follows: -

2.1.18.1. The data obtained shows a headwind increase of ~30 kt during the climb.

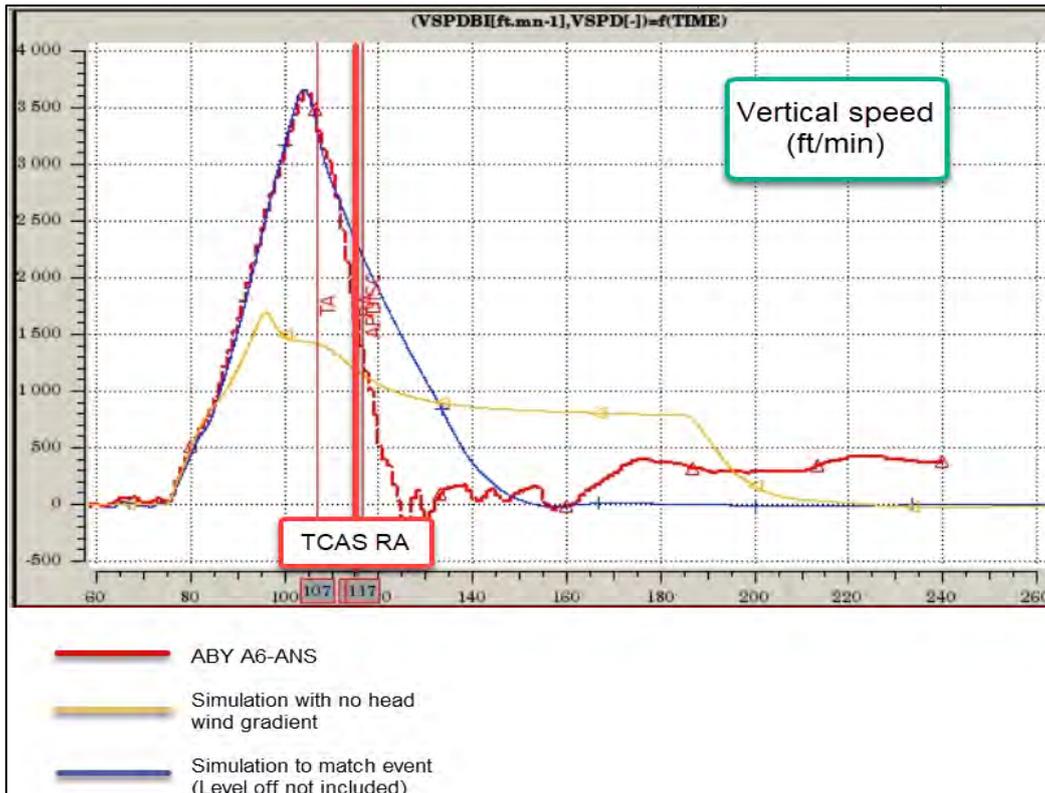
Figure 12 – Vertical Speed Data

2.1.18.2. The effect of the increase in headwind resulted in an increase in vertical speed is as shown below: -

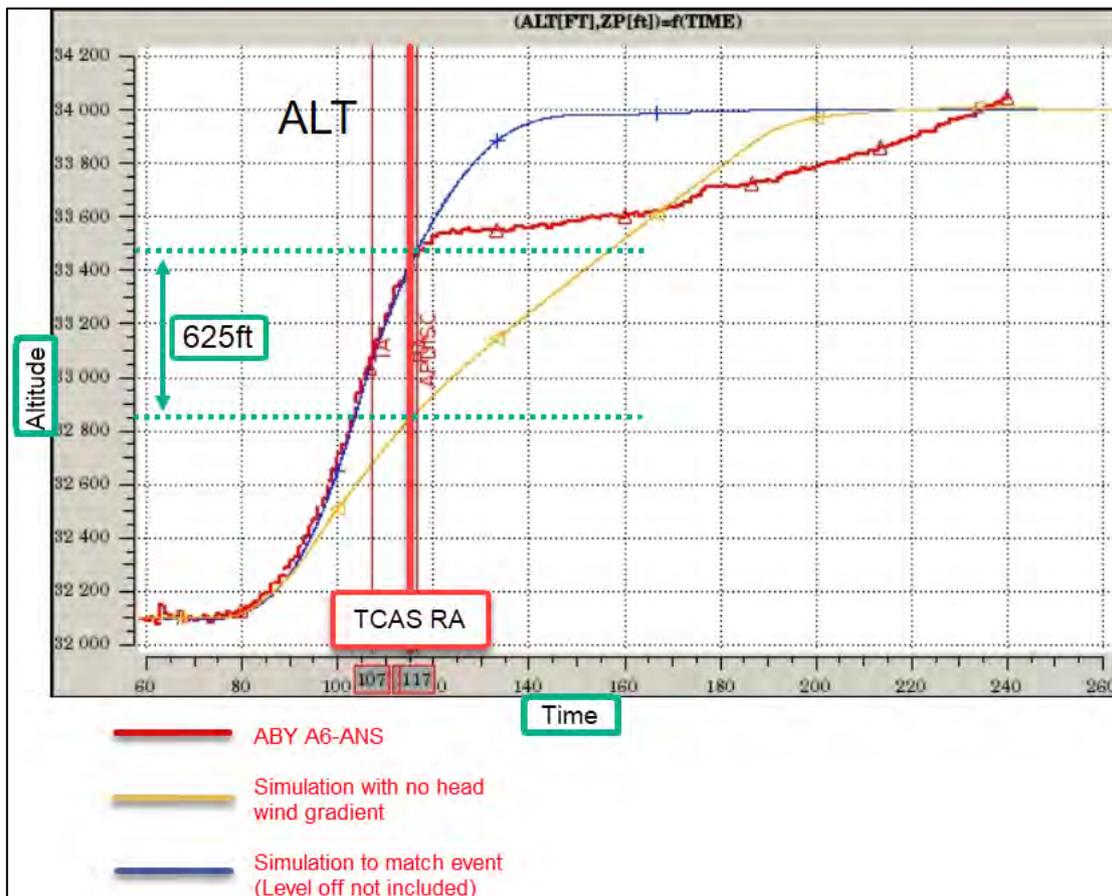
Figure 13 – Vertical Profile and Vertical Speed

2.1.18.3. Without an increase in headwind, the vertical speed would have reached 1,700 ft/min whereas with the increase in headwind during the climb, the vertical speed reached 3,600 ft/min. The vertical profiles with both vertical speeds are as shown: -

2.1.18.4. The analysis shows that the increase in headwind increased the vertical speed of the aircraft. this meant that at the time of the TCAS-RA, the aircraft was 625 ft higher and climbing at a speed 1,900 ft/min faster than a climb profile with no headwind increase. Without the headwind increase, the climb rate would have been ~1,700 ft/min.

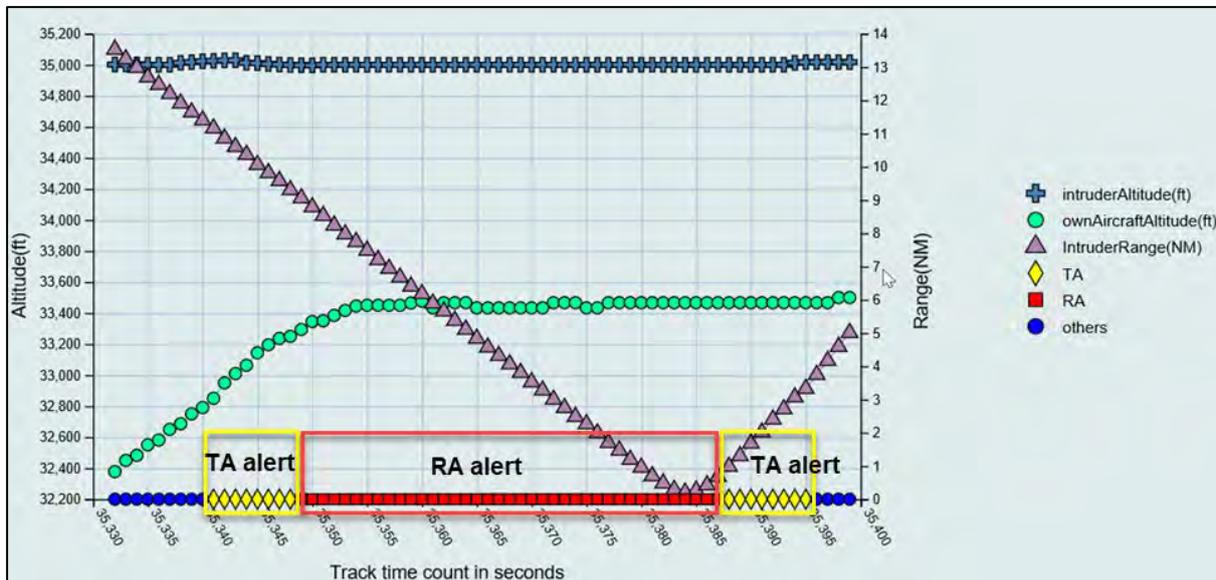
Figure 14 – TA and RA Alerts

2.1.18.5. The TA and RA alerts as a result of prevailing circumstances is shown as follows: -

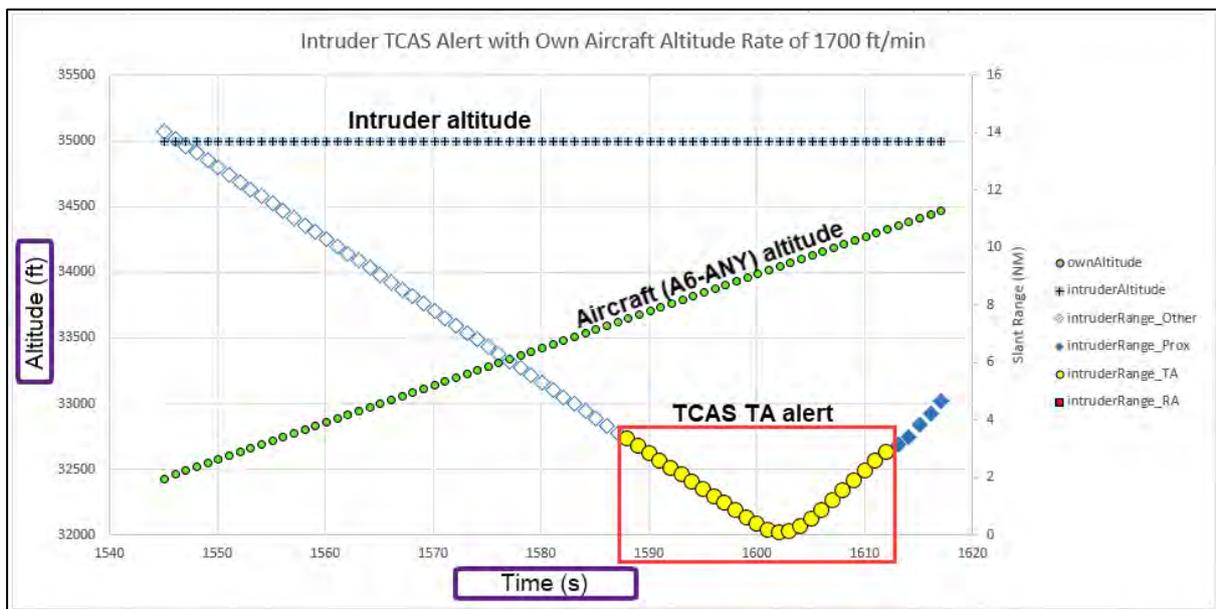
Figure 15 – TCAS Simulation

2.1.18.6. A TCAS simulation performed to establish whether TCAS-RA would have triggered at a nominal 1,700 ft/min climb rate indicates that at this climb rate, only a TCAS-TA would have triggered and not a TCAS-RA:-
