## FINAL INVESTIGATION REPORT

**SERIOUS INCIDENT (TCAS – RA) BETWEEN PIAC FLIGHT PIA352, A320-214 AIRCRAFT, REG. NO. AP-BLC (OPQT-OPIS) & PIAC FLIGHT PIA785, B777-240(ER) AIRCRAFT, REG. NO. AP-BGK (OPIS-EGLL) ON 18-03-2020**

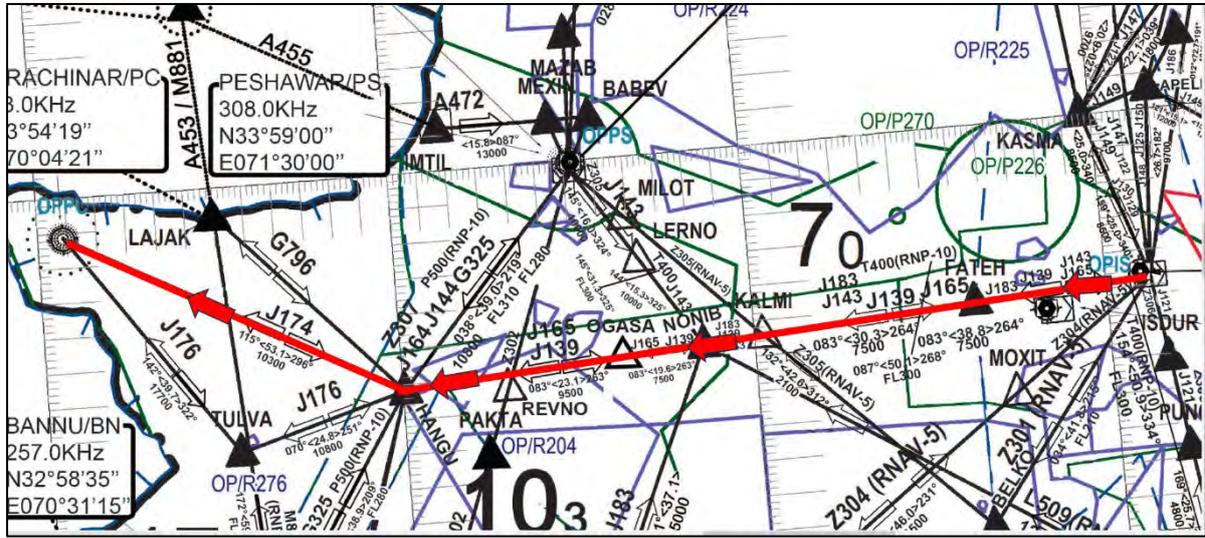
Figure 1 Route Plan PIA785

1.1.1. On 18<sup>th</sup> March, 2020 PIA flight PIA785, Boeing 777-240(ER) aircraft Reg. No. AP-BGK was a scheduled passenger flight which operated from OPIS, Islamabad, Pakistan to EGLL, London, UK on ATS route ISLAMABAD – KALMI – HANGU – LAJAK climbing FL340.

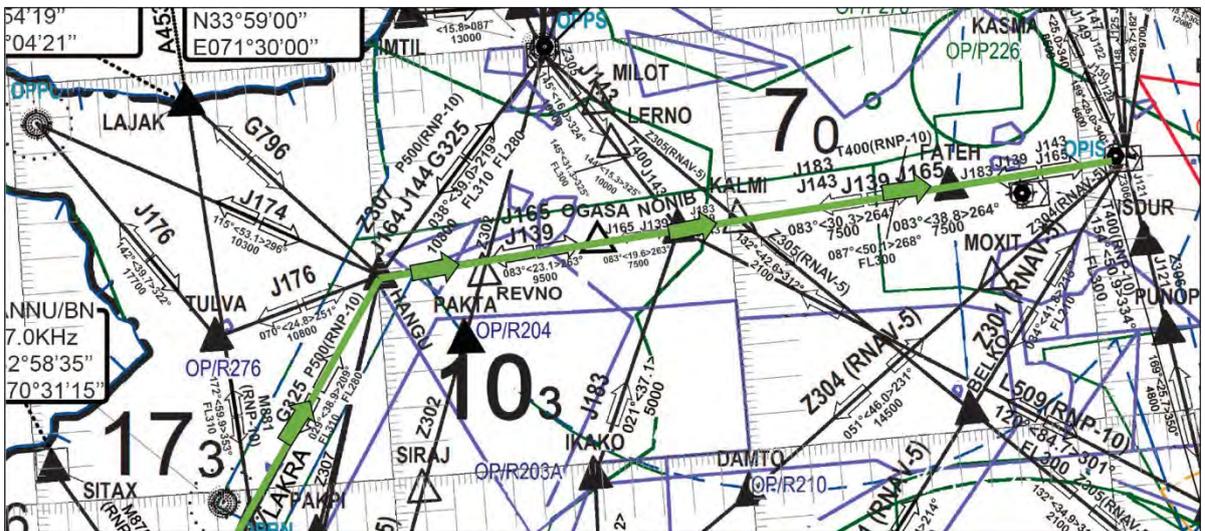
Figure 2 Route Plan PIA352

1.1.2. PIA flight PIA352, Airbus 320-214 aircraft Reg. No. AP-BLC was also a scheduled passenger flight operating from OPQT, Quetta, Pakistan to OPIS, Islamabad, Pakistan on ATS route HANGU – J139 – KALMI – ISLAMABAD and was descending to FL150.

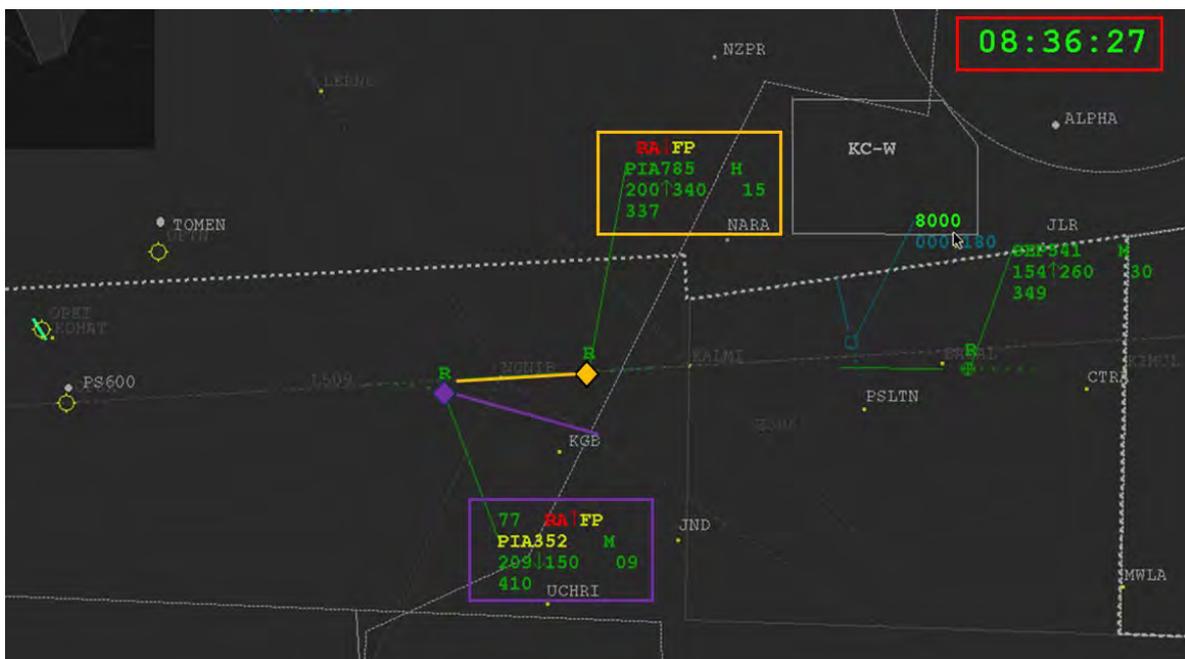
Figure 3 Activation of TCAS – RA

1.1.10. At time 08:36:27, TCAS-RA alert on both aircraft was activated.

1.1.11. At 08:36:50 h, PIA352 and PIA785 reported TCAS-RA.

1.1.13. PIA352 reported maintaining Rate of Descent (ROD) 800 ft while PIA785 reported maintaining Rate of Climb (ROC) 900 ft at the time of RA.

1.1.14. As per radar screenshot PIA352 was maintaining ROD 900 ft whereas PIA785 was maintaining ROC 1,500 ft<sup>4</sup>.

<sup>4</sup> Refer Figure 3

3.1.1. The incident resulted from a loss of adequate vertical separation between the two aircraft in the AOR of Cherat Approach South.

3.2.1.1. Activation of TCAS – RA (**MAC – Mid Air Collision**) due to inadequate separation management by Cherat Approach South Controller.

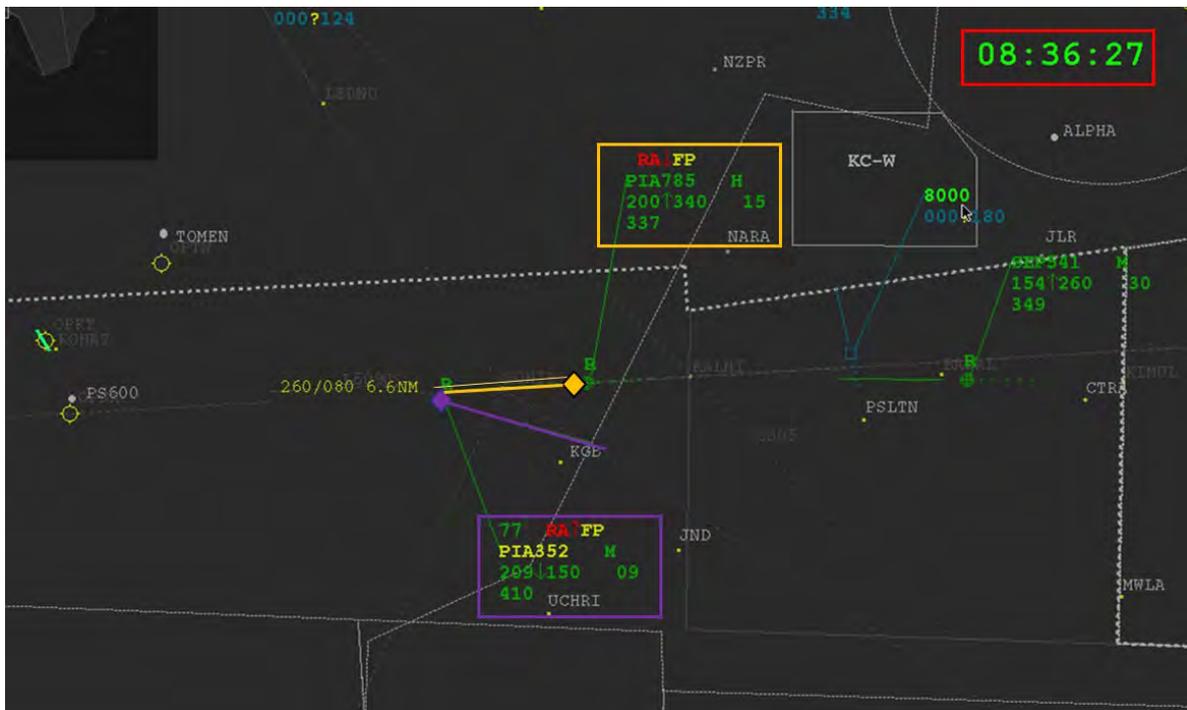
Figure 4 Minimum Vertical Separation

1.1.16. At the time of incident, 900 ft vertical and 6.6 NM lateral separation existed between the two aircraft (as per radar screenshot).

2.1.14. At the time of incident, 900 ft vertical and 6.6 NM lateral separation existed between the two aircraft (as per radar screenshot).

3.1.7. At the time of incident, 900 ft vertical and 6.6 NM lateral separation existed between the two aircraft. Both aircraft responded correctly to TCAS-RA, ensuring a safe resolution of the conflict.

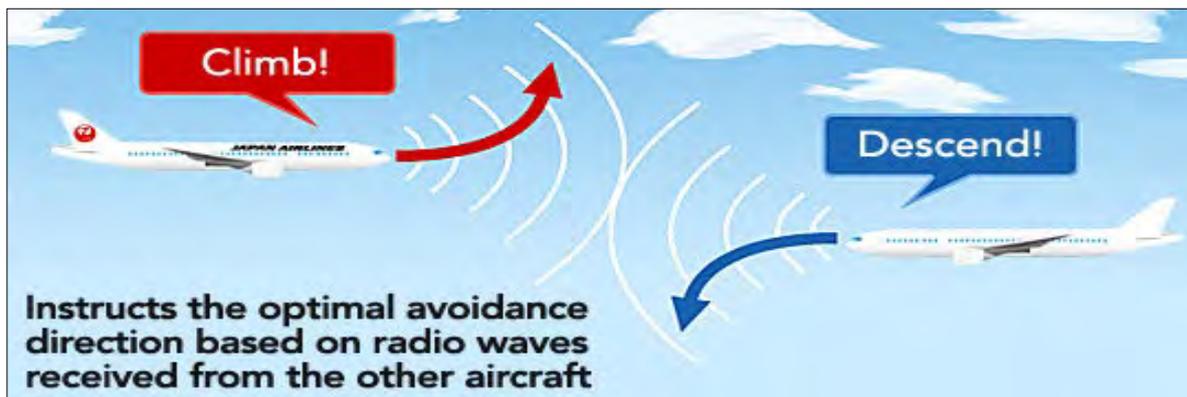
Figure 5 TCAS (TA) alert

1.18.1. **TCAS Working Principle** – TCAS stands for Traffic Collision Avoidance System, and its purpose is to minimize the risk of mid-air collisions between aircraft. Working independently from Air Traffic Control, TCAS uses nearby aircraft's transponder signals to alert pilots to the danger of mid-air collisions. It does so by constructing a three-dimensional map of airspace through which the aircraft is travelling. In detecting the other aircraft's transponder signals, it can foresee the potential collisions based on speeds and altitude of planes passing through the airspace in question. If TCAS detects a potential collision, it will automatically notify each of the affected aircraft. In this instance, it will automatically initiate a mutual avoidance manoeuvre. This involves the system informing the crews of the aircraft in question both audibly and visibly to either climb or descend in a manner that ensures that, when their paths cross, they do not meet.

1.18.2.3. **Traffic Advisories (TAs)** - TAs alert the flight crew to potential RAs and may indicate the range, range rate, altitude, altitude rate and bearing of the intruding aircraft relative to own aircraft. TAs without altitude information may also be provided on Mode 'C' or Mode 'S' equipped aircraft that have temporarily lost their automatic altitude-reporting capability. The information conveyed in TAs is intended to assist the flight crew in sighting nearby traffic.

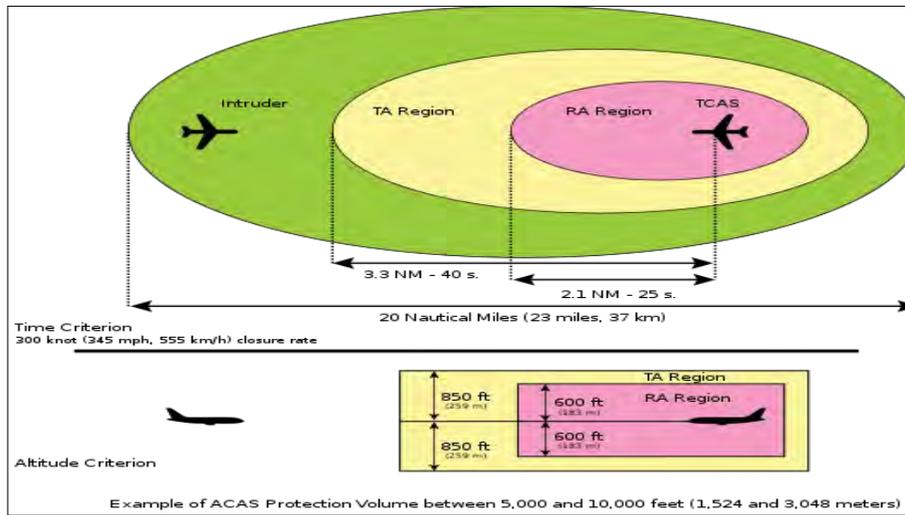
Figure 6 TCAS TA &amp; RA ranges

1.18.2.6. **Warning Times** - In any potential collision, ACAS generates an RA nominally 15 to 35 seconds (s) before the Closest Point of Approach (CPA) of the aircraft. The ACAS equipment may generate a TA up to 20 s in advance of an RA. Warning times depend on Sensitivity Levels (SLs) of RAs.

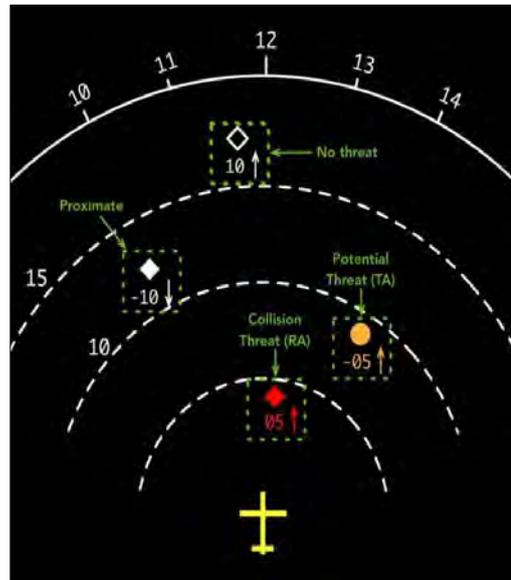
Figure 7 Traffic Display

1.18.3. **Traffic Display Symbology** – On the TCAS traffic display both colour and shape are used to assist the pilot in interpreting the displayed information.

1.18.3.1. Own-aircraft is depicted as a white or yellow aircraft-like symbol. Targets are displayed by different symbols, according to their threat status

1.18.3.2. Hollow white diamond – for other traffic. (No threat).

1.18.3.3. Solid white diamond – for proximate traffic.

1.18.3.4. Solid yellow or amber circle – for intruders (i.e., aircraft which trigger a TA).

1.18.3.5. Solid red square – for threats (i.e., aircraft which trigger an RA).
