FINAL INVESTIGATION REPORT

**SERIOUS INCIDENT (FLAME OBSERVED IN RIGHT ENGINE)
AIRBLUE FLIGHT ABQ-410, AIRBUS 321-211 AIRCRAFT,
REG. NO. AP-BMP, AT AIIAP, LAHORE ON 02-08-2022**

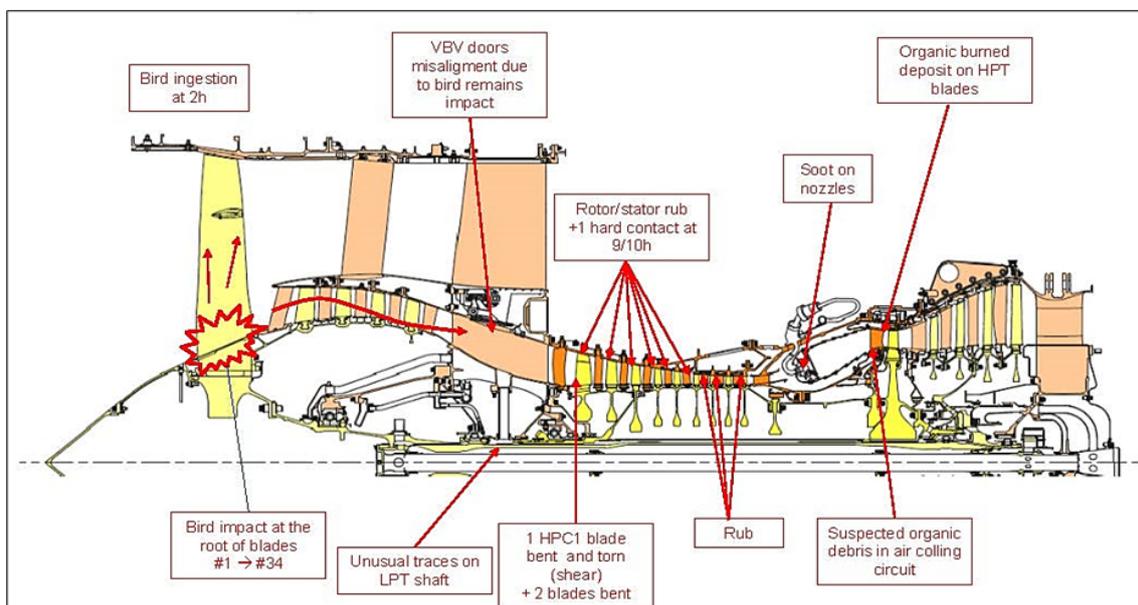
Figure 3 Bird Strike Cause Series of Failure / Malfunction

2.3.3. Bird ingestion into the Engine can cause series of findings and potential malfunctions that can result in engine stall, details can be seen in figure below: -

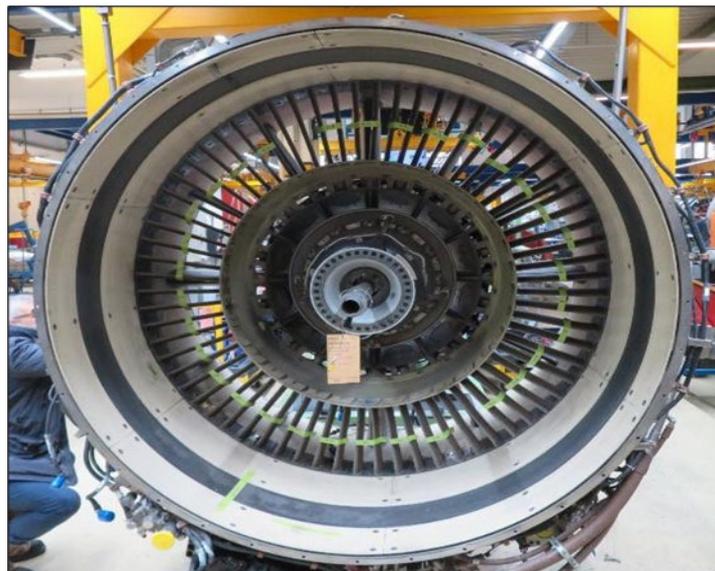
Figure 5 Fan Case Module FWD overview

2.3.4. **FAN** – FAN case module has large quantity of bird remains on primary flow path. Bird ingestion was founded on Fan blades No. 1, No. 35 and No. 36, its impact was at the root of the blade. Impact on VBV doors was founded and they were misalignment.
