FINAL INVESTIGATION REPORT

SERIOUS INCIDENT LANDING ON WRONG RUNWAY

**SAUDI AIRLINES FLIGHT SVA-724 BOEING 777-368 (ER)
REG NO HZ-AK21 AT IIAP, ISLAMABAD ON 14-10-2024**

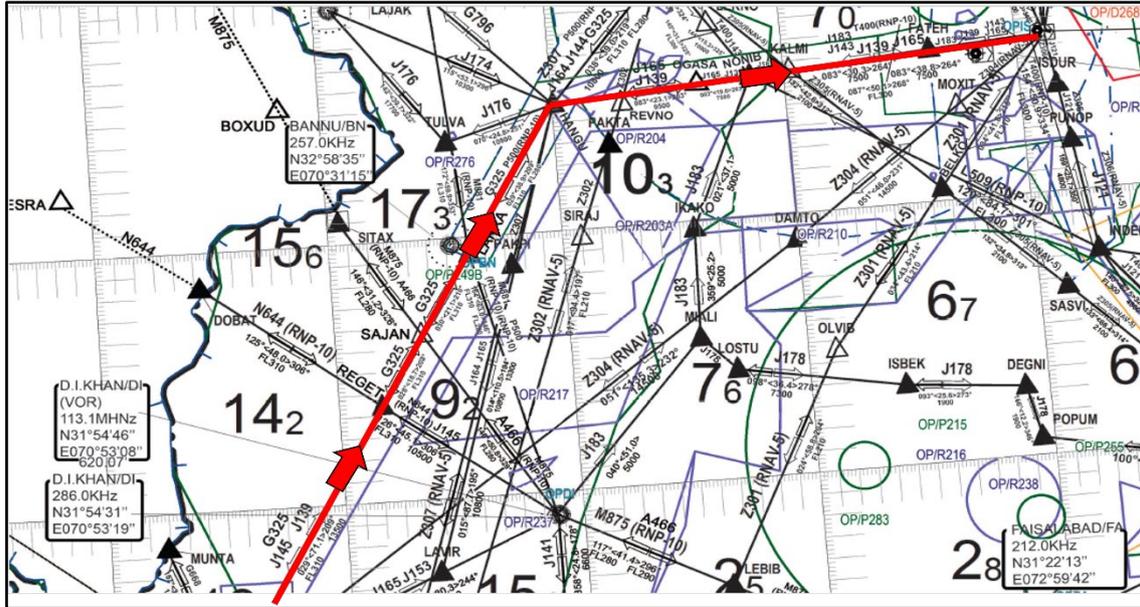
Figure 1 SVA-724 Flight Route

1.1.1. On 14 October 2024, Saudi Arabian Airlines flight SVA-724, Boeing 777-368ER aircraft, bearing Reg No. HZAK-21 took off from King Khalid International Airport (OERK), Riyadh, Saudi Arabia for Islamabad International Airport (OPIS), Islamabad and entered Pakistan airspace via Air Traffic Services (ATS) route PG – G325 – HANGU – J139 – KALMI – OPIS.
