FINAL INVESTIGATION REPORT

SERIOUS INCIDENT LANDING ON WRONG RUNWAY

**PAKISTAN INTERNATIONAL AIRLINES FLIGHT PK-150
AIRBUS 320-214 AIRCRAFT REG NO. AP-BON AT AIIAP,
LAHORE ON 17-01-2025**

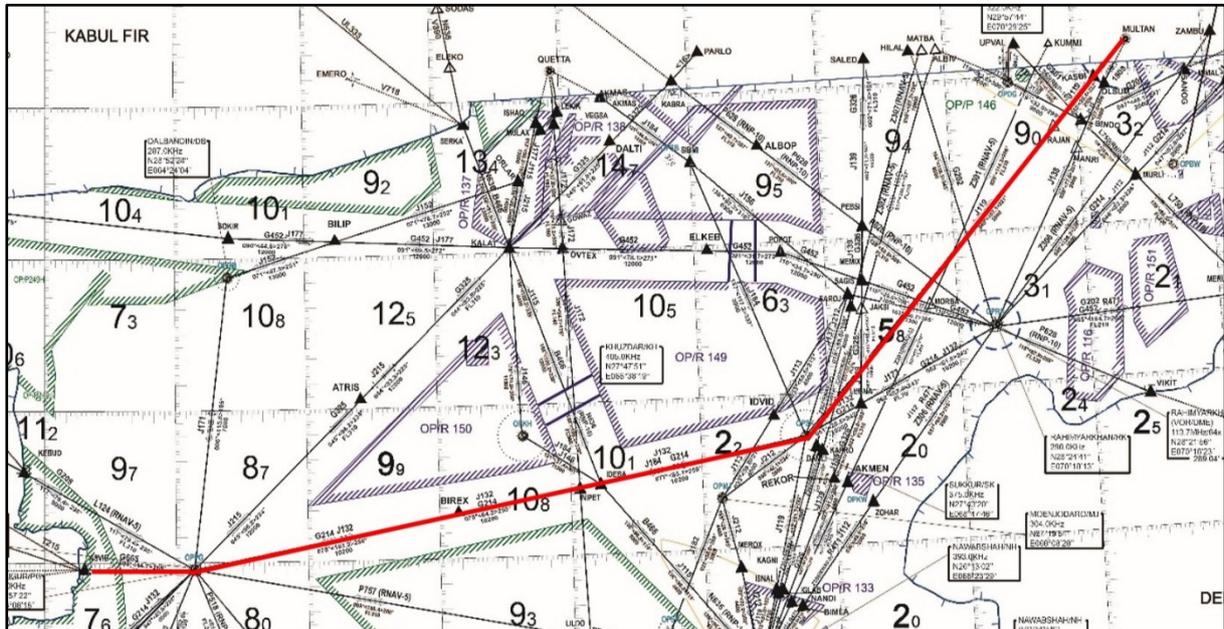
Figure 1 PK-150 Flight Route

1.1.1. On 17 January, 2025, M/s PIAC Flight PK-150, Airbus 320-214 aircraft, Registration No. AP-BON took off from OEDF, Dammam, Saudi Arabia for MIAP, Multan and entered Pakistan airspace via Air Traffic Services (ATS) route ASVIB – G665 – PG – G214 – SK – J119 – KASBI.

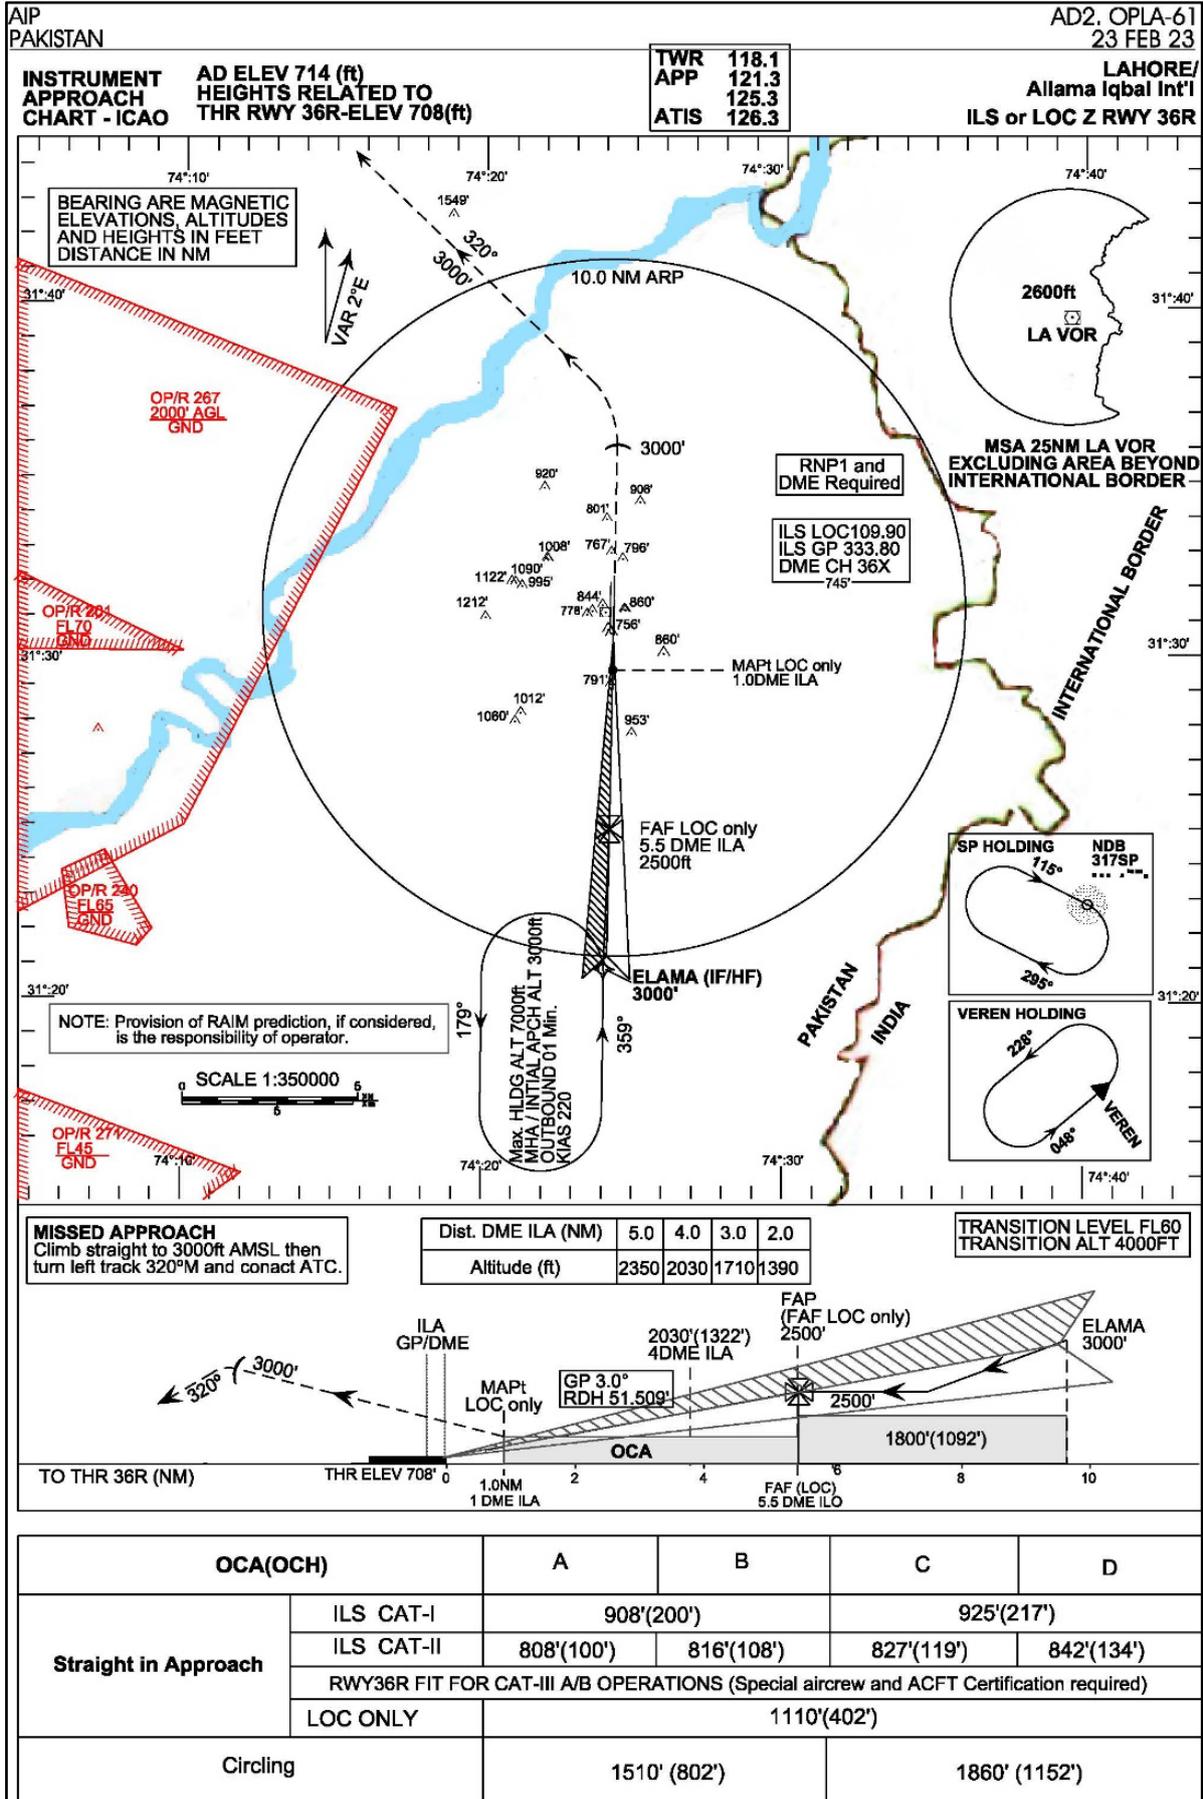
Figure 2 ILS Z Approach for RW 36R AIIAP, Lahore

- 1.1.34. **022809.** PK-150 was given left heading 040° and cleared for an ILS Approach to R/W 36R.

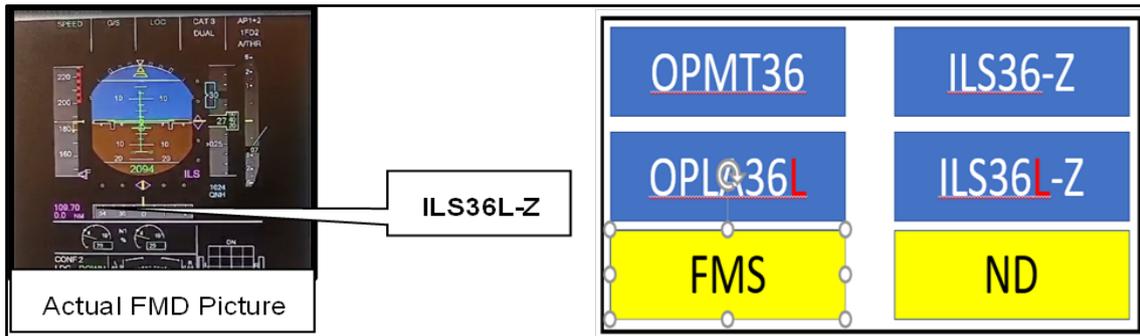
Figure 9 FMD Display

2.2.8. Moreover, PF & PM were so engrossed in LVP brief and took considerable time to revise LVP. During LVP briefing by PF, PM was lagging and was not attentive as number of times, PF had to guide and assist him to view at right place and correct data feeding. This speaks of poor knowledge level of PM. Furthermore, they did not revise Failures and Associated actions & Airport Lighting System and Runway markings section during LVP briefing.

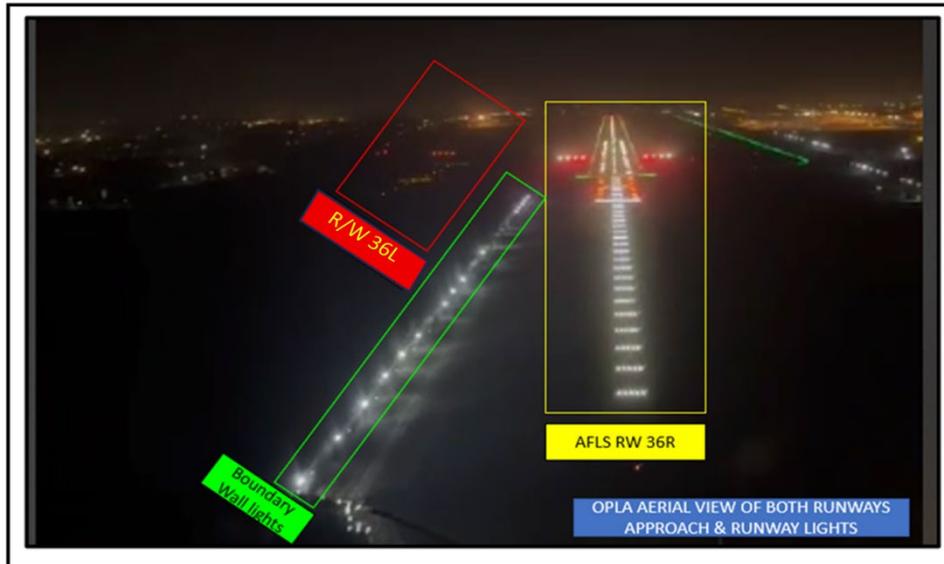
Figure 11 Aerial View of both R/W Approach and R/W Lights

- 1.1.41. **023400.** Tower Controller confirmed from the pilot if he was visual with the airfield as the aircraft was observed to be left of track upon which the pilot responded “**NEGATIVE**”. Meanwhile, the Tower Controller switched on the lights of R/W 36L.

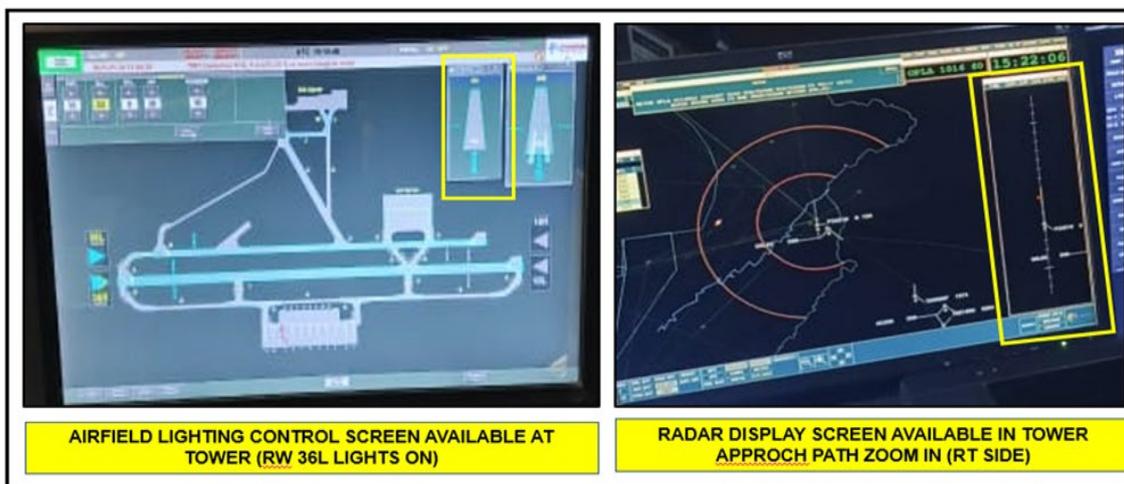
Figure 14 AFLS and Radar Display screen at Control Tower

2.2.10. **ATC Analysis** – Early changed over by Approach controller assuming PK-150 fully established on Glide Slope at 10 NM as announced by PM, however, the aircraft was still turning and remained towards left of track. The changeover to Tower could have been delayed till stabilization of approach, however, as in routine, he shifted his responsibility to tower controller and continued to monitor.

2.2.12. During interview with both Controllers, it has been learnt that both Air Traffic Controllers were hesitating to give “Go-Round” as it has been drilled in mind that its pilot responsibility. ATCs hesitate to issue Go-Around instructions due to pressure from higher authorities, with instances of license or rating cancellations creating a culture of fear. This hesitancy to intervene during critical phases reflects systemic cultural issues and training deficiencies.

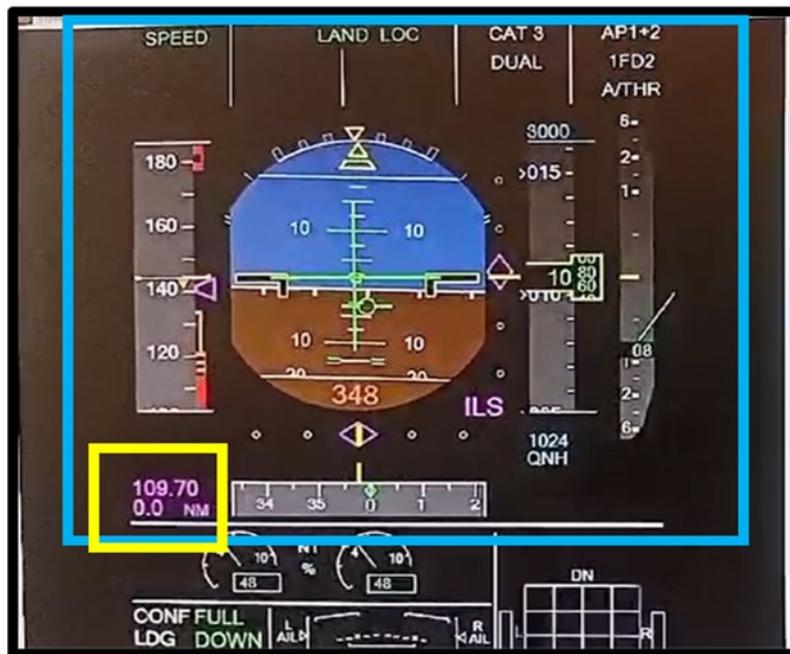
Figure 16 PFD

2.2.15. Both aircrew realized that they landed on wrong R/W at end of landing roll. The aircraft touchdown left half of R/W 36L (Nose wheel approximate 47 ft from centreline whereas the left wheel touchdown approximately 59.5 ft), thus leaving margin error of approximate 15 ft from R/W edge. Moreover, the aircraft carried out CAT-III B ILS Approach in Auto Land Mode on CAT-I ILS capability, any deviation could have been catastrophic (182 souls on board).
