PRELIMINARY INVESTIGATION REPORT

**ACCIDENT OF Mi-8-MTV-1 PANH HELICOPTERS
FLIGHT NO PNH9537 / REG. NO RA-24537
CRASHED AT SHEWA NEAR BANNU, KPK PAKISTAN ON 28-09-2024**

MI-8-MTV-1 HELICOPTER CRASH AT SHEWA, KPK, PAKISTAN dated 28-09-24 OPERATED BY PRINCELY JETS, FLIGHT NO PNH9537 PANH HELICOPTERS REG. NO RA-24537

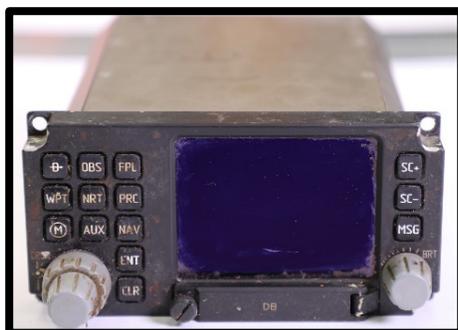
Figure 17
Satellite Navigation
Receiver

19. FDR and CVR were retrieved from the accident site in damaged condition. Vital navigation equipment including Satellite Navigation Receiver (TSS) Terrain Awareness Warning System (TAWS). TTA-12h and Air Navigation multiple indication Garmin GTN750 were also recovered for analysis.
