FINAL INVESTIGATION REPORT

**ACCIDENT OF M/S SHAHEEN AIR FLYING TRAINING
SCHOOL CESSNA-162 AIRCRAFT, REG # AP-ZBQ ON
24TH FEBRUARY, 2017 AT FAISALABAD**

ACCIDENT OF M/S SHAHEEN AIR FLYING TRAINING SCHOOL CESSNA-162 AIRCRAFT, REG # AP-ZBQ ON 24TH FEBRUARY, 2017 AT FAISALABAD

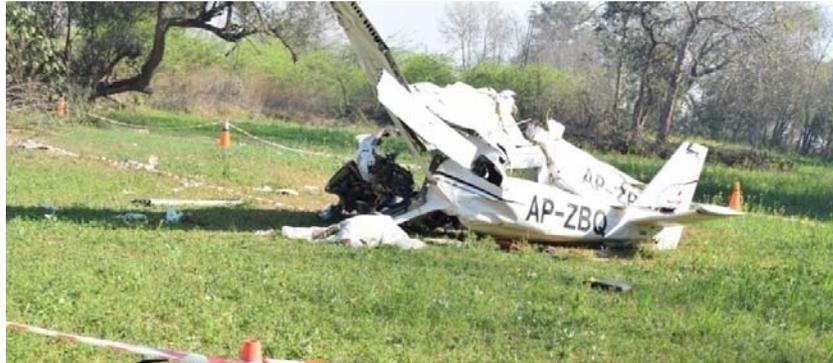
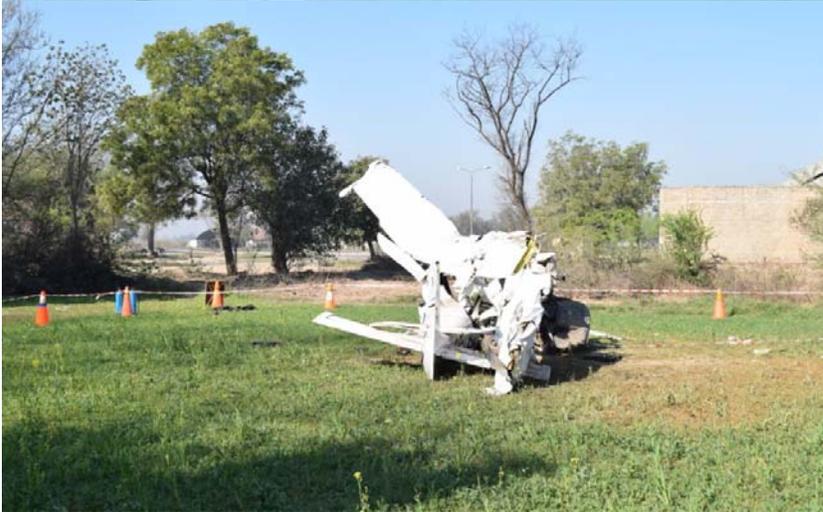
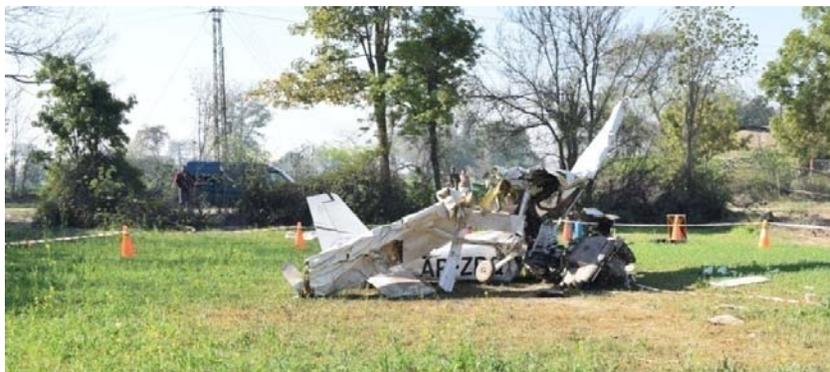
2.2.3 **Structural Integrity of the Aircraft / Flight Controls.** Entire wreckage of the aircraft was confined to a limited area and all four corners of the aircraft were well accounted. Since, it was a short duration lift off, the entire track of the aircraft was scanned for any lost structure prior to the crash site, however, nothing was found. Moreover, the flight parameters analysis also revealed nothing un-usual that could have been recorded especially due to an in-advertant loss of any lift generating or flight control surfaces etc. Therefore, crash of the aircraft due lost structural integrity has been ruled out. All primary and secondary flight surfaces were intact. Left aileron was detached and lying under the left wing, however, it was due to aircraft impact with the ground. Rest of the left wing and left flap was intact.

Fig. Tail section of the aircraft and badly damaged right wing
