FINAL INVESTIGATION REPORT

SERIOUS INCIDENT (TCAS – RA) BETWEEN AERO NOMAD AIRLINE FLIGHT ANK4506, AIRBUS 320-233 AIRCRAFT, REG. NO. EX-32009 (OPIS – UCFM) & BRITISH AIRWAYS FLIGHT BAW2261, BOEING 777-236ER AIRCRAFT, REG. NO. GYMMD, (EGLL – OPIS) ON 05-06-2022

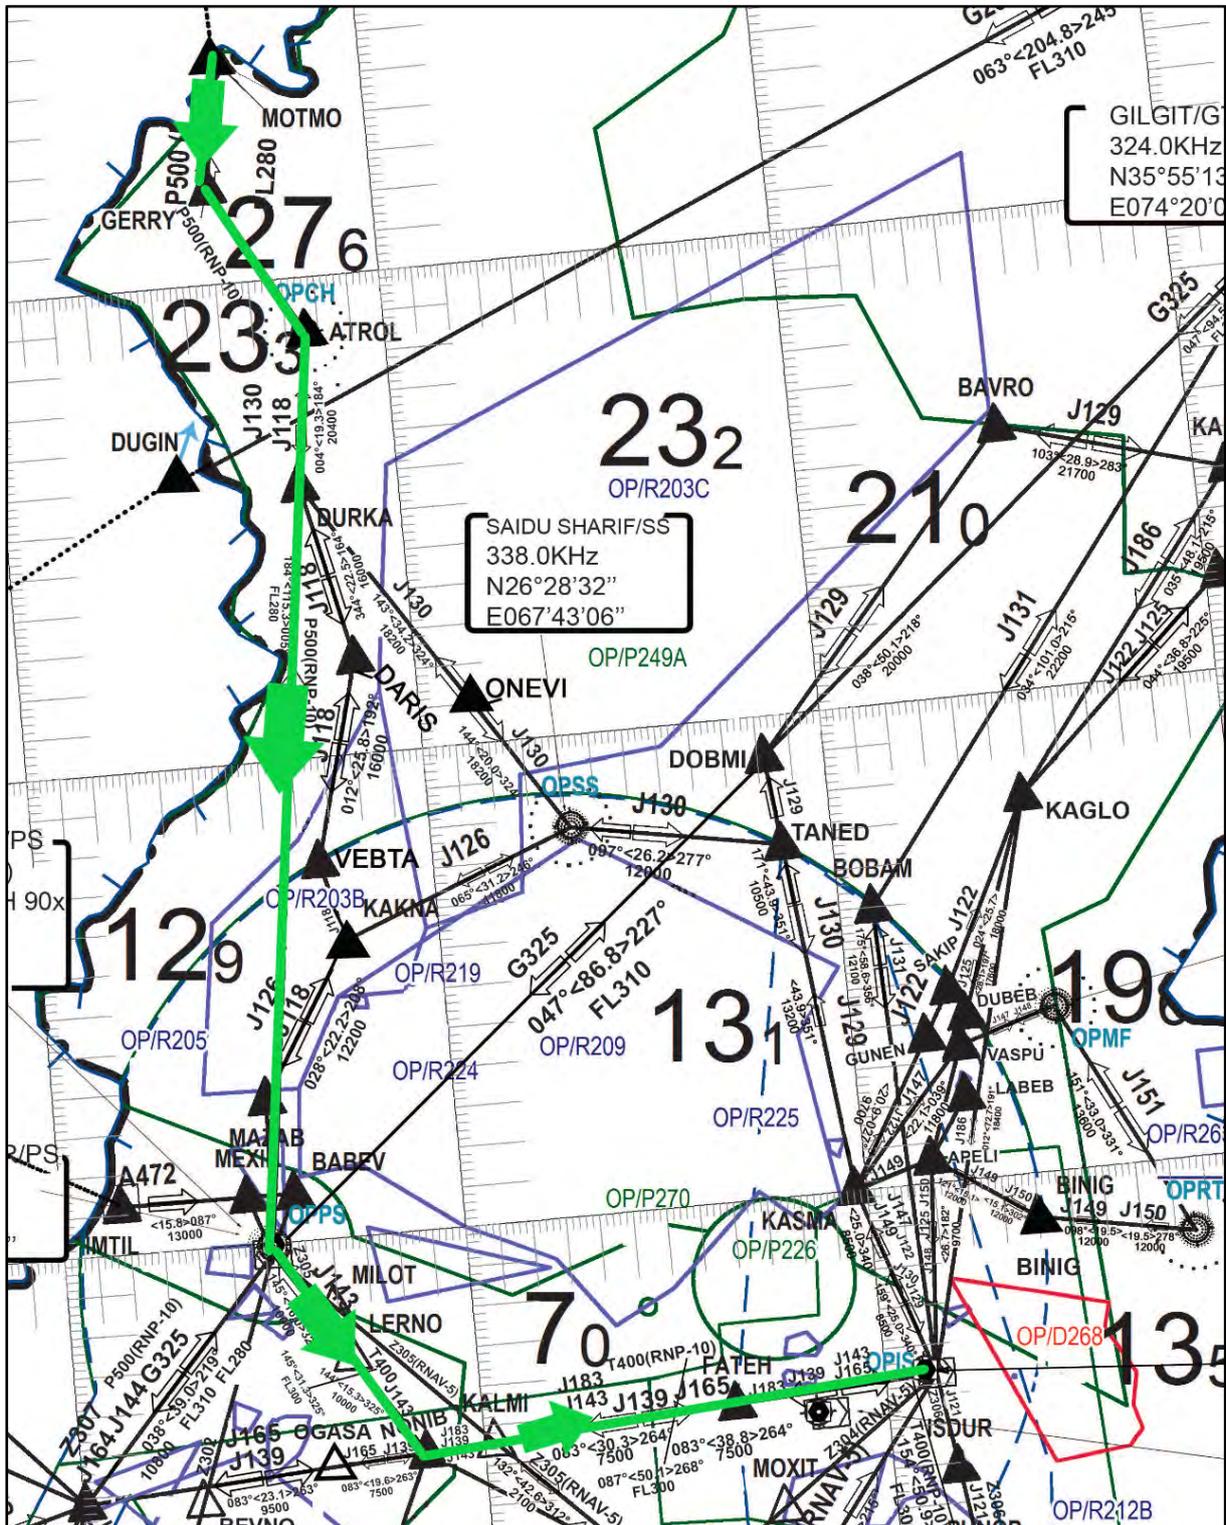
Figure 2 BAW2261 Route

1.1.3. When ANK4506 was 05 NM North of position PS VOR climbing out of FL318 for FL320 with Rate of Climb (ROC) 1,100 ft/min, it encountered TCAS-RA with reciprocal traffic BAW2261 which was descending from FL390 to FL330 passing FL332 with Rate of Descent (ROD) 1,600 ft/min at the time of incident.

1.1.4. ANK4506 descended from FL318 to FL315 on TCAS-RA. BAW2261 did not report TCAS-RA however, it followed TCAS-RA command to level off at FL330.

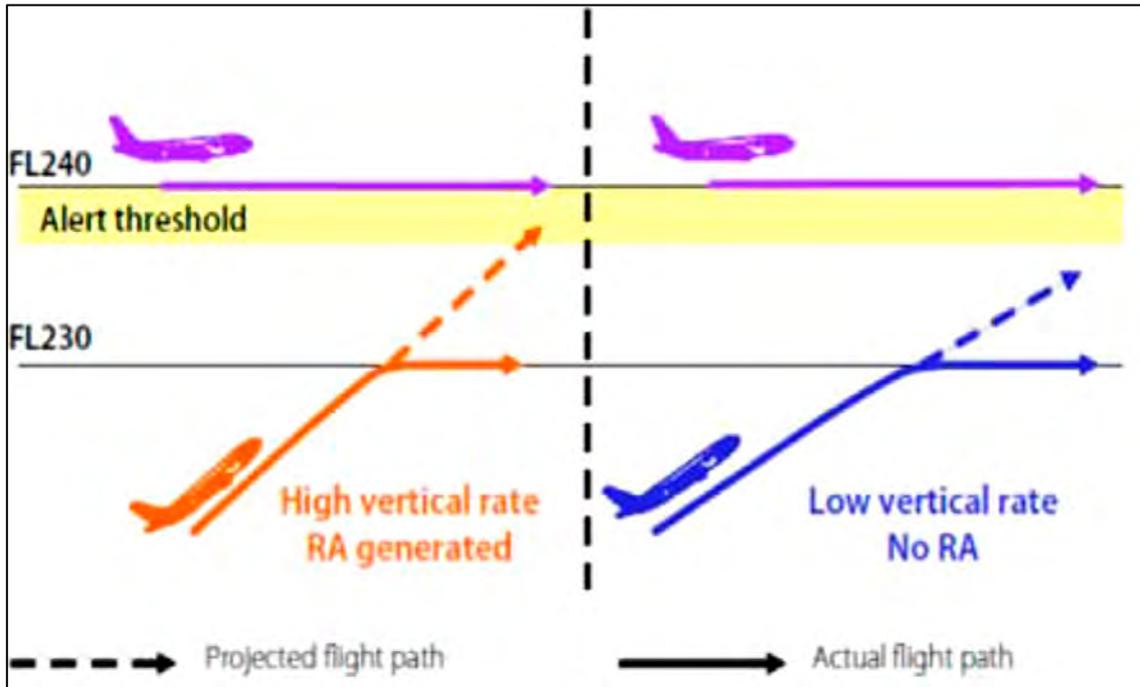
Figure 6 HVR Encounters

1.18.3.1. ICAO Doc 8168 Vol-III, states that Pilots should use appropriate procedures by which an aeroplane climbing or descending to an assigned altitude or flight level, especially with an autopilot engaged, may do so at a rate less than 8 m/s (or 1,500 ft / min) throughout the last 300 m (or 1,000 ft) of climb or descent to the assigned altitude or flight level when the pilot is made aware of another aircraft at or approaching an adjacent altitude or flight level, unless otherwise instructed by ATC. Some aircraft have auto-flight systems with the capability to detect the presence of such aircraft and adjust their vertical rate accordingly. These procedures are intended to avoid unnecessary ACAS II resolution advisories in aircraft at or approaching adjacent altitudes or flight levels. For commercial operations, these procedures should be specified by the operator.

3.1.11. BAW2261 high ROD before the TCAS-RA and fluctuating RODs observed on radar display indicate deviation from ICAO guidelines.
