FINAL INVESTIGATION REPORT

SERIOUS INCIDENT (TCAS – RA) BETWEEN AIRBLUE FLIGHT ABQ611, AIRBUS 321-211 AIRCRAFT, REG. NO. AP-BMW (DUBAI – PESHAWAR) AND MILITARY AIRCRAFT ON 13-12-2021

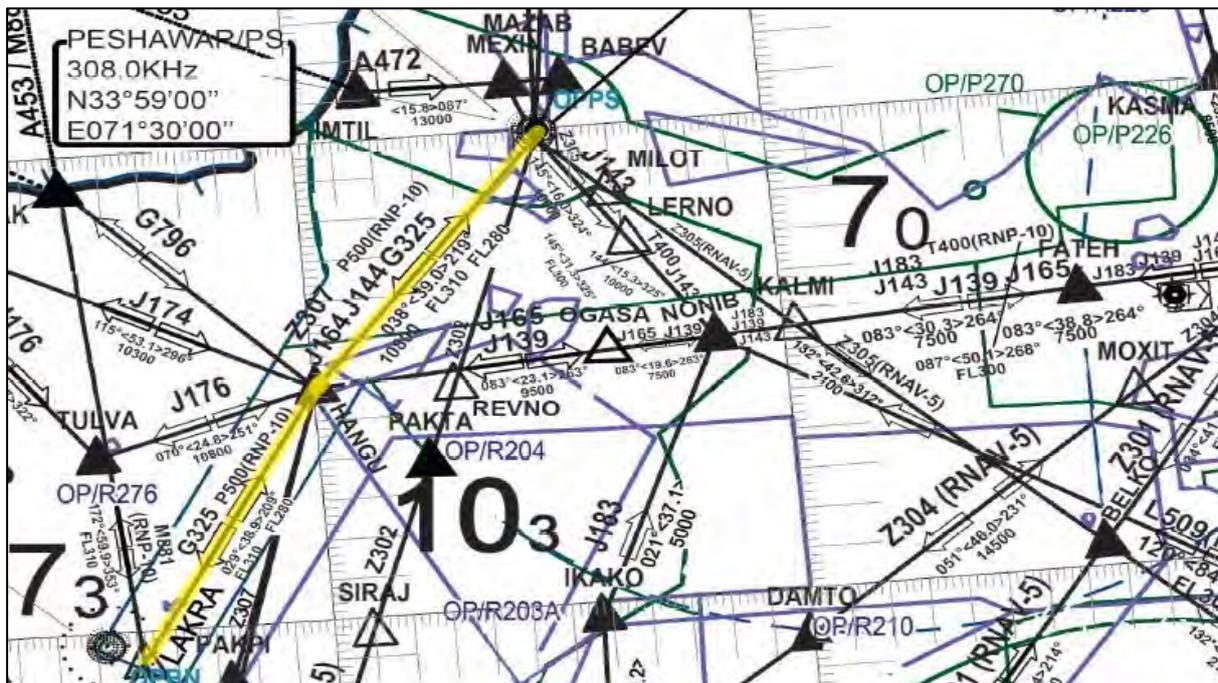
Figure 1 ABQ611 Route

1.1.1. On 13th December, 2021, Airblue flight ABQ611, Airbus 321-211 aircraft, Reg No. AP-BMW was operating from Dubai International Airport, Dubai, UAE to BKIAP, Peshawar, Pakistan on ATS route PG – G325 – HANGU – OPPS.

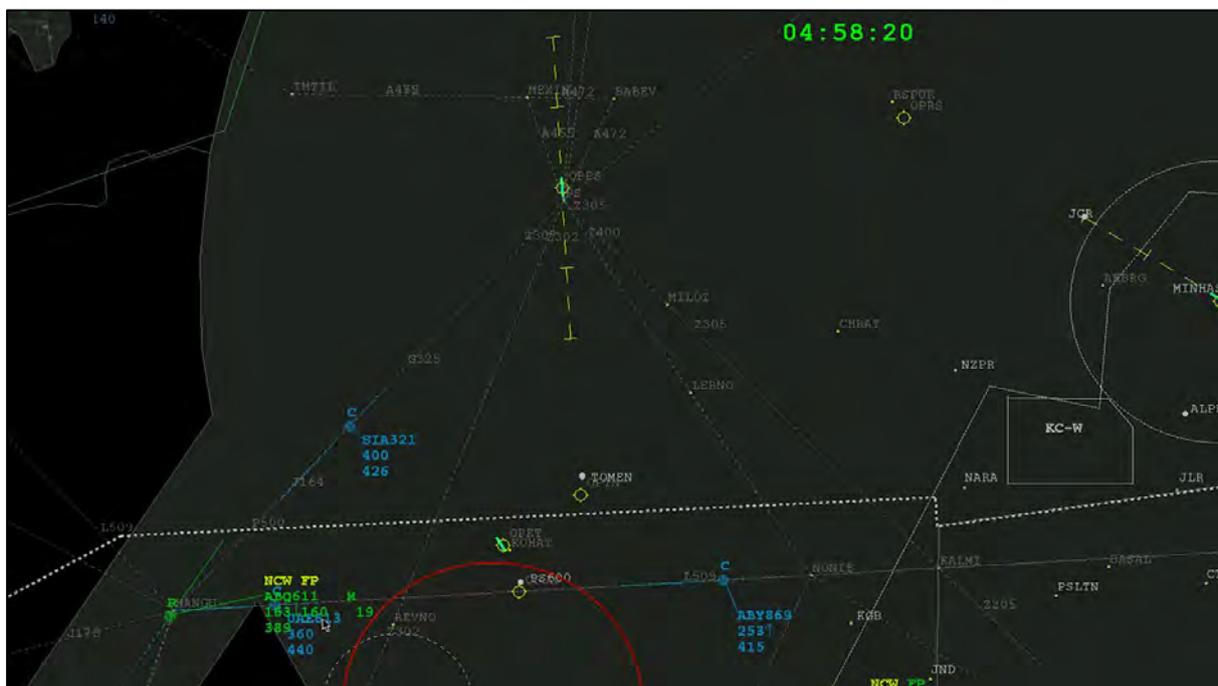
Figure 2 ABQ611 came in contact with Tower Controller

1.1.2. Once ABQ611 came in contact with Peshawar ATC Tower, Civil Controller asked ABQ611 to maintain FL160 and hold over Peshawar VOR for 20 min as advised by Military Supervisor due to Military traffic at FL140 on recovery for landing.
