FINAL INVESTIGATION REPORT

SERIOUS INCIDENT (TCAS – RA) – KUWAIT AIRWAYS FLIGHT KAC920, BOEING 777-369(ER) AIRCRAFT, REG. NO. 9K-AOE (SECTOR GUANGZHOU TO KUWAIT) AND MILITARY AIRCRAFT ON 01-12-2021

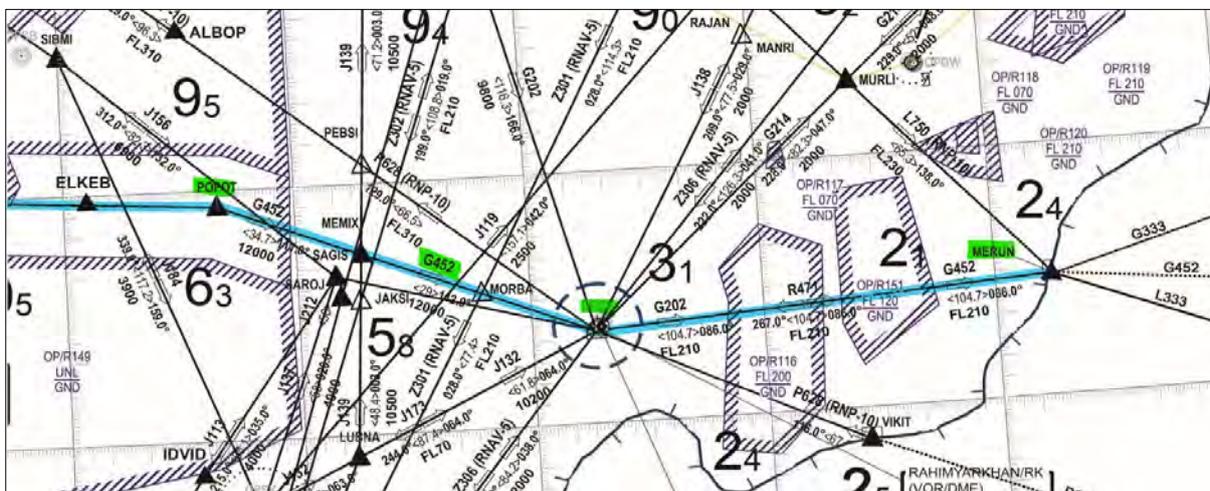
Figure 4 KAC920 Flight Plan Route

2.1.1. On 1st December, 2021 a transit flight of Kuwait Airways KAC290, Boeing 777-368(ER) aircraft, Reg. No. 9K-AOE was operating from ZGGG, China to OKBK, Kuwait following ATS route G452 maintaining FL340.
