FINAL INVESTIGATION REPORT

SERIOUS INCIDENT (TCAS – RA) BETWEEN PIAC FLIGHT PIA303, A320-214 AIRCRAFT, REG. NO. AP-BOL (OPLA - OPKC) AND MILITARY AIRCRAFT ON 04-03-2022

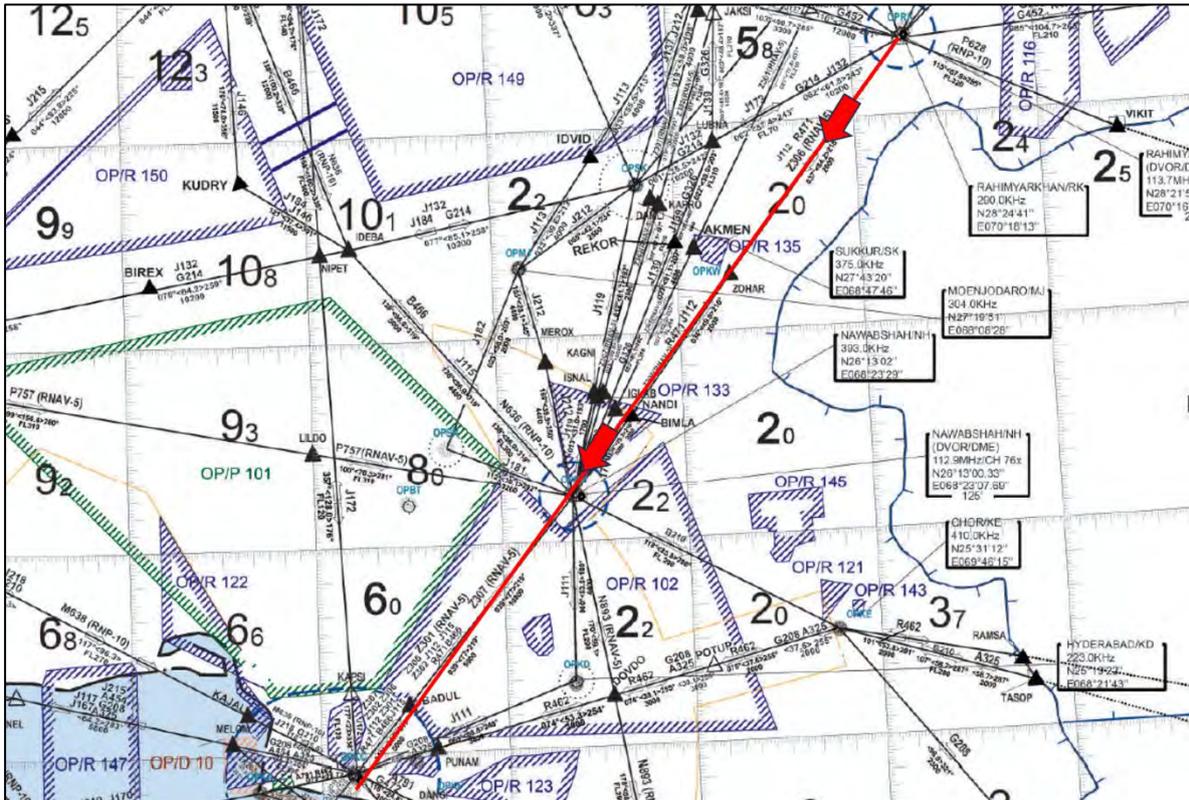
Figure 1 PIA303 Route

1.1.1. On 04th March, 2022, PIA Flight PIA303, A320 aircraft, Reg. No. AP-BOL was operating from OPLA, Lahore, Pakistan to OPKC, Karachi, Pakistan on ATS route J112 – NSH – KC maintaining FL380.

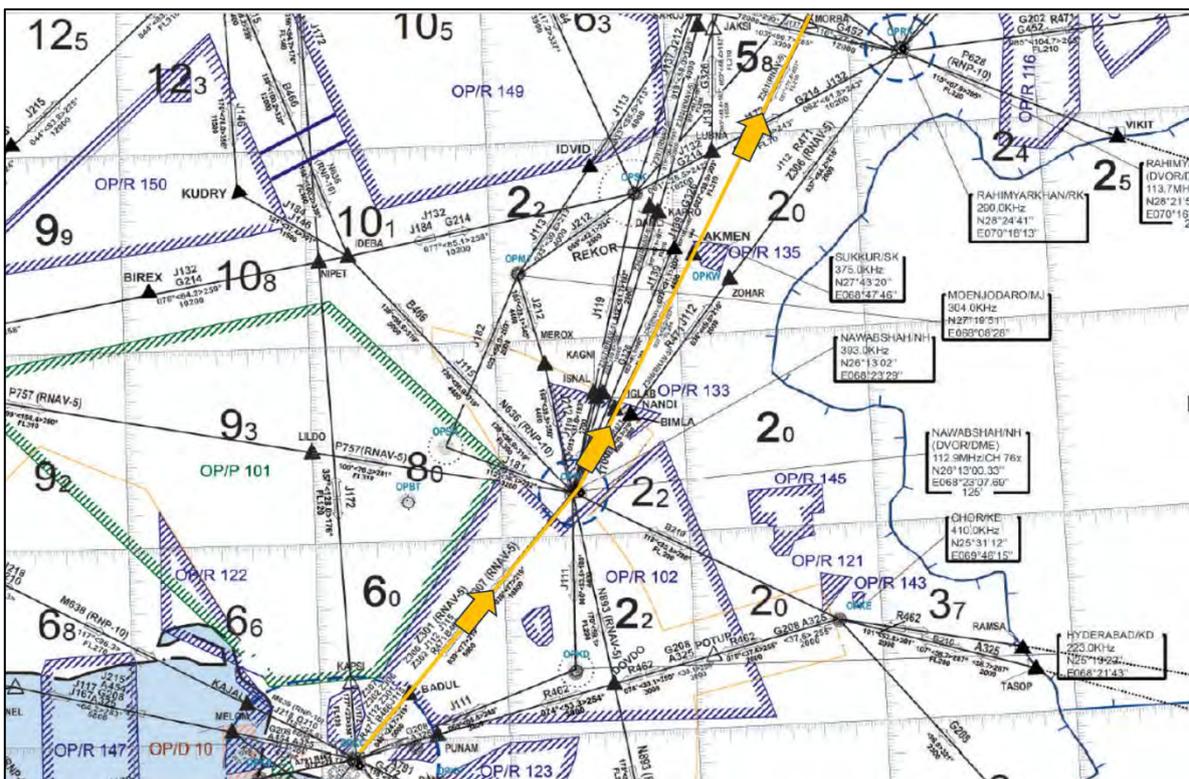
Figure 2 GHAURI-62 Route

1.1.2. GHAURI-62, HBC aircraft was operating from OPSF, Karachi, Pakistan to OPRN, Rawalpindi, Pakistan on ATS route OPSF-NSH-Z301-OPRN climbing to FL390.
