FINAL INVESTIGATION REPORT

SERIOUS INCIDENT OF GULF AIR FLIGHT GFA 770 BOEING 787-9 AIRCRAFT REG. NO. A9C-FF AT ISLAMABAD ON 02-06-2021

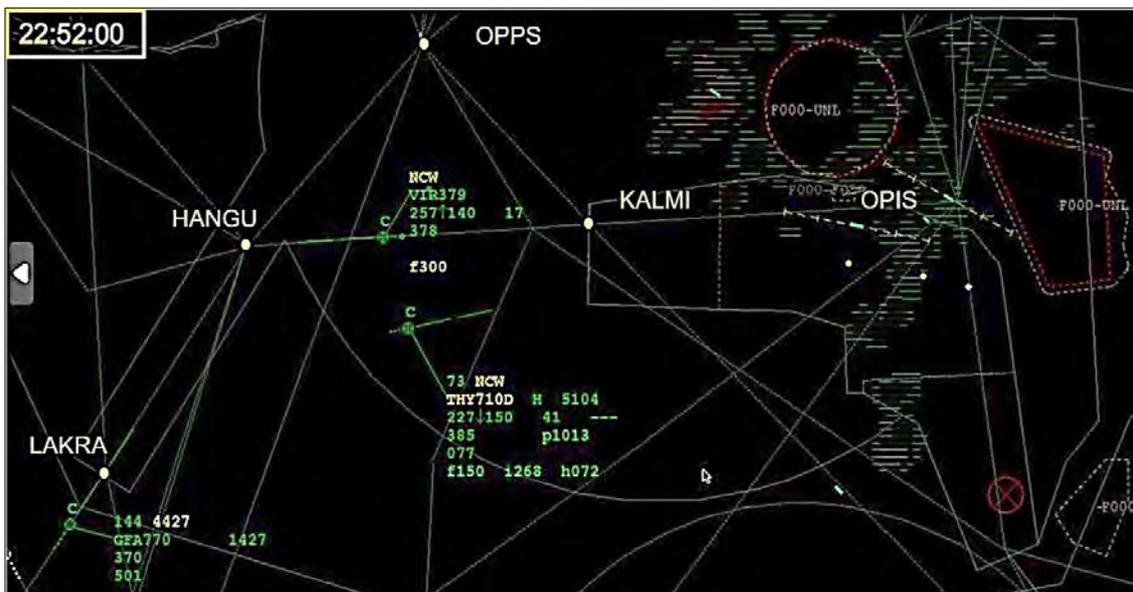
Figure 1 GFA 770 came in contact with Area Control Islamabad

1.1.3. At 22:52:00 h, GFA 770 came in contact with Area Control Islamabad while approaching position LAKRA and descending Flight Level (FL) 290. Aircraft was identified and given arrival clearance with descent to FL150.

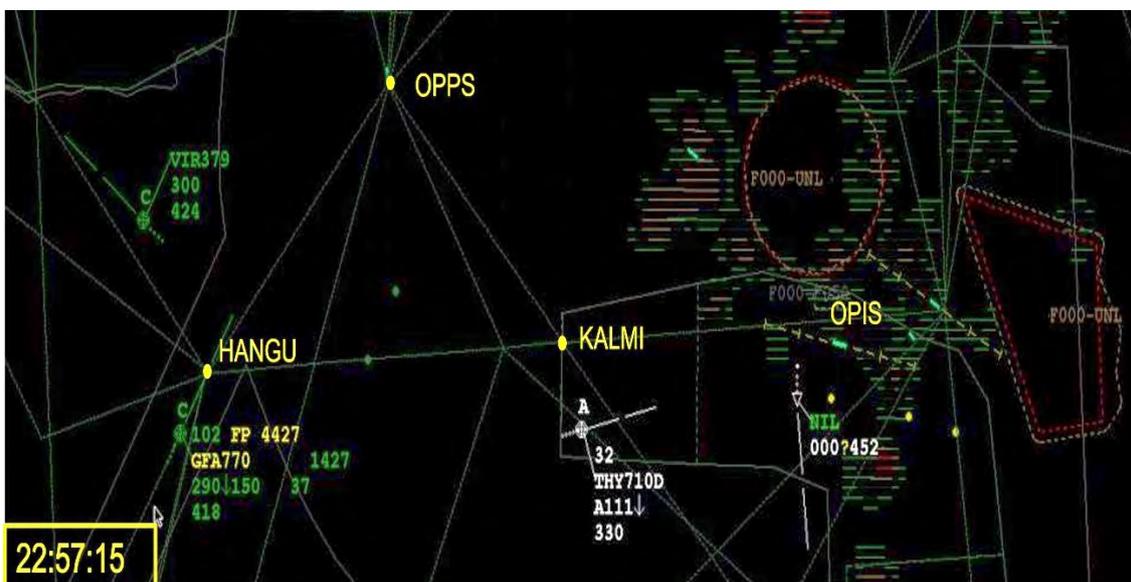
Figure 2 Weather at IIAP, Islamabad and Surrounding Areas

1.1.5. At 22:57:15 h, approaching South of HANGU, aircraft requested to maintain heading 060° for 10 NM to avoid flying into inclement weather. Weather deviation was approved by Area Radar Controller. The weather reported at that time was Thunderstorm / Rain at IIAP, Islamabad and surrounding areas.

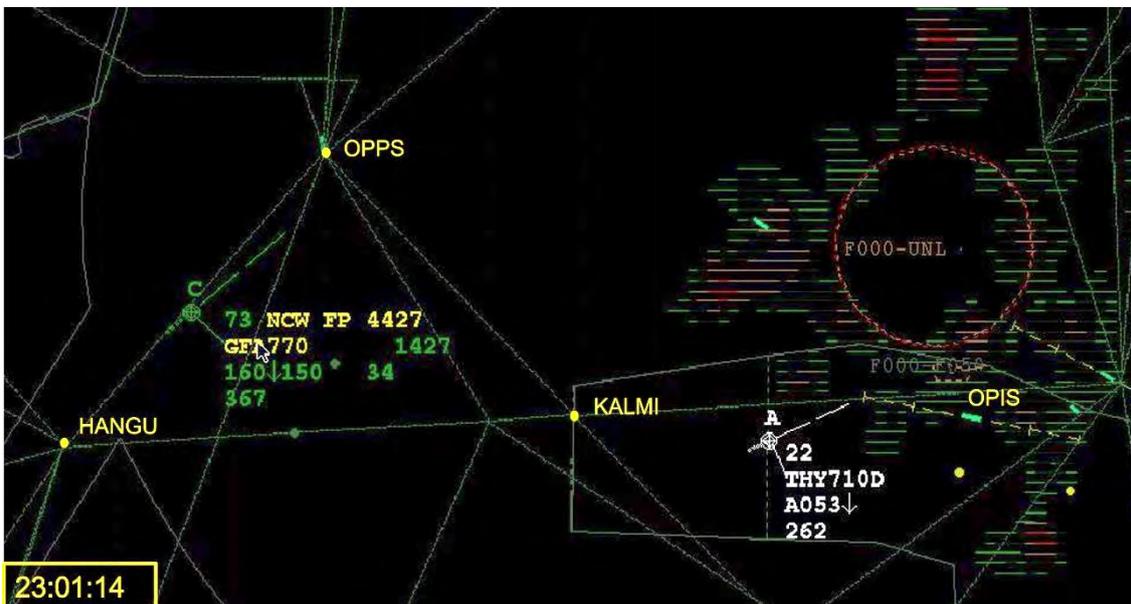
Figure 3 GFA 770 given descent to 9,000 ft

1.1.6. At 23:01:14 h, GFA 770 requested for further descent. Area Control Islamabad inquired “how long you will maintain this heading”. GFA 770 informed that they are turning right heading 060°. GFA 770 was given descent 9,000 ft on QNH 1006 Hectopascal (hPa) (QNH for IIAP, Islamabad). Same was acknowledged by GFA 770.

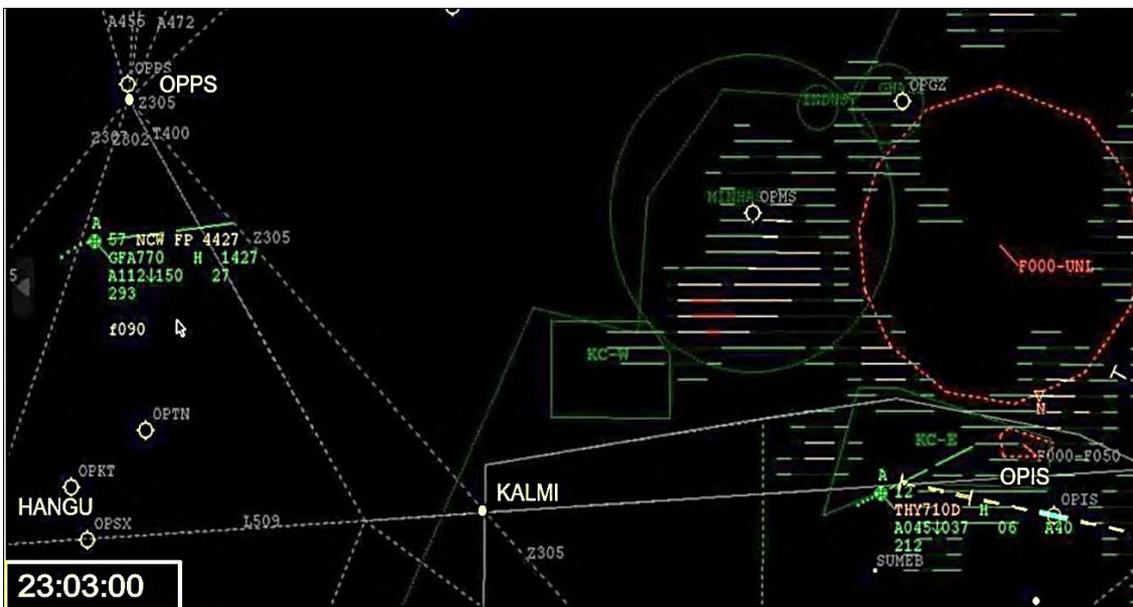
Figure 5 GFA 770 turning right heading 080°

1.1.9. At 23:03:00 h, GFA 770 informed turning right heading 080°. Approach Control Islamabad inquired “for how long you will maintain heading 080°”. GFA 770 replied that they would be maintaining heading for another 05 miles and informed Approach Control Islamabad that they need to descend otherwise they will enter into weather at this level.

1.1.10. Approach Control Islamabad informed GFA 770 that on present heading they will be proceeding towards hilly terrain and they have to turn right for descent.

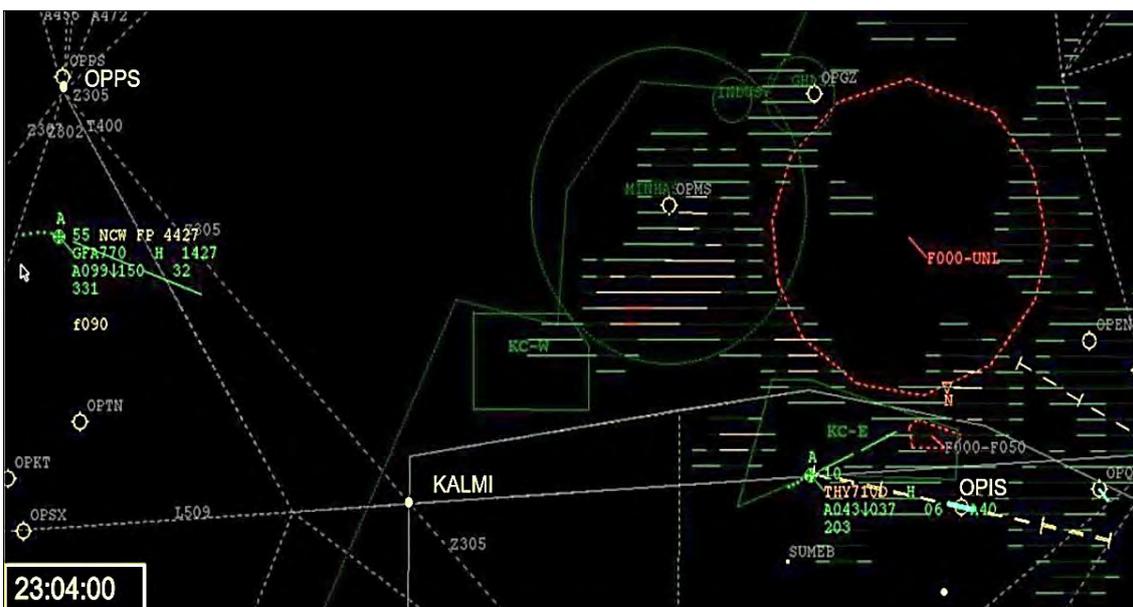
Figure 6 GFA 770 given descent to 5,000 ft

1.1.12. At 23:04:00 h, GFA 770 requested descent again to which the Approach Control Islamabad cleared GFA 770 to descend 5,000 ft on QNH 1006 and advised GFA 770 to expect further descent 25 NM short of Islamabad.

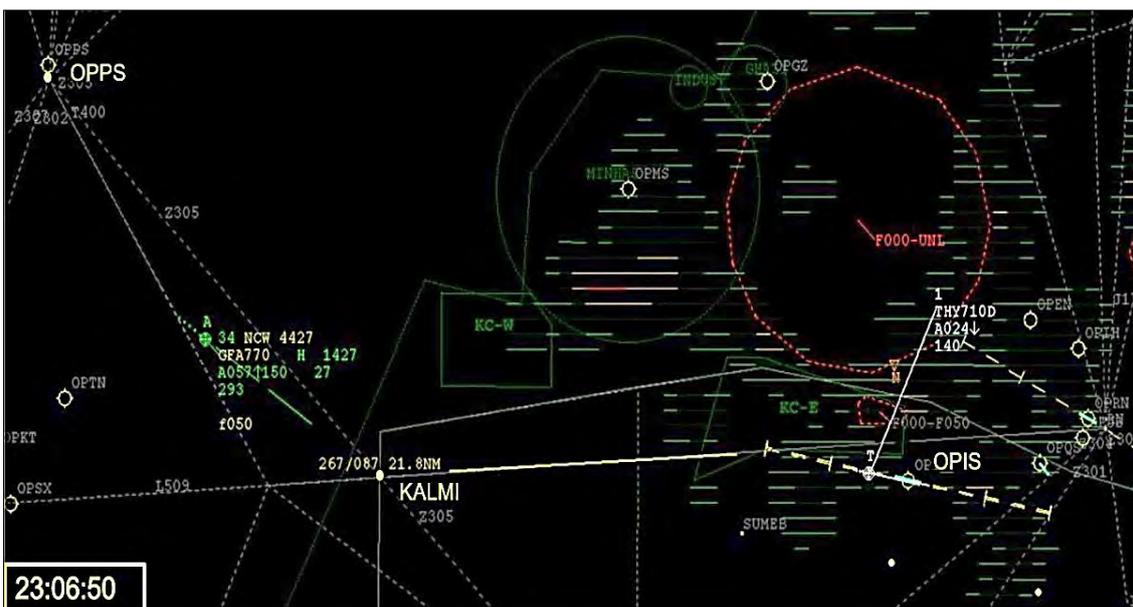
Figure 8 GFA 770 reported climbing 7,000 ft and then 10,000 ft

1.1.15. At 23:06:50 h, GFA 770 reported climbing 7,000 ft and subsequently 10,000 ft. GFA 770 informed Approach Control Islamabad that they had to climb due to GPWS warning. Same was acknowledged by Approach Control Islamabad.

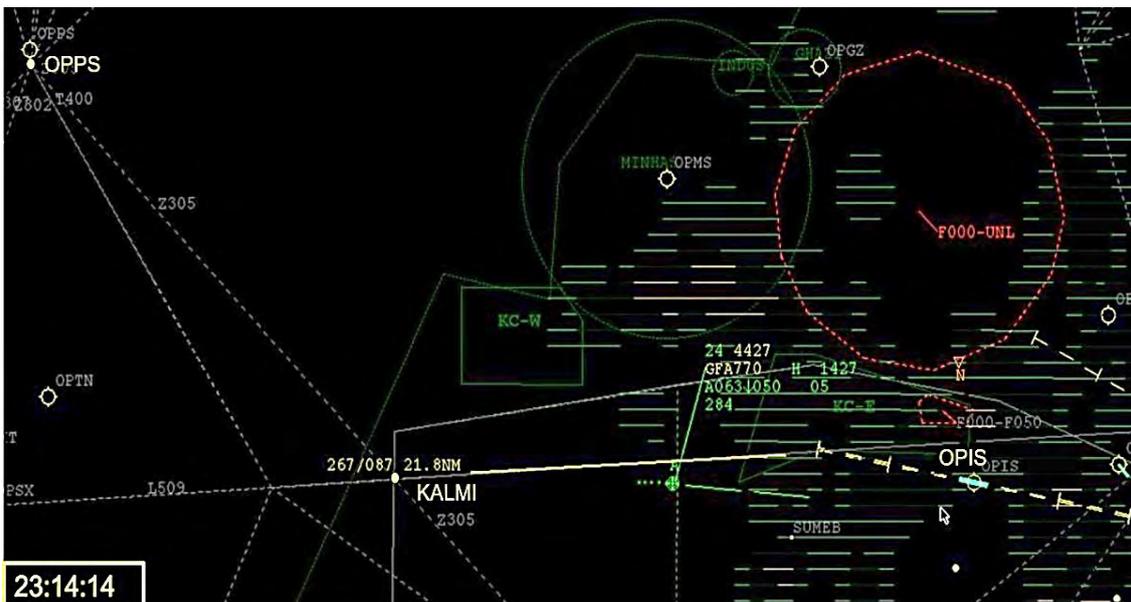
Figure 10 GFA 770 decided to hold for Weather Improvement

1.1.22. At 23:14:14 h, while passing 6,200 ft, GFA 770 decided to discontinue Approach and hold present position at 6,000 ft.

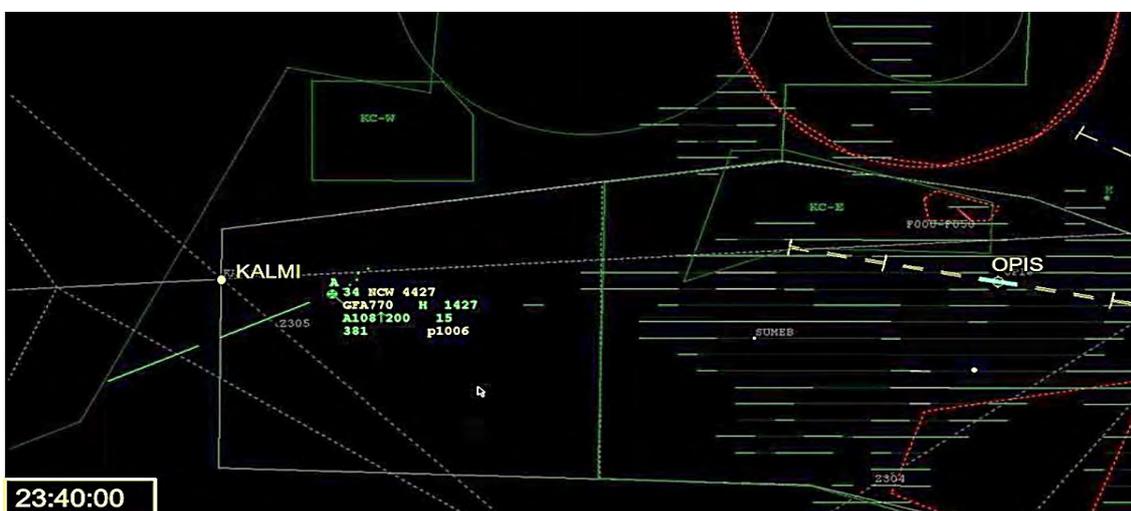
Figure 11 GFA 770 climbing to FL200

1.1.25. At 23:39:46 h, GFA 770 requested for higher level. Approach Control Islamabad cleared GFA 770 to climb FL200.

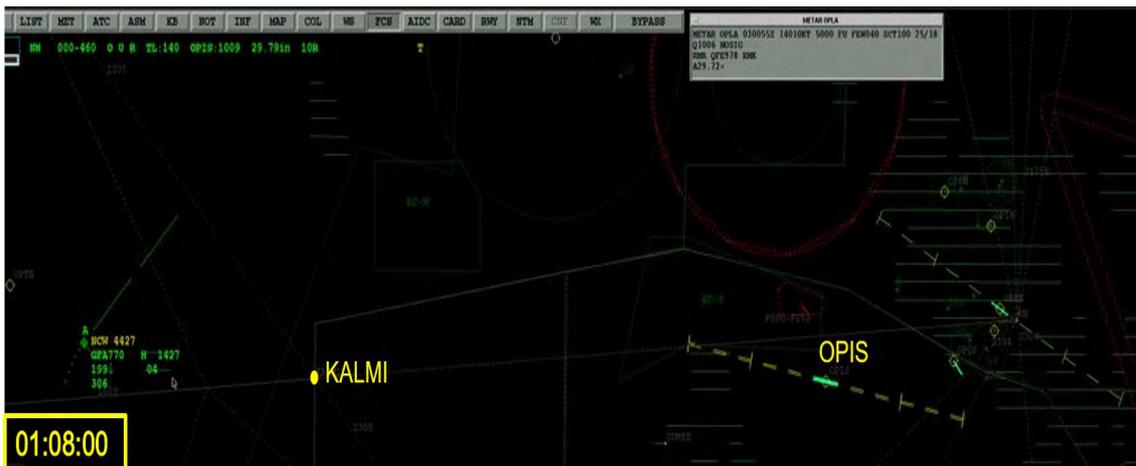
Figure 12 GFA 770 Approach for ILS Z for R/W 10R

1.1.32. At 01:07:36 h, GFA 770 reported ready for Approach. Approach Control Islamabad cleared GFA 770 for ILS 'Z' Approach for R/W 10R.

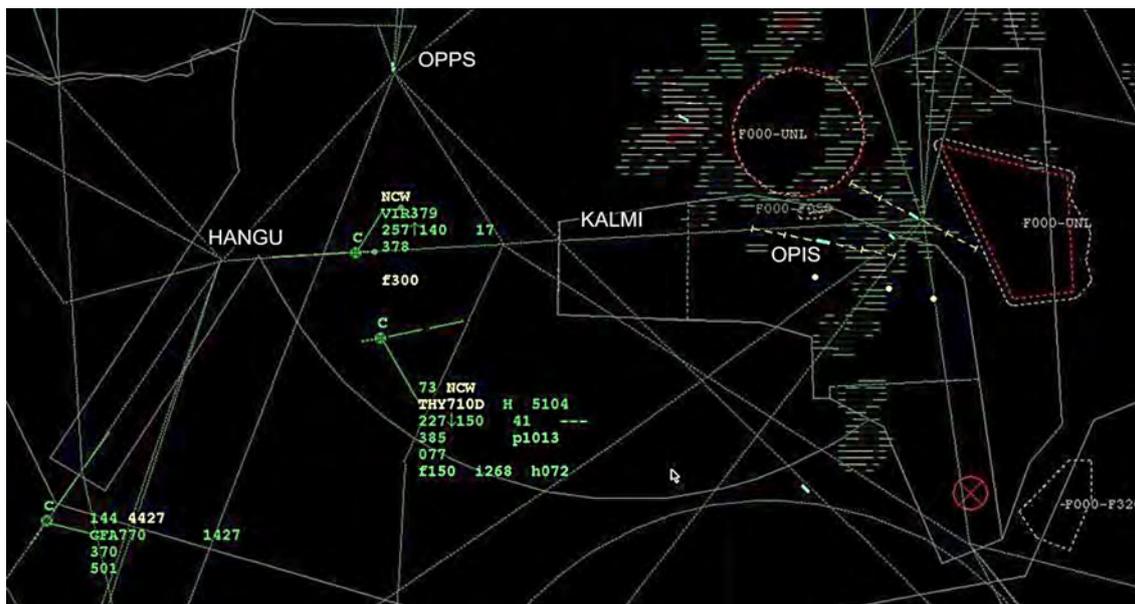
Figure 18 Arrival ahead of GFA 770

(d) The arrival ahead of GFA 770 was THY710D, which was vectored South of HANGU for traffic management and thereafter for ILS Approach R/W 10R. At the same time another flight bearing call sign VIR 379 departed from IIAP, Islamabad and was following standard ATS route for HANGU.

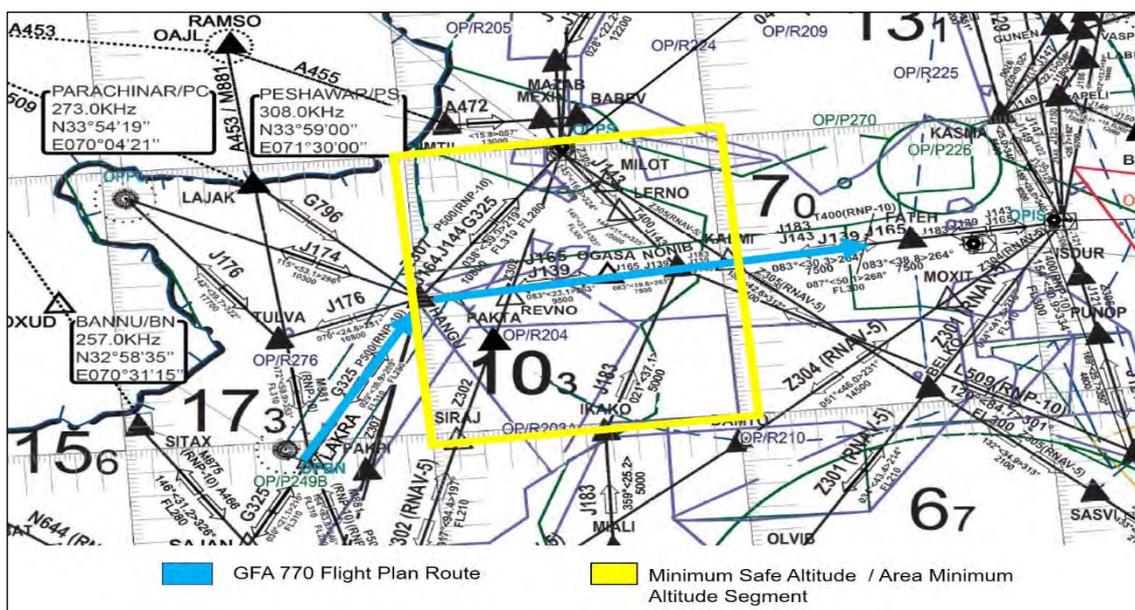
Figure 20 Enroute Chart 6-1 B (GFA 770 Flight plan route and MSA of 10,300 ft)

(f) **Non-activation of Minimum Safe Altitude Warning (MSAW) feature** – There was provision for MSAW feature within SI-ATM but it had not been activated at that time contrary to ICAO Doc 4444 PANS-ATM Chapter 8 Section 8.4.1. However, AIP and relevant documents were available for ready reference at ACC IIAP.

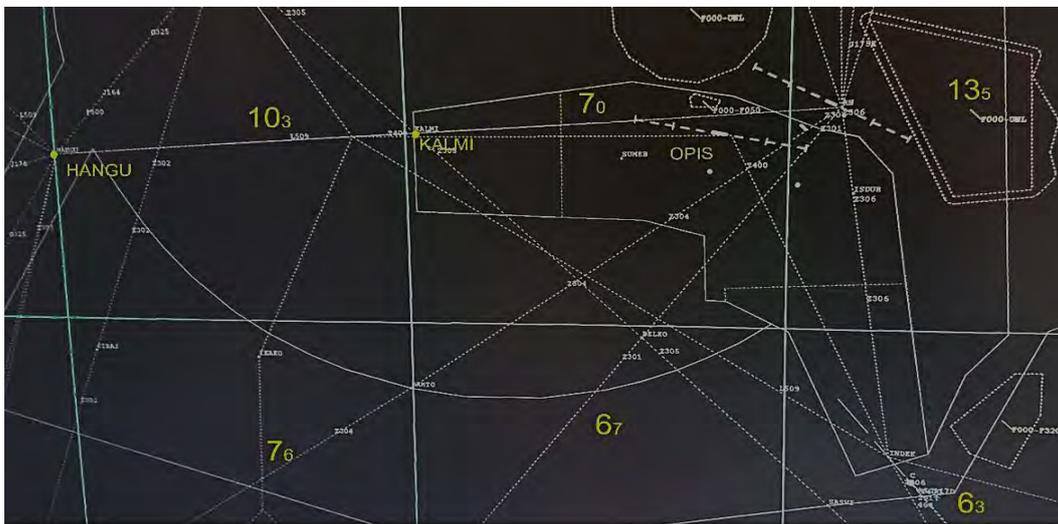
Figure 21 AMA on SI-ATM Display System

2.2.4.5. After the incident, a map depicting AMA (as provided in AIP Pakistan) was provided in the SI-ATM system for the guidance of the controllers.

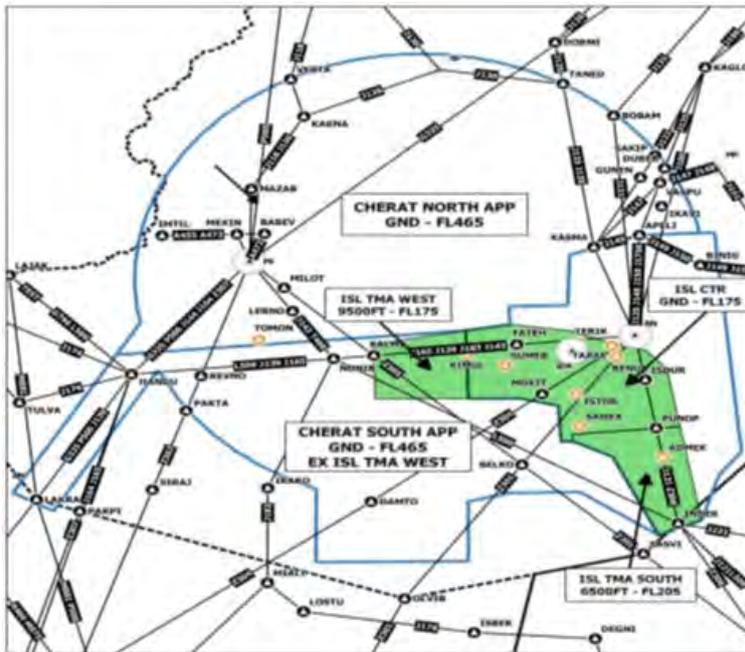
Figure 22 Cherat Control Zone

(b) In this case, although the aircraft was not yet in the AOR of Islamabad Approach, yet the aircraft was transferred over to Approach Control well before start of TMA west while the aircraft was flying in AOR of Cherat Approach North and without handing over to Cherat Approach.

(c) Though the distribution of airspace has been clearly demarcated and mentioned in the AIP and SATI, IIAP, Islamabad however mutually agreed LOAs between Area control Islamabad and Cherat Approach South / North and between Approach Control Islamabad and Cherat Approach South units were not available.

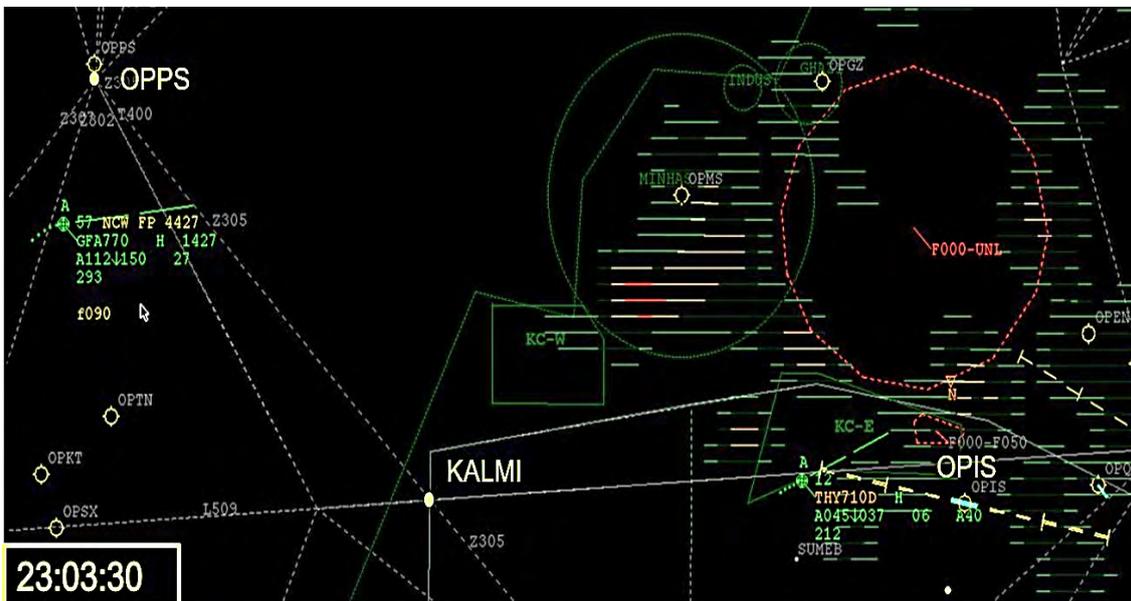
Figure 26 GFA 770 proceeding direct to point KALMI

- (b) As GFA 770 was flying North of HANGU, no attempt was made by Approach Control Islamabad to transfer GFA 770 to Cherat Approach North. Instead, Approach Control Islamabad took control of the GFA 770 in AOR of Cherat Approach North.
- (c) At 23:03:00 h, GFA 770 informed turning right heading 080° and requested further descent in order to avoid bad weather. However, at 23:03:18, Approach Control Islamabad informed GFA 770 that descent was not possible unless it turned further right as it was heading towards hilly terrain.
- (d) At 23:03:30 h, GFA 770 decided to proceed direct to point KALMI which was approved.

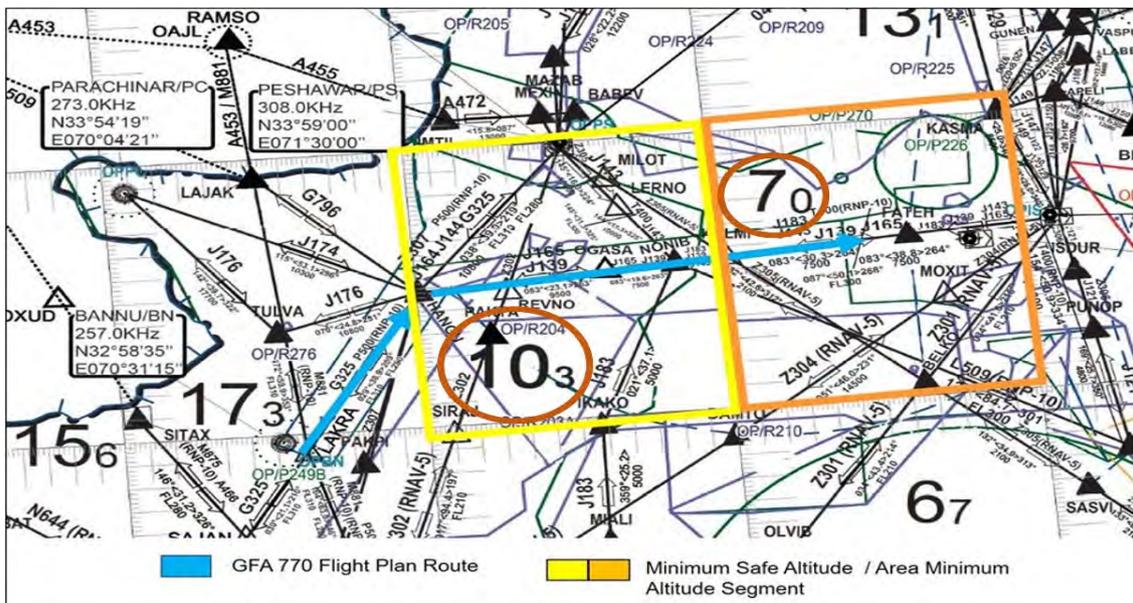
Figure 28 Enroute Chart 6-1 B (showing GFA 770 Flight Plan Route and AMA of 10,300 ft and 7,000 ft.)

(e) Approaching KALMI, at 23:04:00 h, GFA 770 requested for descent twice in response to which the Approach Control Islamabad cleared GFA 770 to descend to 5,000 ft contrary to AMA of 10,300 ft and advised GFA 770 to expect further descent 25 NM short of Islamabad (KALMI). GFA 770 was at this time approximately 15 NM North West of KALMI.

(d) Flight crew wrongly selected MSA of 4,200 ft from the Approach chart (25 NM from IIAP) instead of considering Grid MORA as they were distracted due to the weather conditions. Lack of Situational Awareness by both flight crew resulted in overlooking sector AMA of 10,300 ft.

4.1.3.1. Gulf Air may conduct refresher trainings for their flight crew with special emphasis on flying in adverse weather conditions and correct interpretation of data charts for the safety of aircraft and its occupants

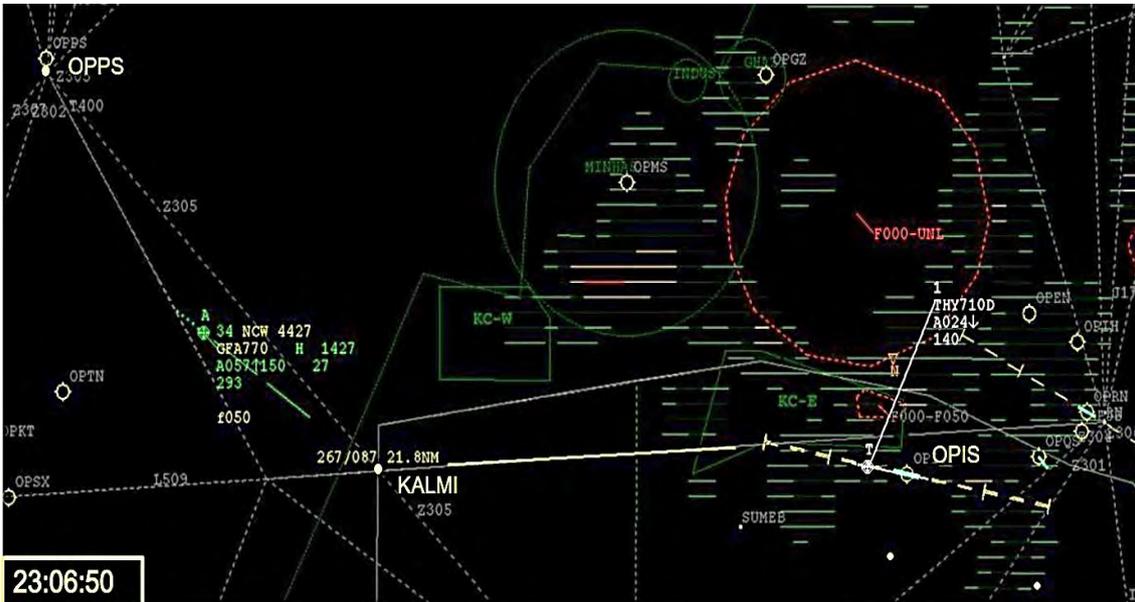
Figure 30 GFA 770 climbing 7,000 ft

- (i) At 23:06:49, GFA 770 reported climbing 7,000 ft and subsequently 10,000 ft.
