## FINAL INVESTIGATION REPORT

### SERIOUS INCIDENT TCAS-RA

**SAUDIA AIRLINE FLIGHT SVA792 AIRBUS 330-343  
AIRCRAFT REG. NO. HZ-AQ18 (OERK TO OPPS) AND  
MILITARY AIRCRAFT ON 05-03-2024**

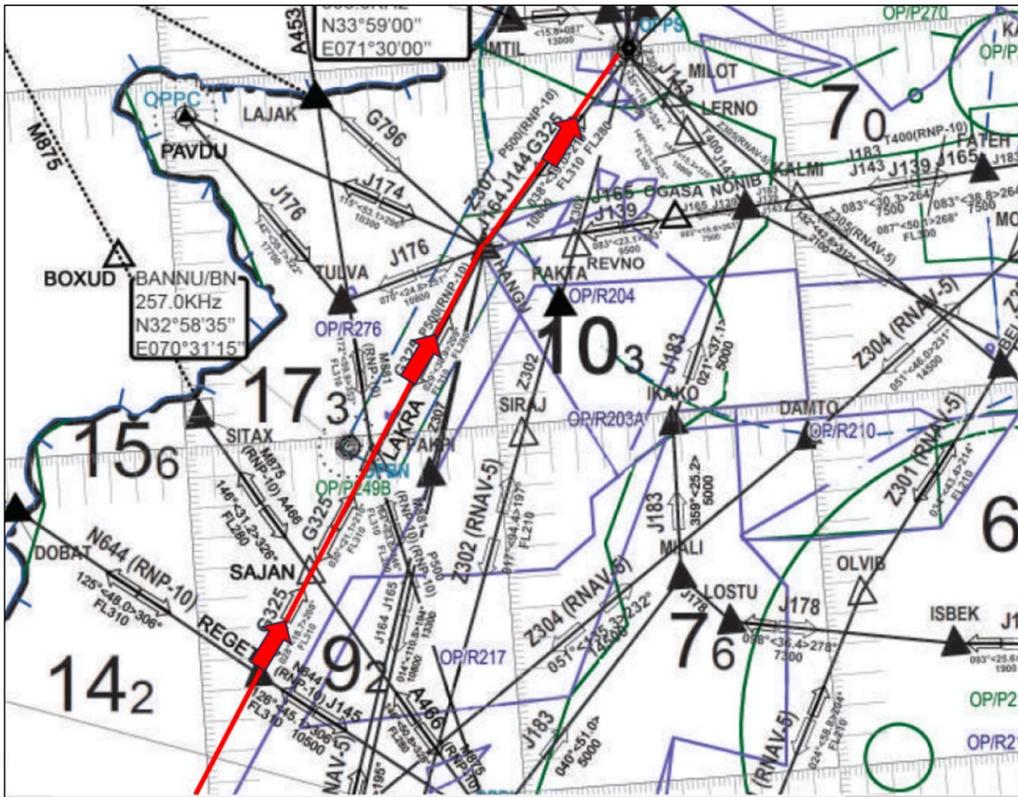
Figure 1 Route Map SVA792

1.1.1. On 05 March, 2024, Saudi Airline flight SVA792, Airbus 330-343 aircraft, Reg. No. HZ-AQ18, operated from OERK, Riyadh, KSA to OPSS, Peshawar, Pakistan on Air Traffic Services (ATS) route PG – G325 – LAKRA – P500 – HANGU – OPSS as a scheduled passenger flight.

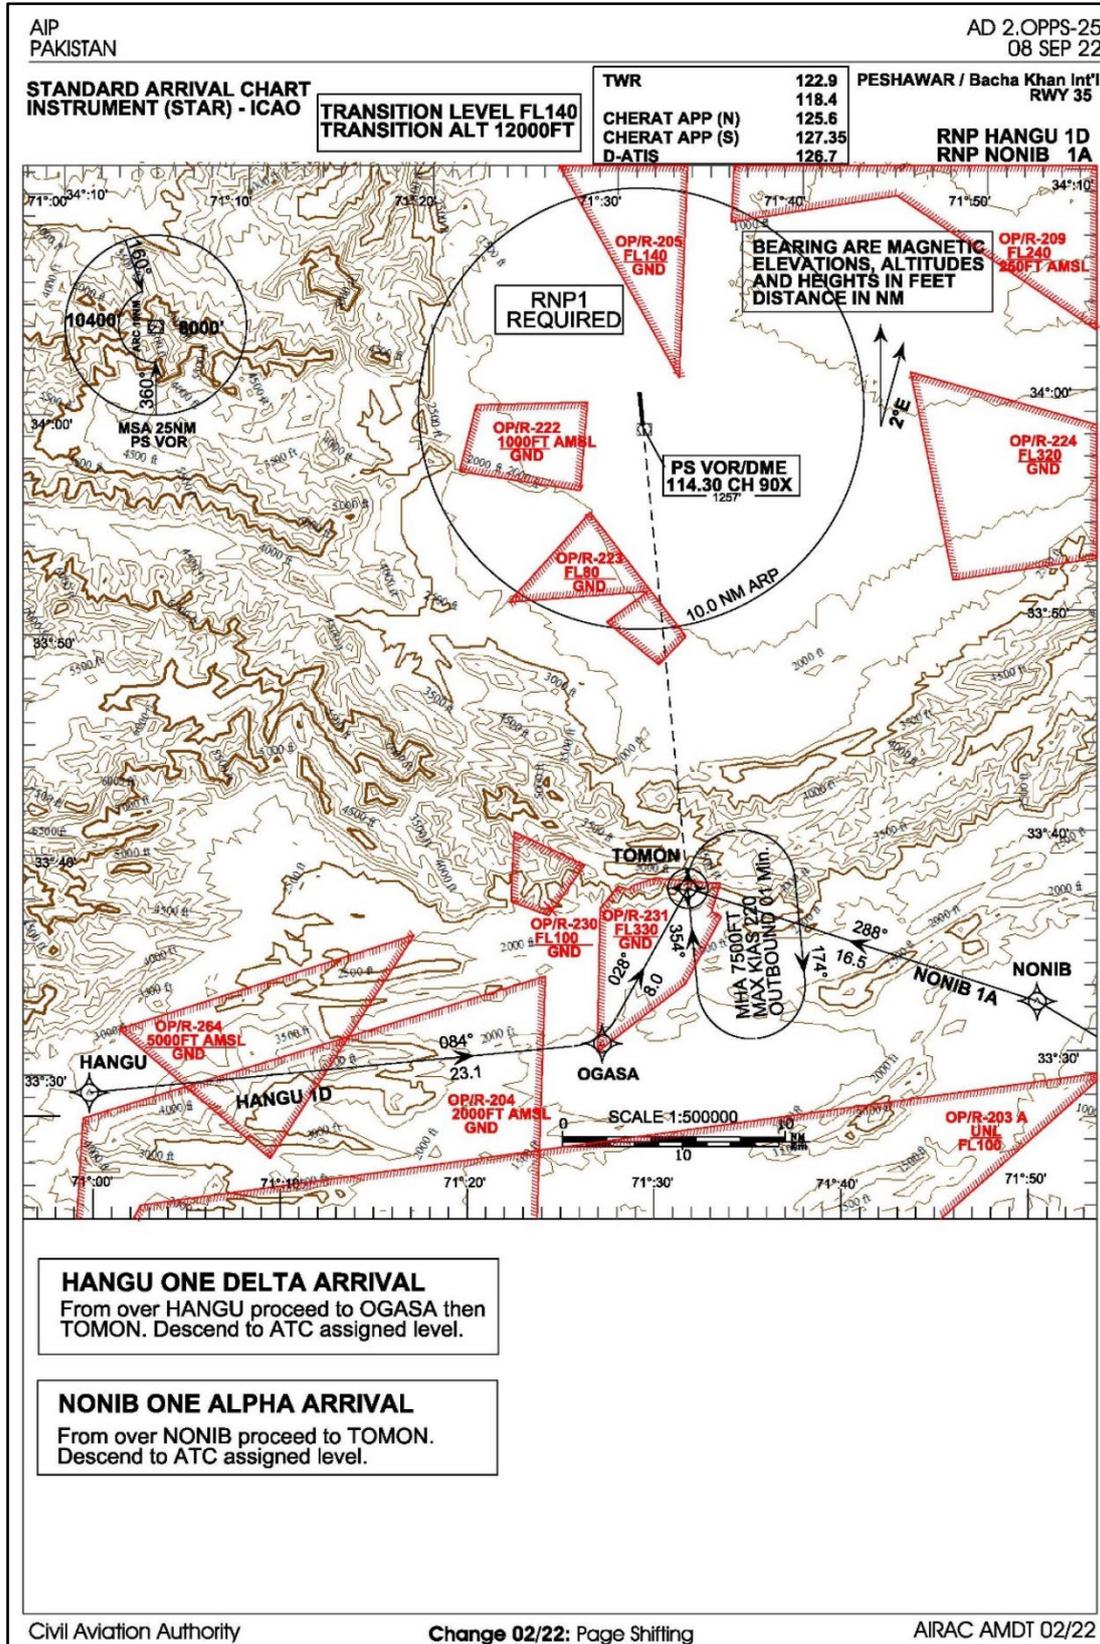
Figure 3 Approach Chart HANGU 1D Arrival

1.1.4. **035230.** SVA792 came in contact with Peshawar Tower at FL160, while proceeding to TOMON via HANGU 1 D Arrival as advised by previous controller (Cherat South Approach).

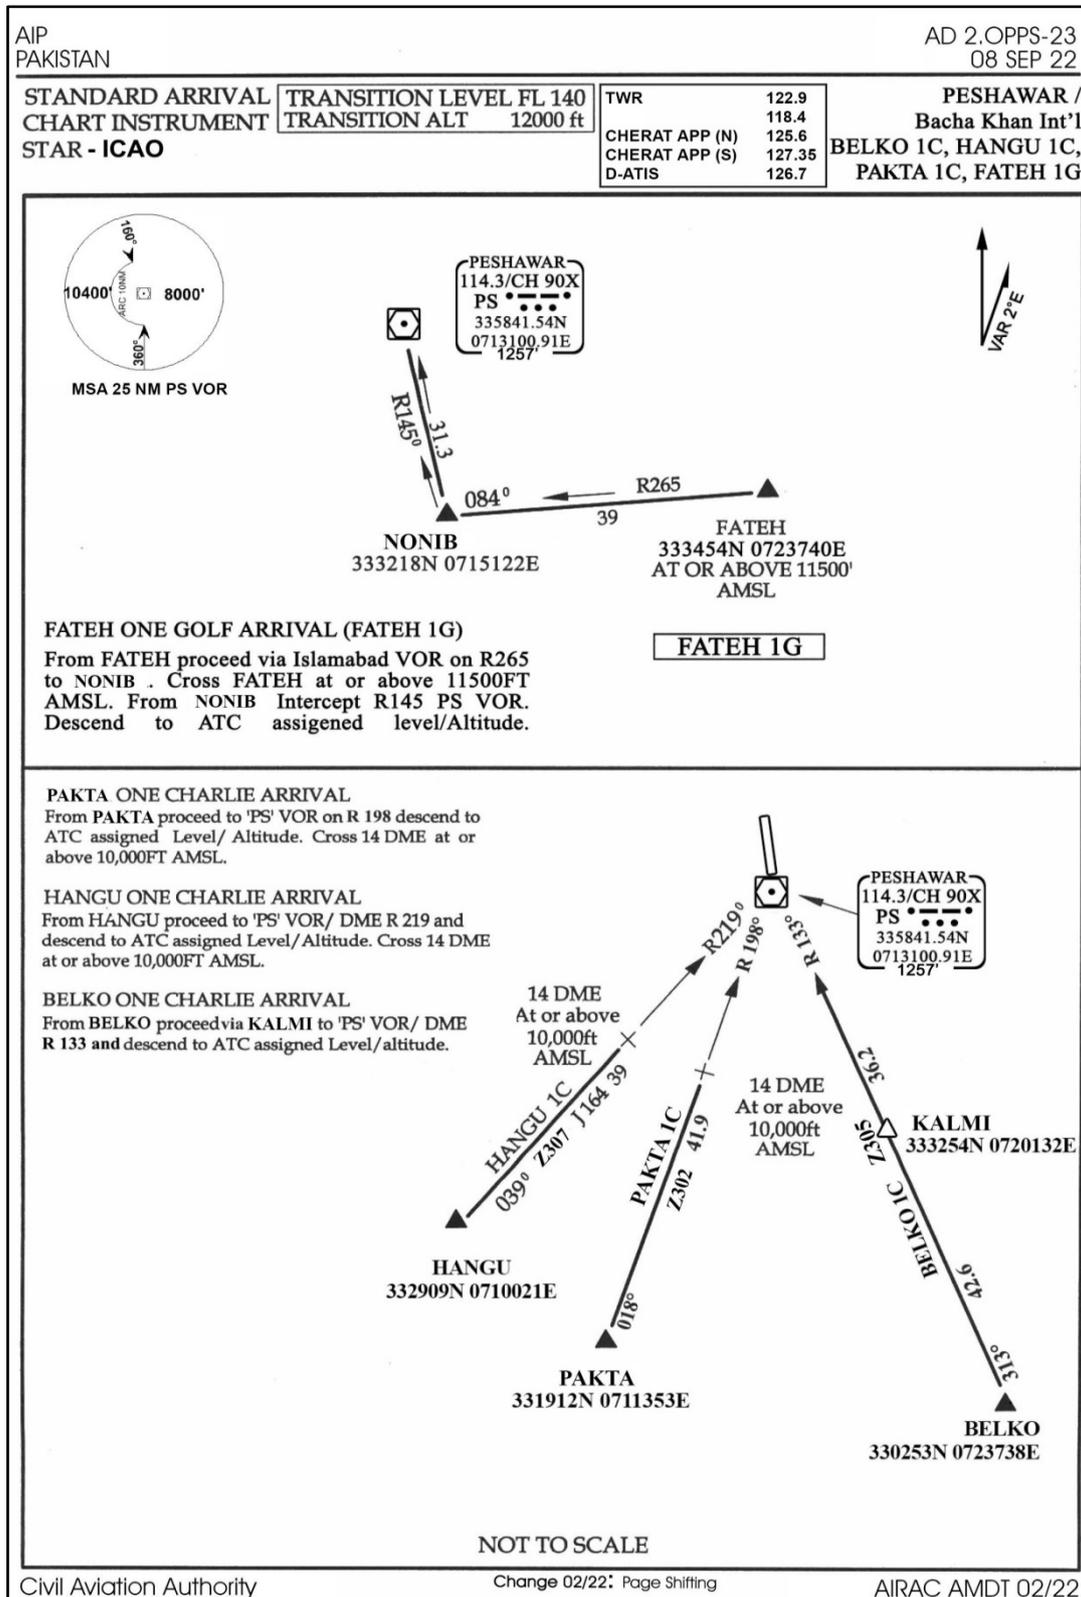
Figure 4 Approach Chart HANGU 1C Arrival

1.1.5. Civil Controller re-cleared the aircraft via HANGU 1 C Arrival for Instrument Landing System Zulu (ILS Z) Approach R/W 35 and instructed the pilot to report overhead PS VOR for holding due to ongoing military flying.

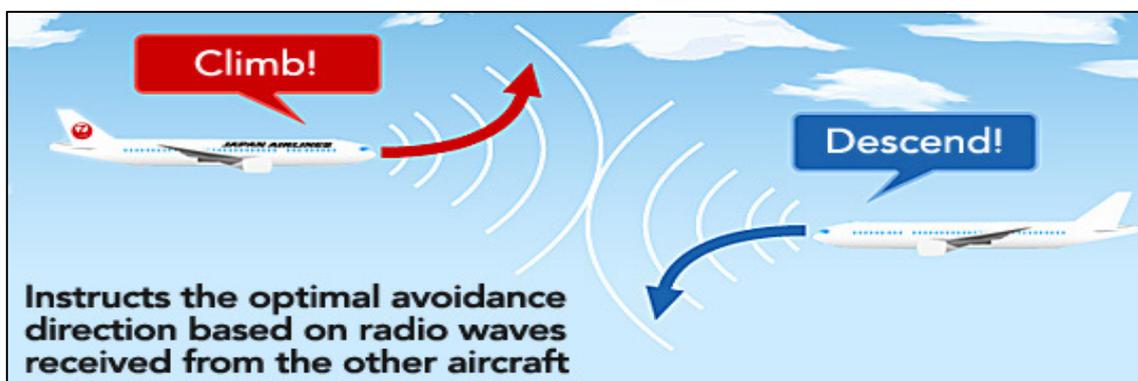
Figure 8 TCAS (TA) alert

1.18.1. **TCAS Working Principle** – TCAS stands for Traffic alert and Collision Avoidance System, and its purpose is to minimize the risk of mid-air collisions between aircraft. Working independently from Air Traffic Control, TCAS uses nearby aircraft's transponder signals to alert pilots to the danger of mid-air collisions. It does so by constructing a three-dimensional map of airspace through which the aircraft is travelling. In detecting the other aircraft's transponder signals, it can foresee the potential collisions based on speeds and altitude of planes passing through the airspace in question. If TCAS detects a potential collision, it will automatically notify each of the affected aircraft. In this instance, it will automatically initiate a mutual avoidance manoeuvre. This involves the system informing the crews of the aircraft in question both audibly and visibly to either climb or descend in a manner that ensures that, when their paths cross, they do not meet.

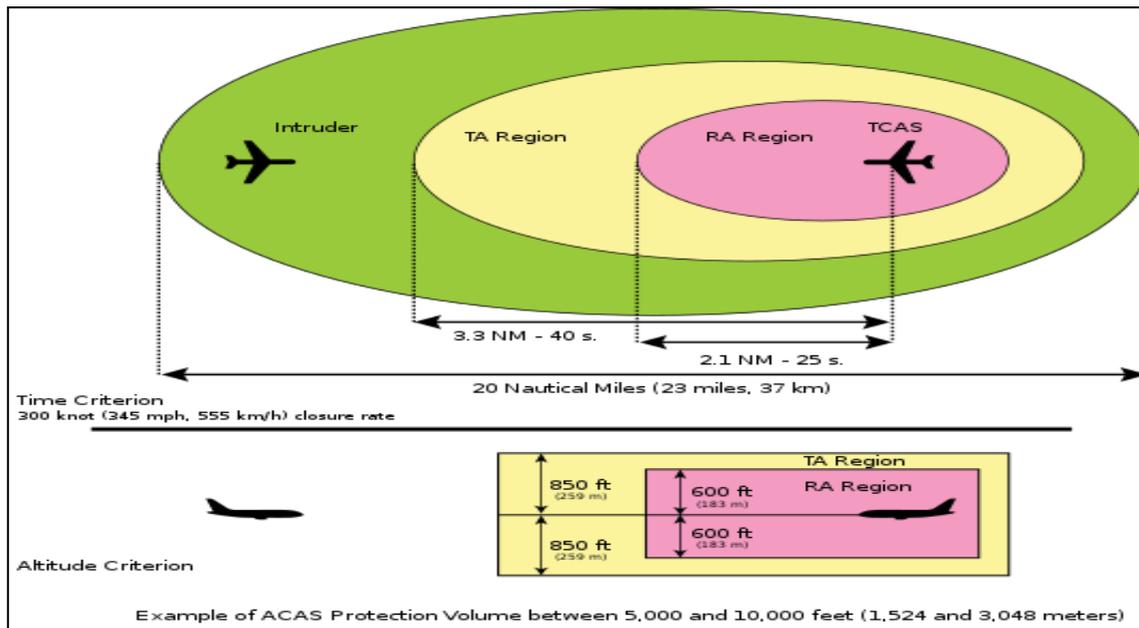
Figure 9 TCAS TA & RA ranges

1.18.2.1. The objective of ACAS is to provide advice to pilots for the purpose of avoiding potential collisions. This is achieved through Resolution Advisories (RAs), which recommend actions (including manoeuvres), and through Traffic Advisories (TAs), which are intended to prompt visual acquisition and to act as a precursor to RAs.

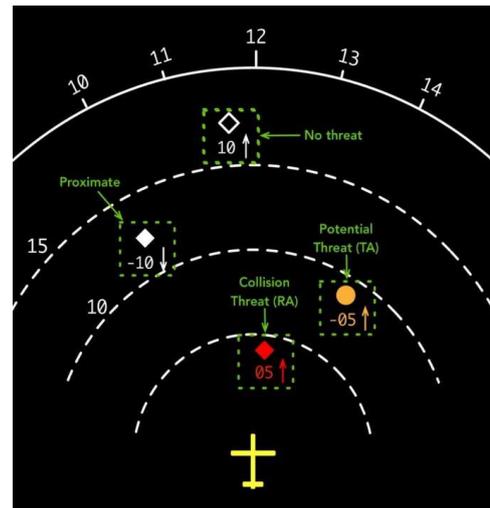
Figure 10 Traffic Display

1.18.3.4. Solid yellow or amber circle – for intruders (i.e. aircraft which trigger a TA).

1.18.3.5. Solid red square – for threats (i.e. aircraft which trigger an RA).
